Wheeler Army Airfield - Field Enclosure Photographs

HUD CONTRACT No.:	H-21248CA
PROJECT TITLE:	“Corrosion of Galvanized Fasteners used in Cold-Formed Steel Framing”
CONTRACTOR:	North American Steel Framing Alliance 1726 M Street, NW, Suite 601 Washington, DC 20036
Principal Investigator:	Tim Waite
Co/Investigators:	Don Moody, Kevin Bielat
SUB-CONTRACTOR:	University of Hawaii Dept. of Civil Engineering 2540 Dole Street, Holmes Hall 383 Honolulu, HI 96822
Principal Investigator	Dr. Ian N. Robertson
PROJECT PERIOD:	From 9/26/2000 to 11/25/2003
LITERATURE REVIEW REPORT:	December 27, 2000

CORROSION OF GALVANIZED FASTENERS USED IN COLD-FORMED STEEL FRAMING

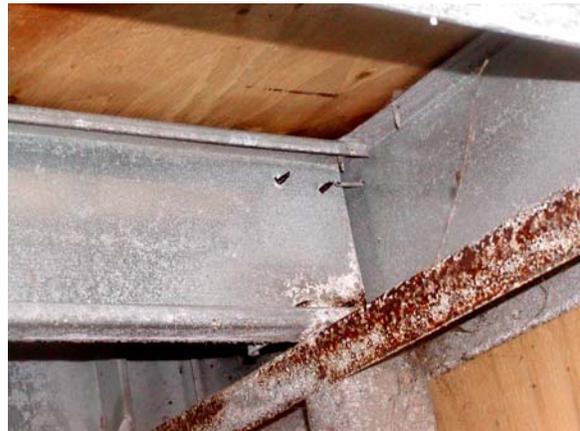
Figure E.82: Corrosion around opening in joist
