Corrosion of Galvanized Fasteners used in Cold-Formed Steel Framing

RESEARCH REPORT RP04-4

FINAL REPORT

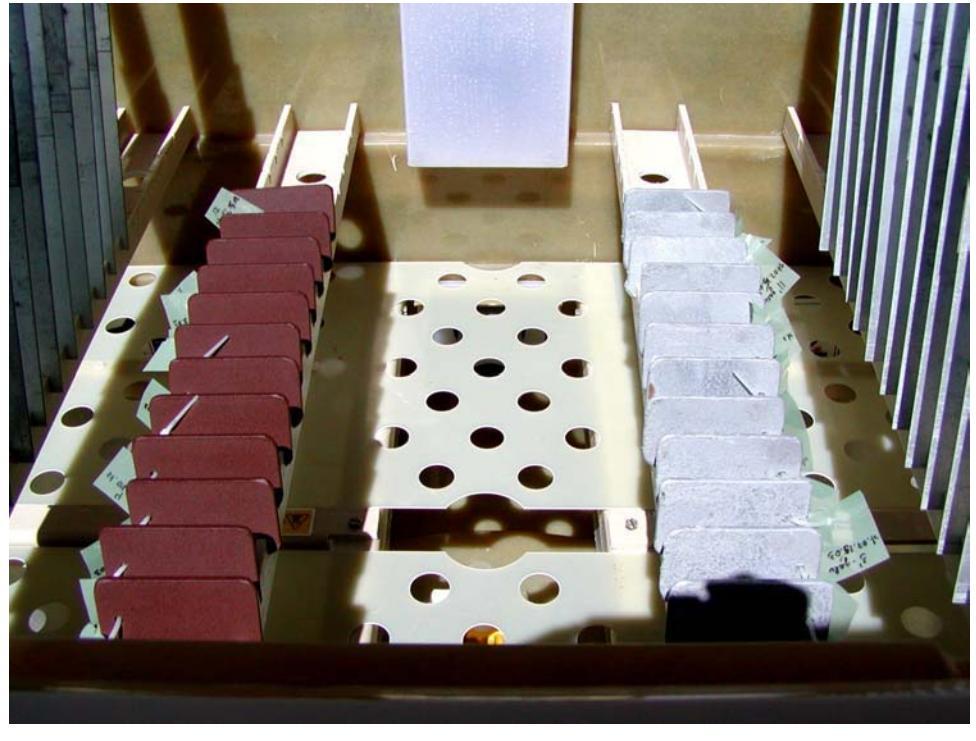
Figure 5.10: Steel and zinc coupons after 5 days in the corrosion chamber (160 cycles)

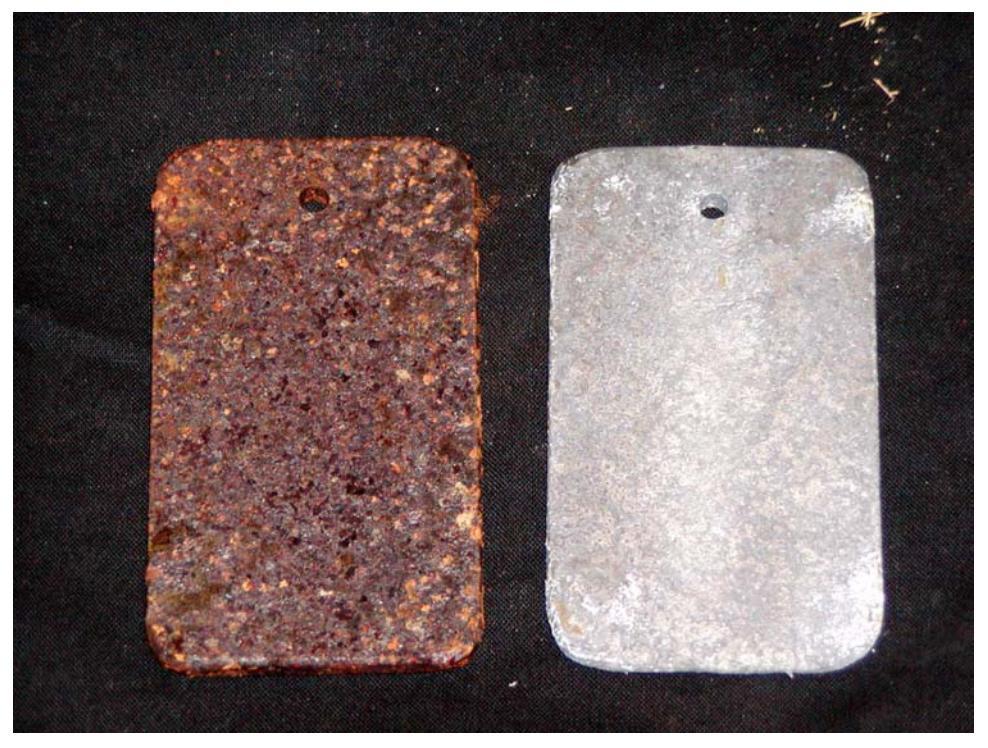
Figure 5.12: Steel and zinc coupons after 3186 cycles in the corrosion chamber.

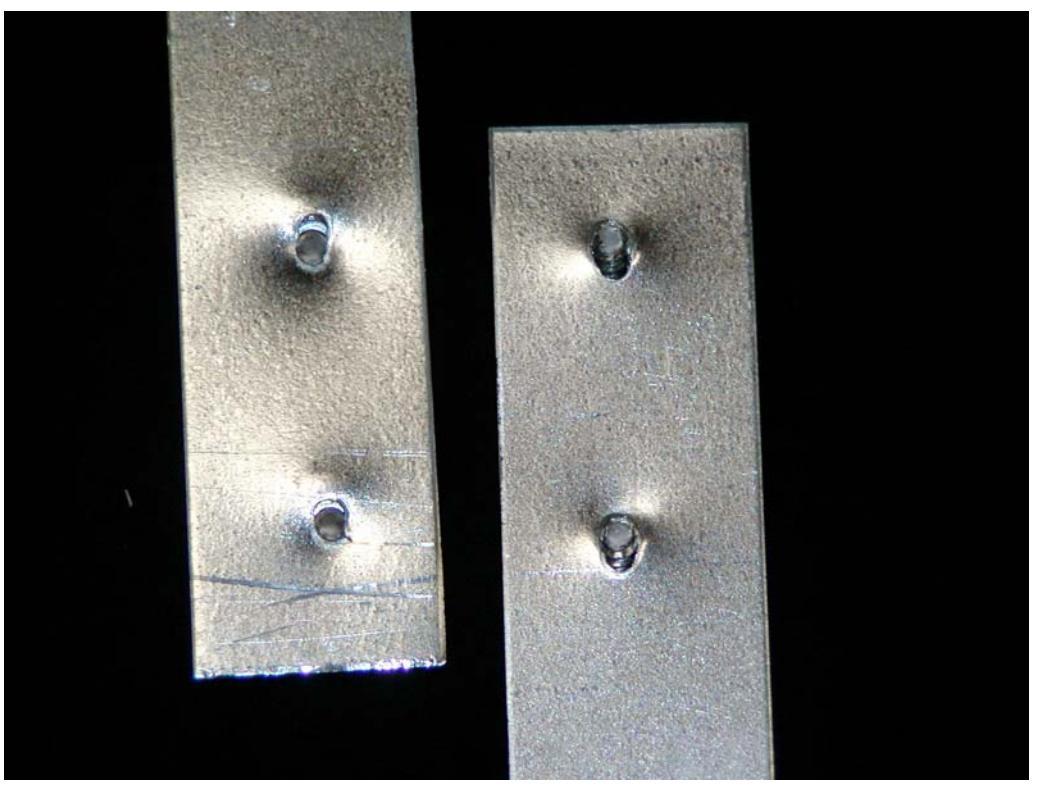
Figure 6.2: Typical control test specimen after failure.

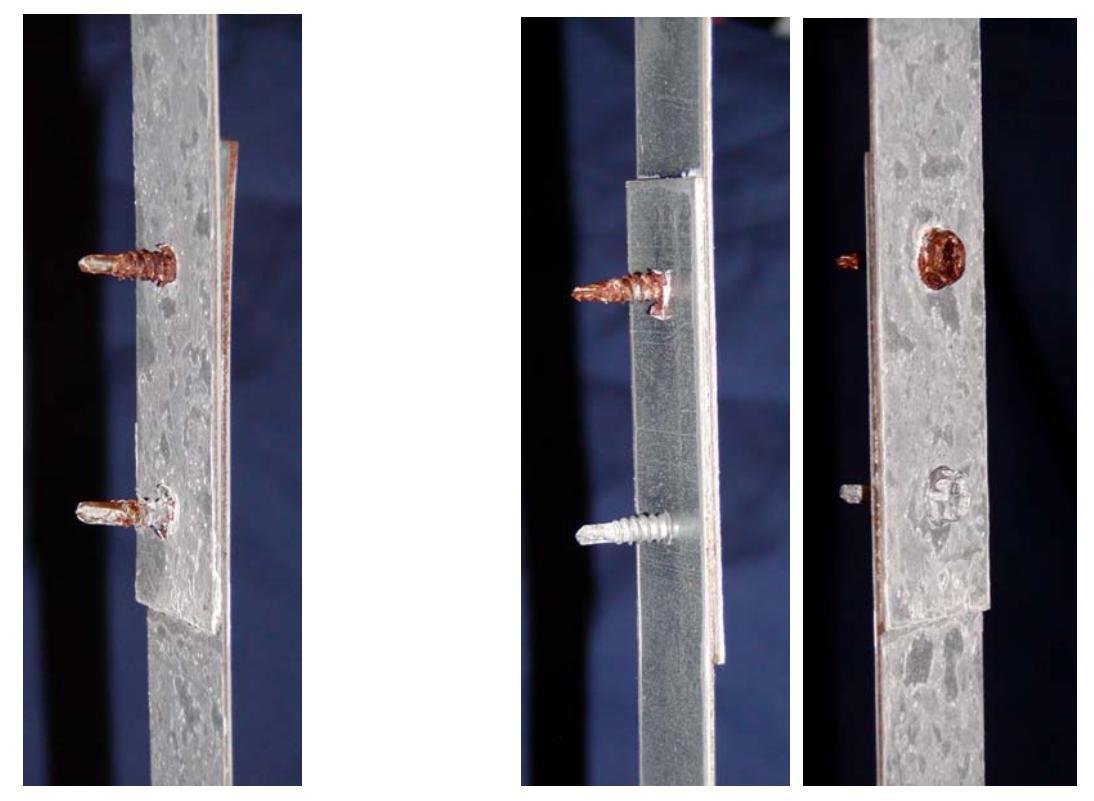
Figure 6.17: Test connections after 1056 cycles – Threads up (left) and down (right)

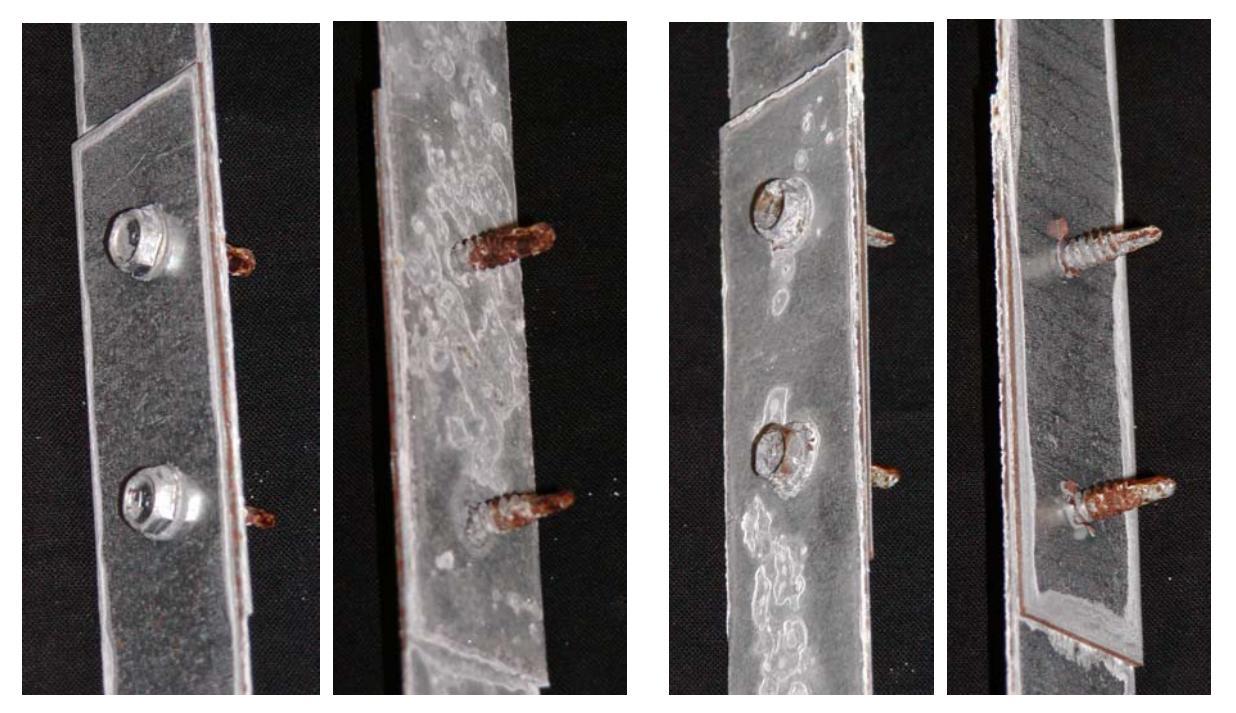
Figure 6.20: Test connections after 1309 cycles – Threads up (left) and down (right)

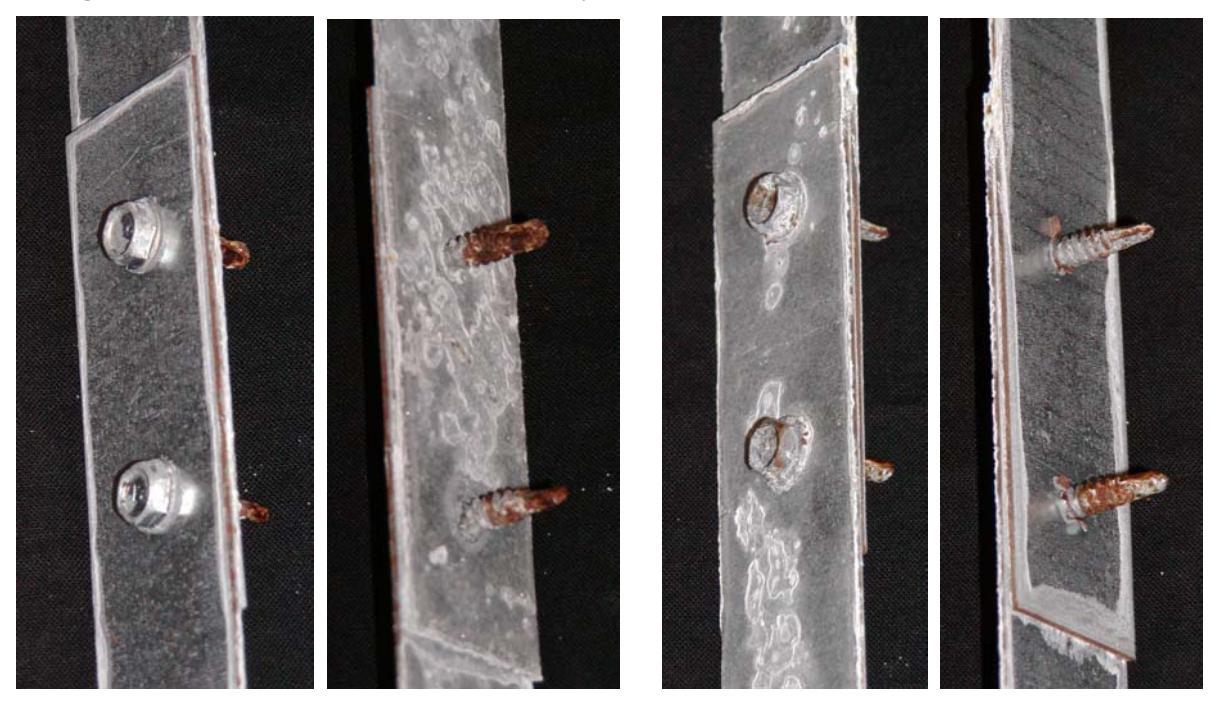
Figure 6.23: Test connections after 1537 cycles – Threads up (left) and down (right)

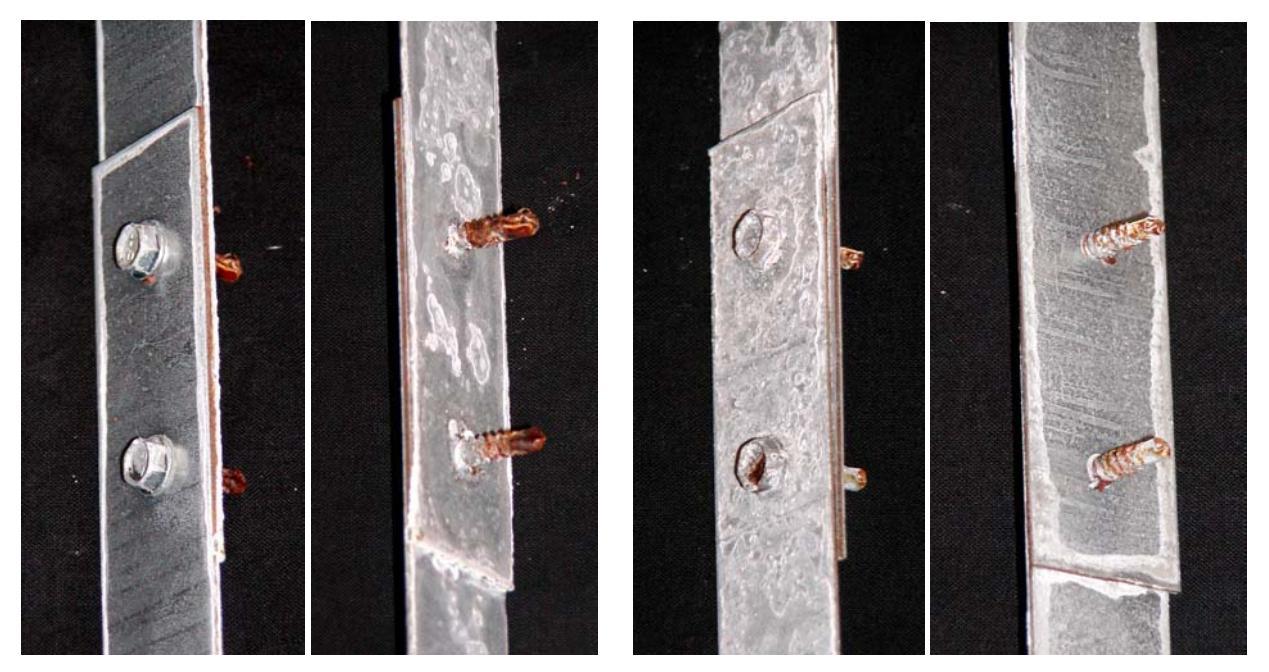
Figure 6.26: Test connections after 1695 cycles – Threads up (left) and down (right)

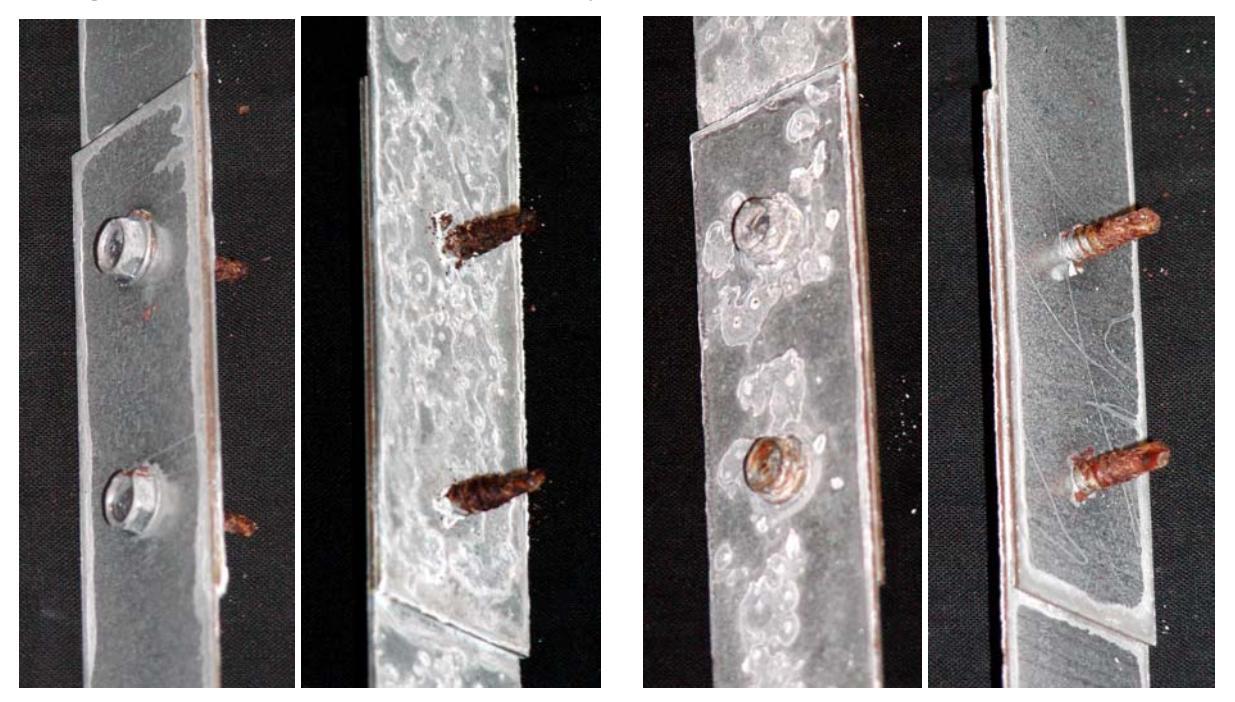
Figure 6.29: Test connections after 1979 cycles – Threads up (left) and down (right)

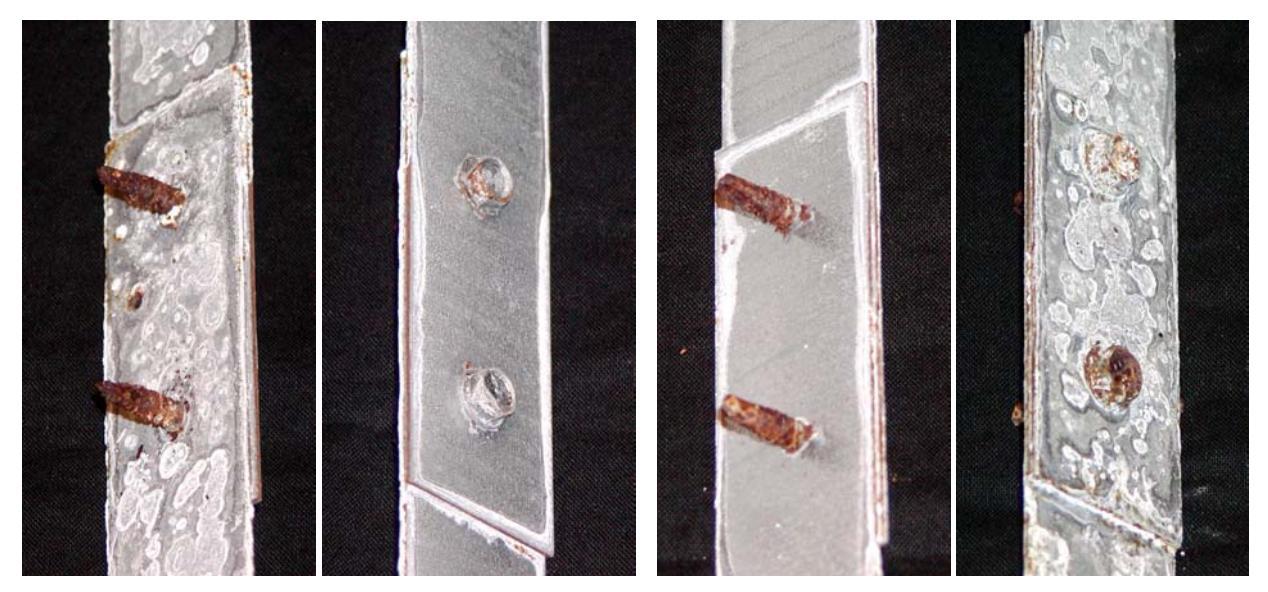
After 2772 cycles in the corrosion chamber, the galvanized screws showed significant surface corrosion (Figure 6.32). Nevertheless, the average connection strength had not decreased, regardless of whether the threads were oriented up or down in the corrosion chamber (Figure 6.35). However, the average specimen elongation at the peak load had decreased to around 80% of that for the control specimen (Figure 6.36). This decrease was larger for the connections stored with threads up. It appears that the connection ductility is affected by this level of corrosion, though the strength is not. Figure 6.37 to Figure 6.40 show microscopic images of the screw threads for control and 1537 cycle test specimens before and after testing. Although the surface corrosion appears significant, it has not yet penetrated the shaft of the screw, and hence has not affected the screw failure strength (Figure 6.40).

Figure 6.32: Test connections after 2772 cycles – Threads up (left) and down (right)

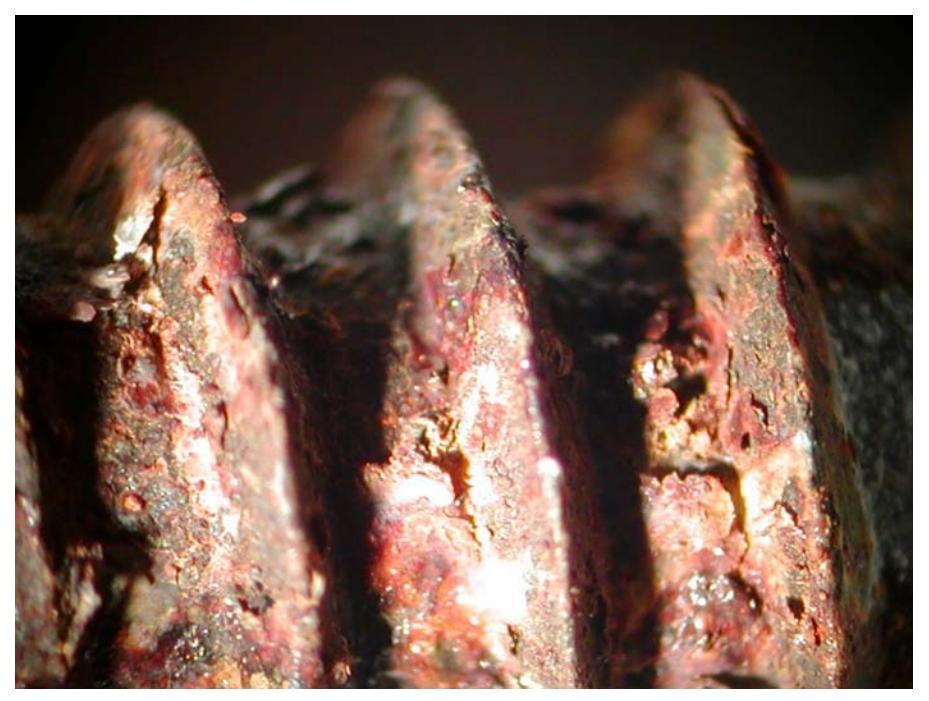
Figure 6.38: Screw threads after 1537 cycles in the corrosion chamber.

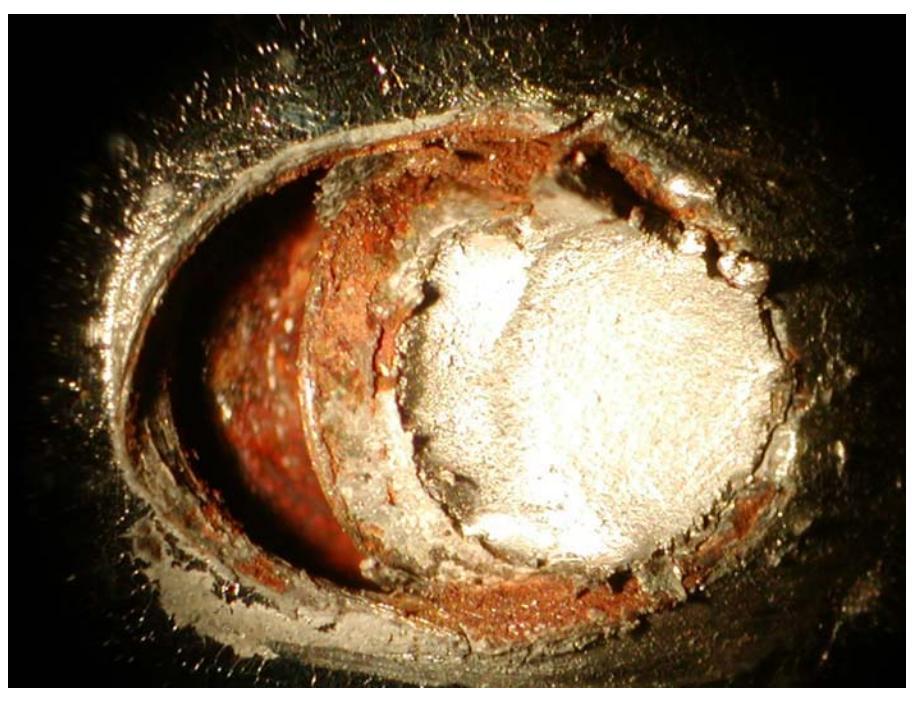
Figure 6.40: Close-up of screw threads after failure of 1537 cycle specimen.

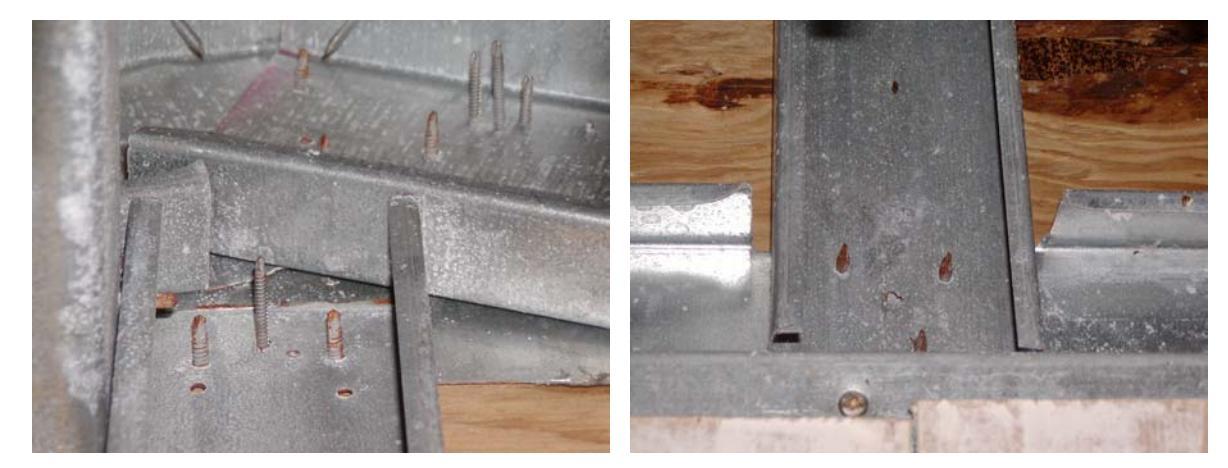
Figure 7.2: Attic framing at Iroquois Coastal site after 20 months exposure.

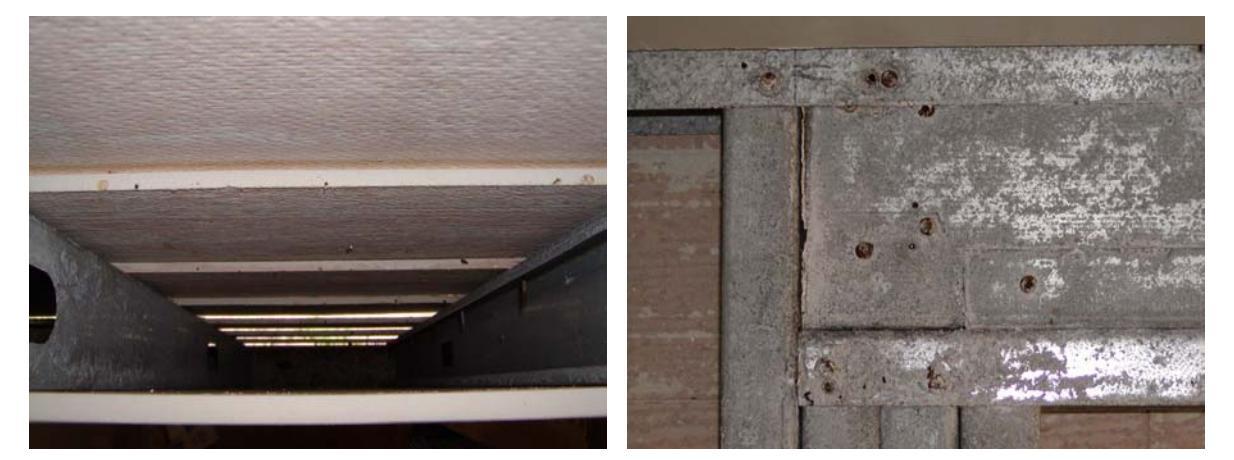
Figure 7.19: Wall framing with lap siding without vapor barrier, MCBH Coastal after 16 months.

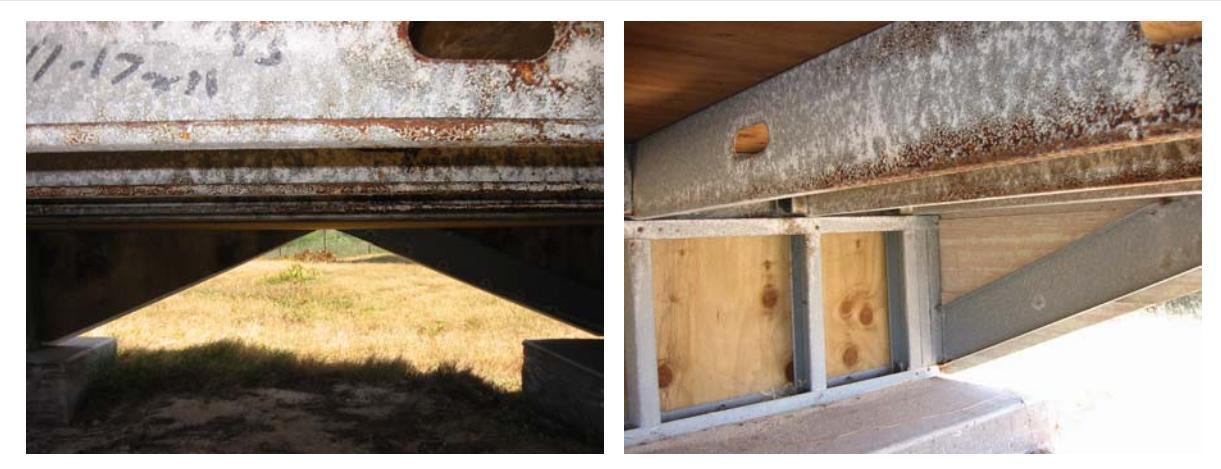
Figure 7.33: Crawl space exposed floor joists, MCBH Coastal after 10 months.

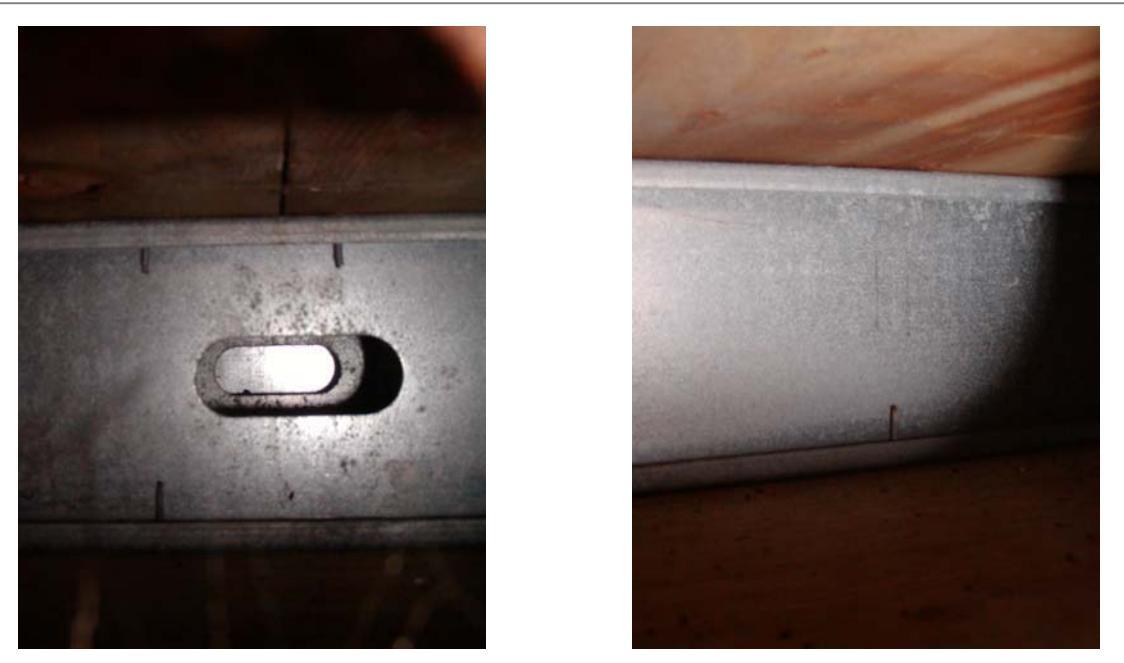
Figure 7.35: Crawl space covered floor joists, MCBH Coastal after 16 months.

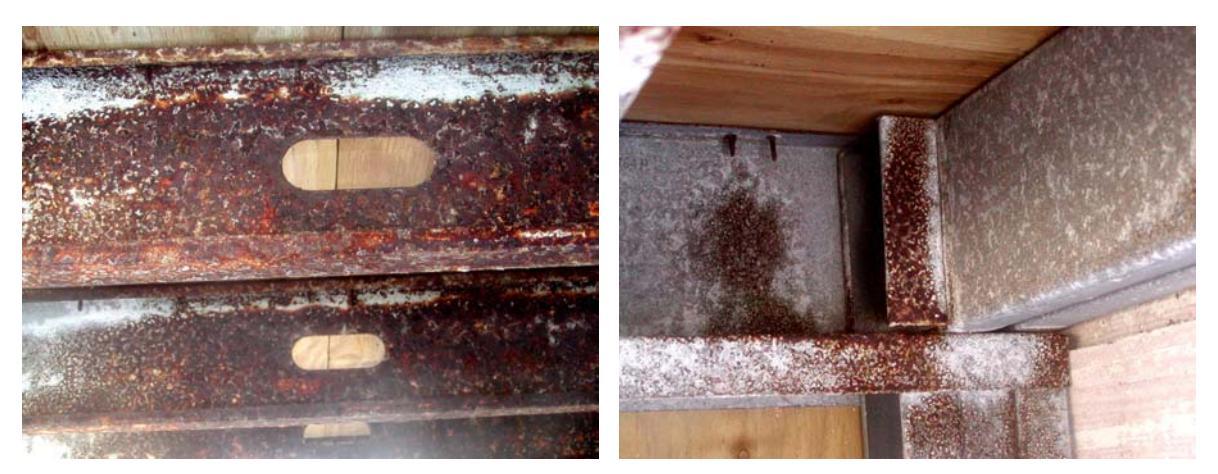
Figure 7.36: Crawl space exposed floor joists, MCBH Coastal after 21 months.

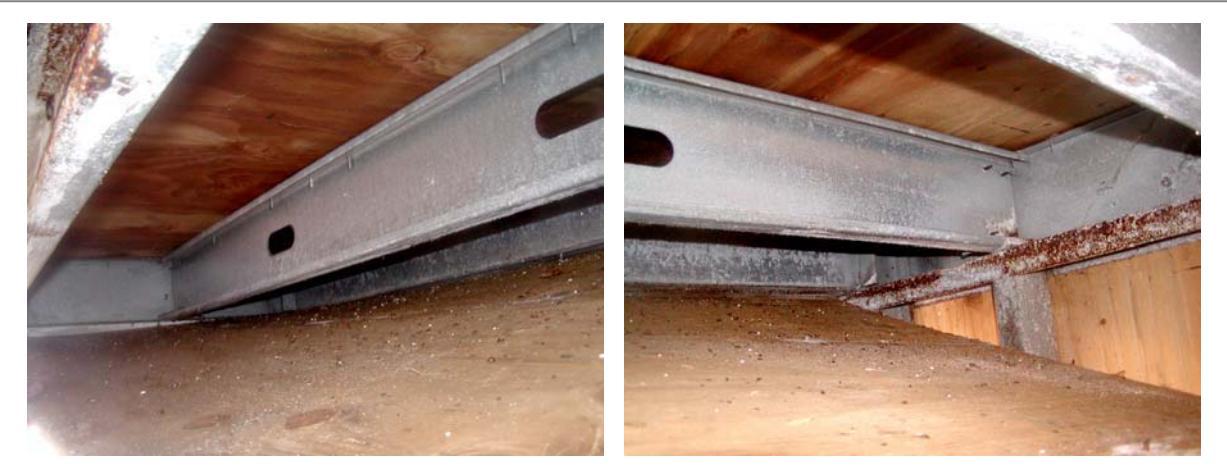
Figure 7.37: Crawl space covered floor joists, MCBH Coastal after 21 months.
