Steel vs. Wood Framing ***Long-Term Thermal*** ***Performance Comparison*** ***Beaufort, SC*** ***Demonstration Homes***

***Steel vs. Wood Framing
Long-Term Thermal
Performance Comparison

Beaufort, SC
Demonstration Homes***

July 2003

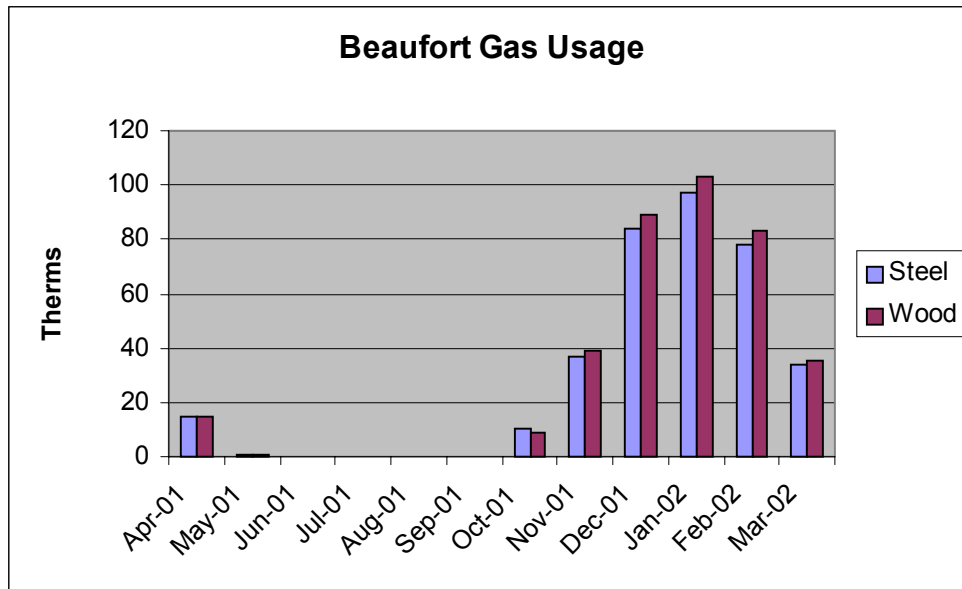
Natural gas consumption in the steel-framed house was slightly lower during the heating months averaging 5.1 percent less than the wood-framed house for the year as shown in Figure 9.2. On a monthly basis, the energy was consistently around 6 percent lower with the lower-use shoulder months of April and October coming in at 1 percent and 14 percent higher for the steel framed house respectively. The actual differences are both less than 2 therms for each month, but it illustrates the sensitivity of the steel house to changing outdoor conditions.

Figure 9.2. Beaufort Gas Usage

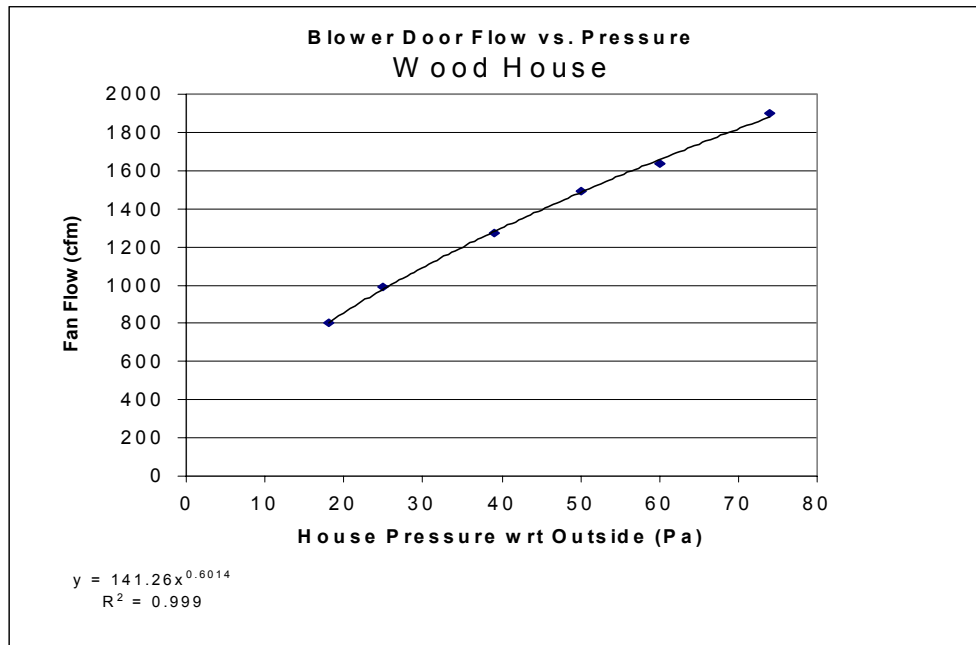
The blower door results are virtually identical for the two houses, as the difference between the two is only 3.6 percent indicating that both steel-framed and wood-framed homes have approximately the same leakage rate. The Estimated Leakage Area (ELA) of the steel-framed house was 7.6 percent higher than that of the wood-framed house. The air tightness of both homes was average by today's construction standard (when compared to a general database of building tightness measurements.) The similarity of the results may indicate that the leakage is originating from common details like the rim joists, windows, plumbing/electrical penetrations, recessed lights, and attic hatches.

Figure B1. Blower Door Flow vs. Pressure (Wood House)

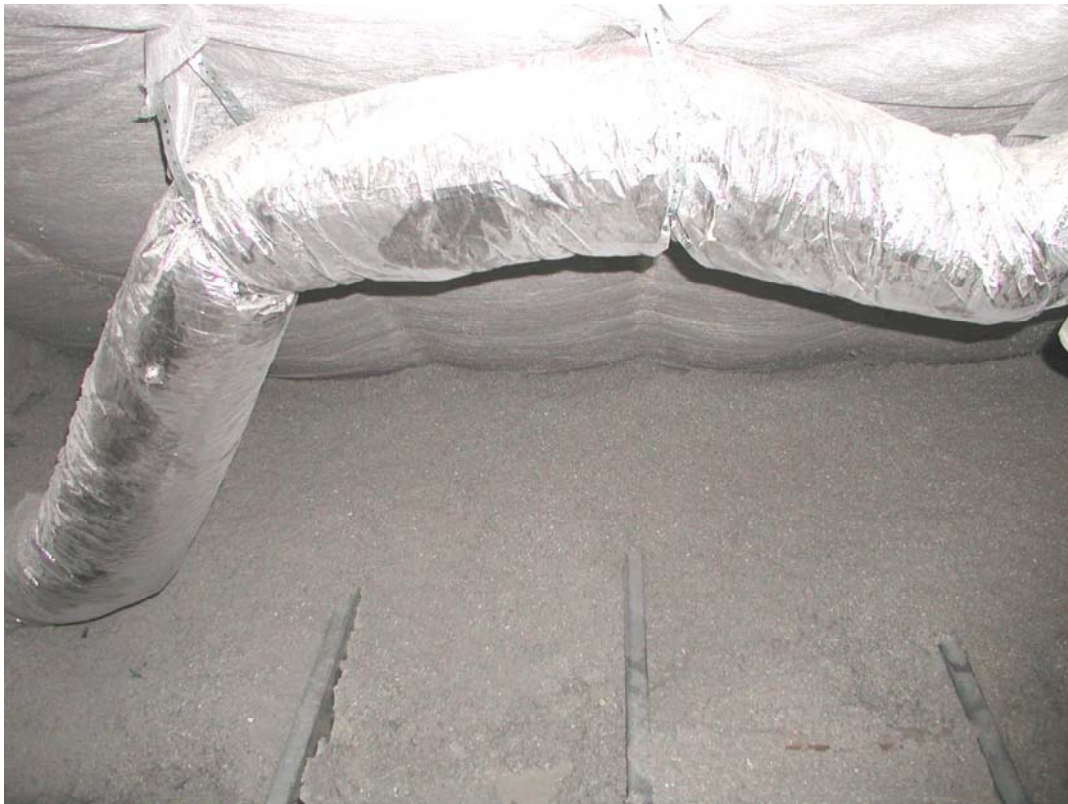
**Figure D2. Steel Framed House
Insulated Attic Rafters and Floor**

Radiated heat from the sun is conducted in the steel framed attic much more readily than the wood attic. Figure D.2 (Appendix D) shows that in the steel attic, the framing will conduct the roof temperature (which can exceed 170°F) directly into the attic air space through the steel rafters. The roof heat encounters no insulative barrier to slow down the transmission of heat. The wood attic has the insulative value of the wood members to reduce the direct solar gains.

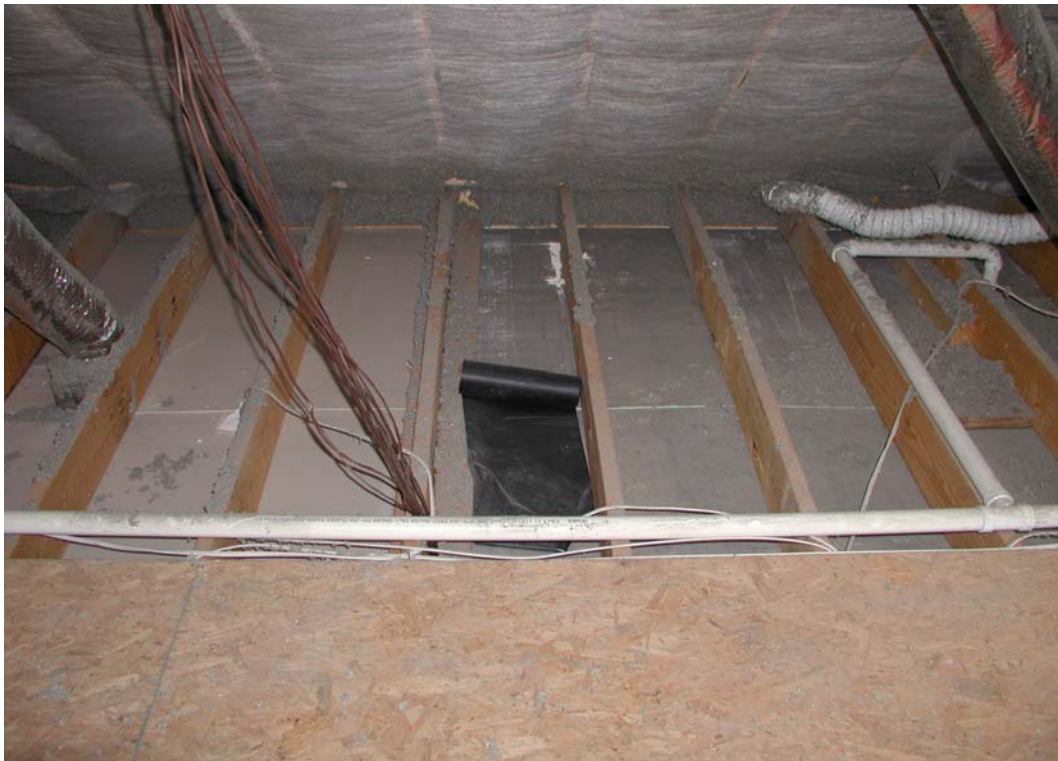
**Figure D3. Wood Framed House
Insulated Attic Rafters and Uninsulated Floor**

This unusual scenario is attributed to the vented attic and the lack of insulation on the floor of the wood attic. Solar attic gains could conduct directly into the wood house through the uninsulated attic floor during the day thus reducing energy use. After the sun sets, the vented attic would begin to cool and heat from the house would conduct back into the vented attic, thereby increasing the nighttime load. The net result is 5.1 percent less heating energy being consumed by the steel house.

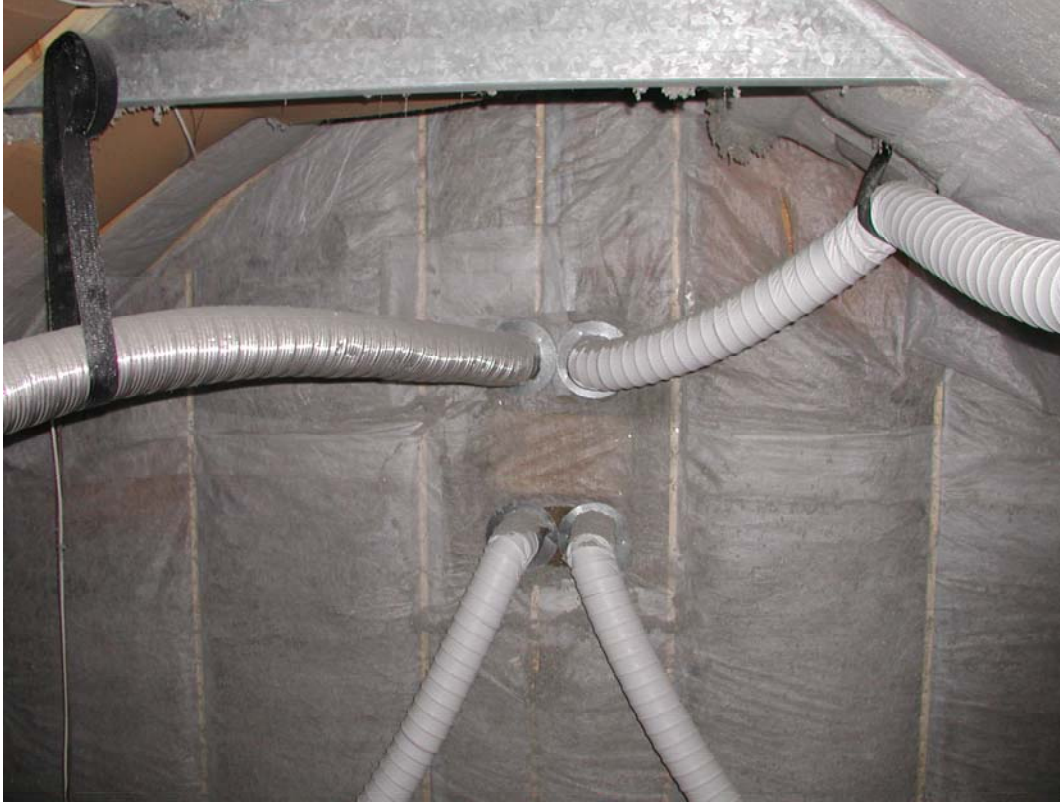
Figure D3. Conditioned Attic with Ventilation

The attics were constructed in a non-standard manner. The vaulted portions of the attics were insulated in both houses making the attic a conditioned space. But, contrary to good design, the conditioned attics also contained vents to the outside. Good design would locate the thermal barrier at the same point as the air barrier. In the wood house the air barrier is the attic floor and the thermal barrier is the vaulted portion of the attic, allowing air to vent into the attic, bypassing the insulation and conduct into the house with no insulation. This was not as much of an issue with the steel house that also had insulation on the attic floor, thus creating a second thermal plane.
