Corrosion of Galvanized Fasteners used in Cold-Formed Steel Framing

RESEARCH REPORT RP04-4

FINAL REPORT

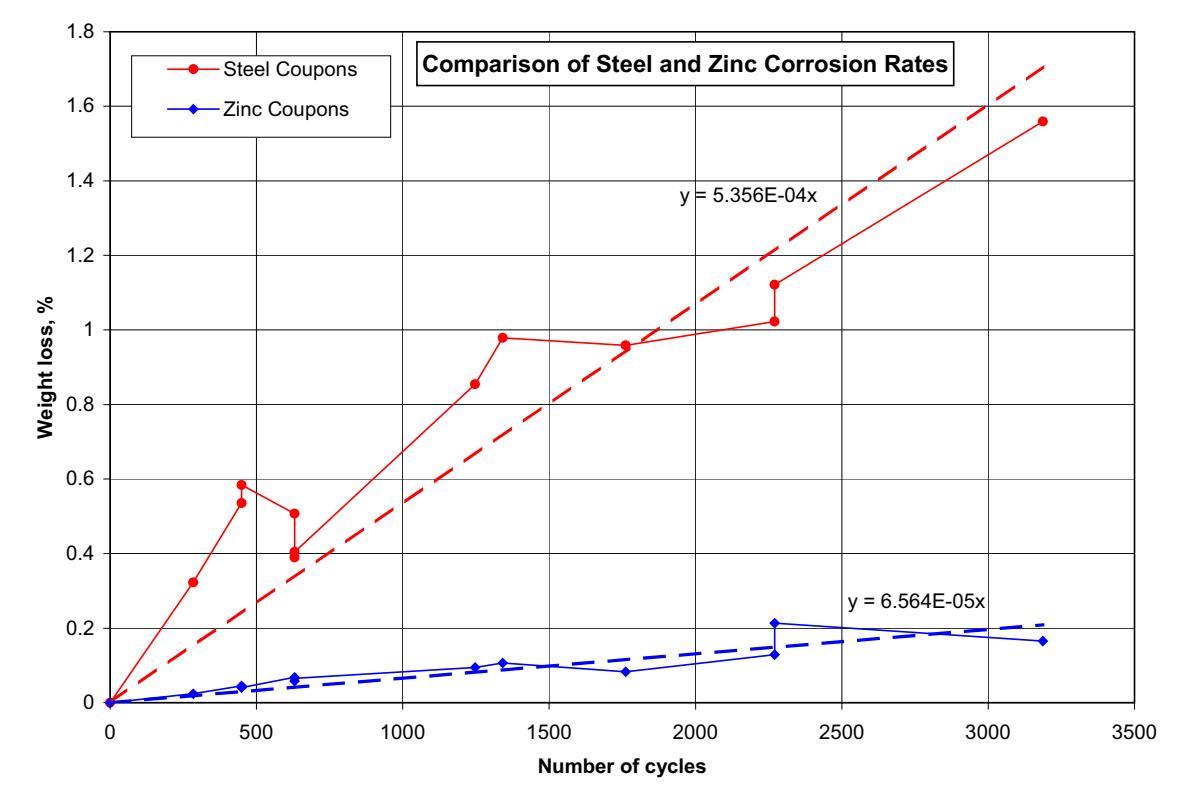
Figure 5.13 to Figure 5.15 compare the corrosion rates for steel and zinc coupons recovered after various periods of exposure in the corrosion chamber. Figure 5.13 shows the weight loss in percent of original weight for steel and zinc coupons. The steel coupons are corroding at a far higher rate than the zinc coupons as shown by the trend lines in Figure 5.13. Figure 5.14 shows the ratio between the percent weight loss for steel and zinc. The trend line shows that this rate started close to 10 and has reduced to 7.5 after 3200 cycles. The cyclic routine applied in the corrosion chamber is therefore replicating atmospheric conditions reasonably well according to the reported rate of approximately 10 (Zhang, 1997).

Figure 5.13: Comparison of corrosion rates for steel and zinc coupons in the corrosion chamber

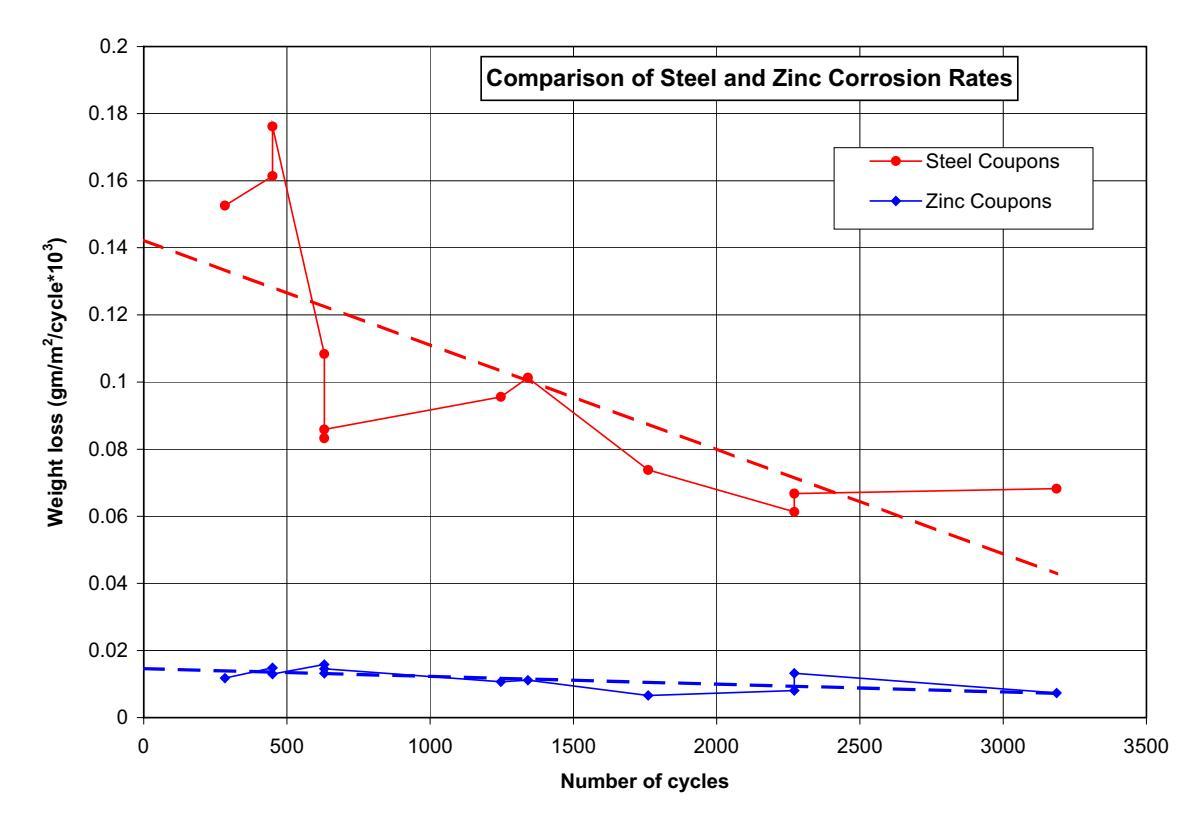
Figure 5.15 shows the corrosion rate for steel and zinc coupons in terms of average mass loss per surface area per cycle in the corrosion chamber. For both materials, this rate decreases with time spent in the chamber, though this decrease is greater for the steel coupons.

Figure 5.15: Steel and zinc corrosion rates in terms of mass loss per surface area per cycle

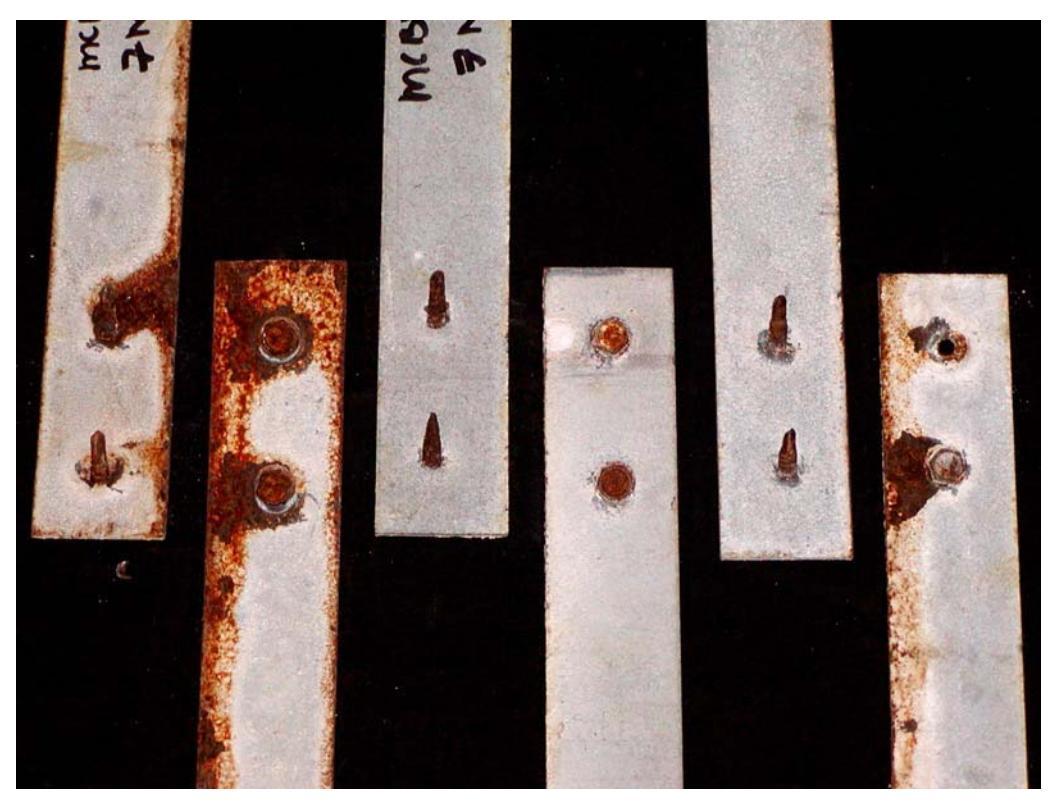
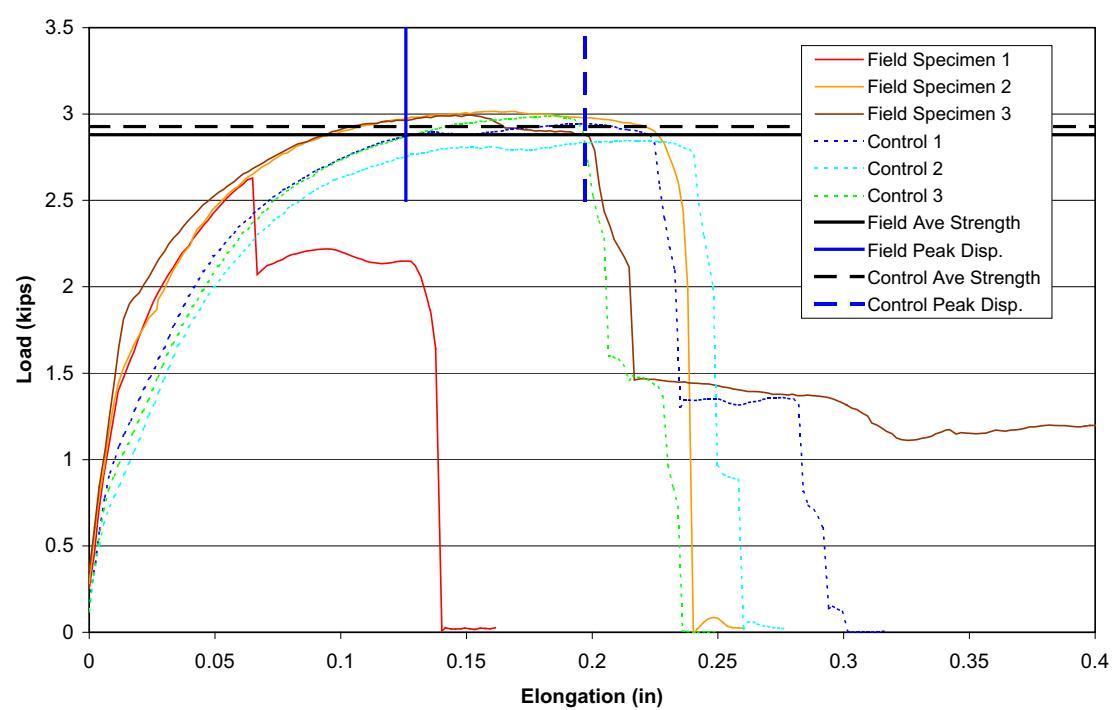
Figure 6.3: MCBH Coastal – 7 Months Exterior Exposure

Figure 6.4: MCBH Coastal – 7 Months Exterior Exposure – Test Results

However, the displacement ratio shows a significant decrease in ductility for the MCBH Coastal specimens that were subjected to exterior exposure, and a modest decrease for the other connection sets (Figure 6.16). The average peak elongation of the field test specimens after 7 months exposure is 74% of that observed in the control connections. This reduction in average elongation is often the result of a single connection, which failed at a significantly lower deformation than the control specimens.

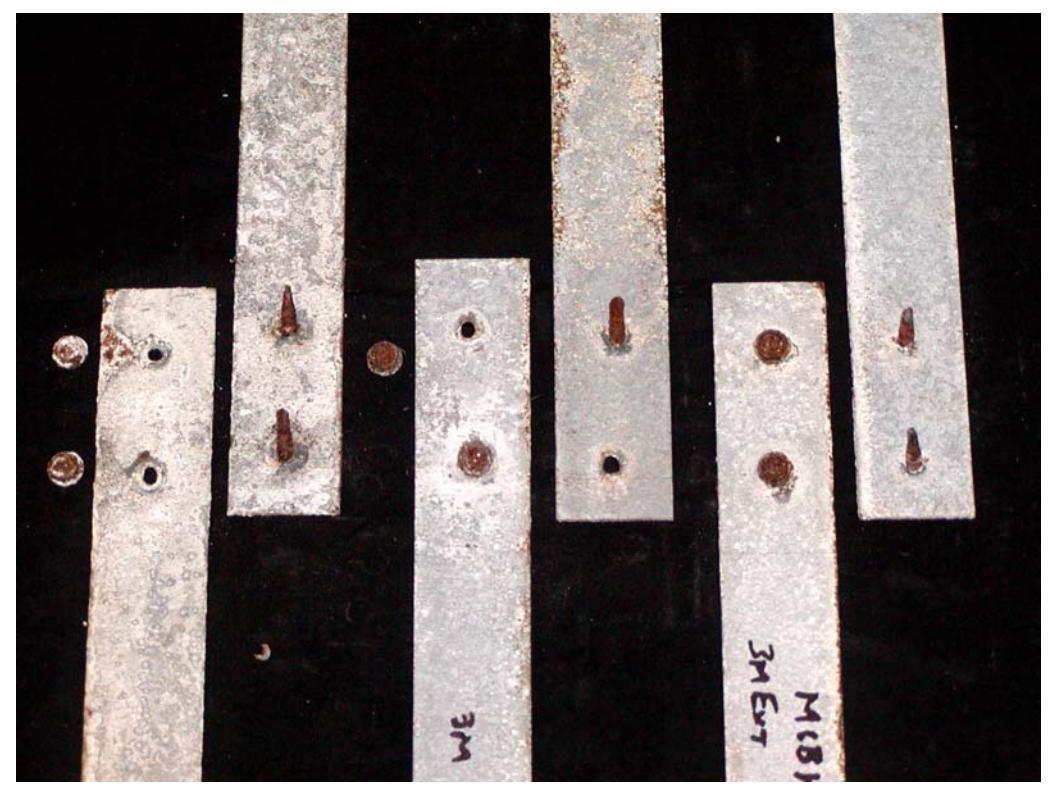
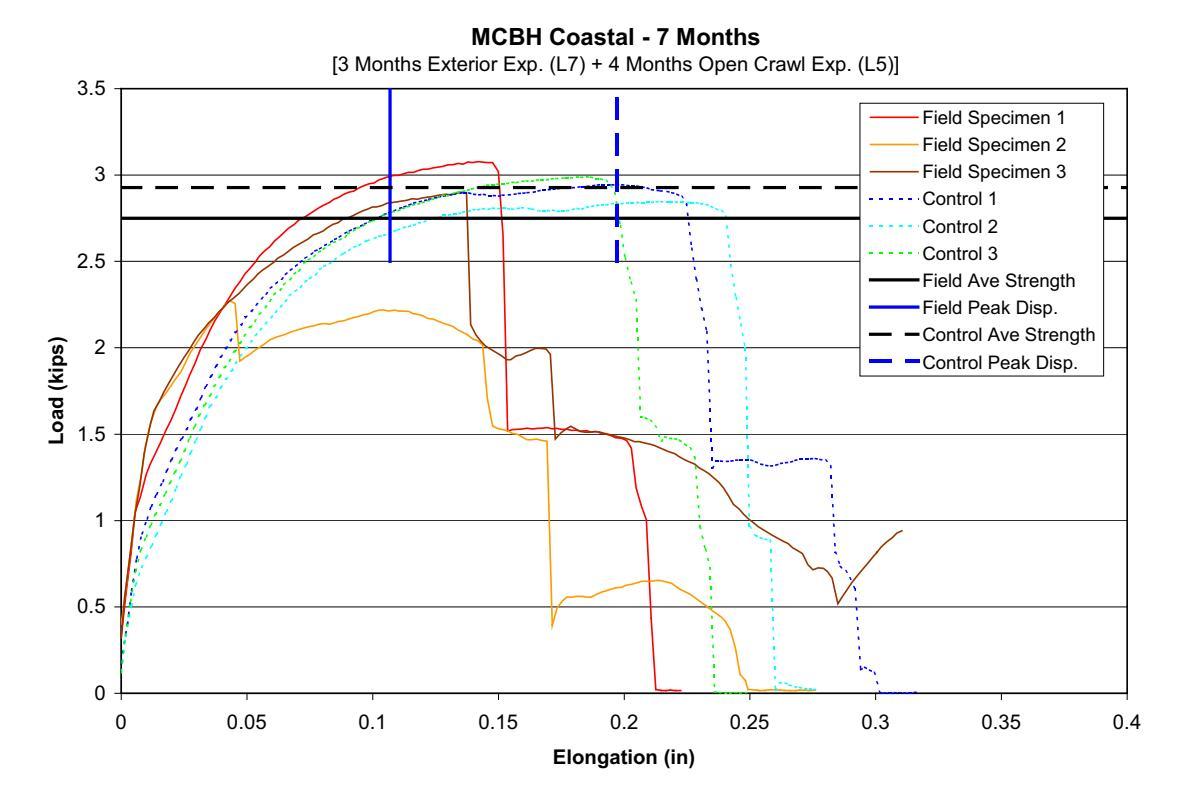
Figure 6.5: MCBH Coastal – 3 Months Exterior Exposure + 4 Months Open Crawl Exposure

Figure 6.6: MCBH Coastal – 3 Months Ext. Exp. + 4 Months Open Crawl Exp. – Test Results

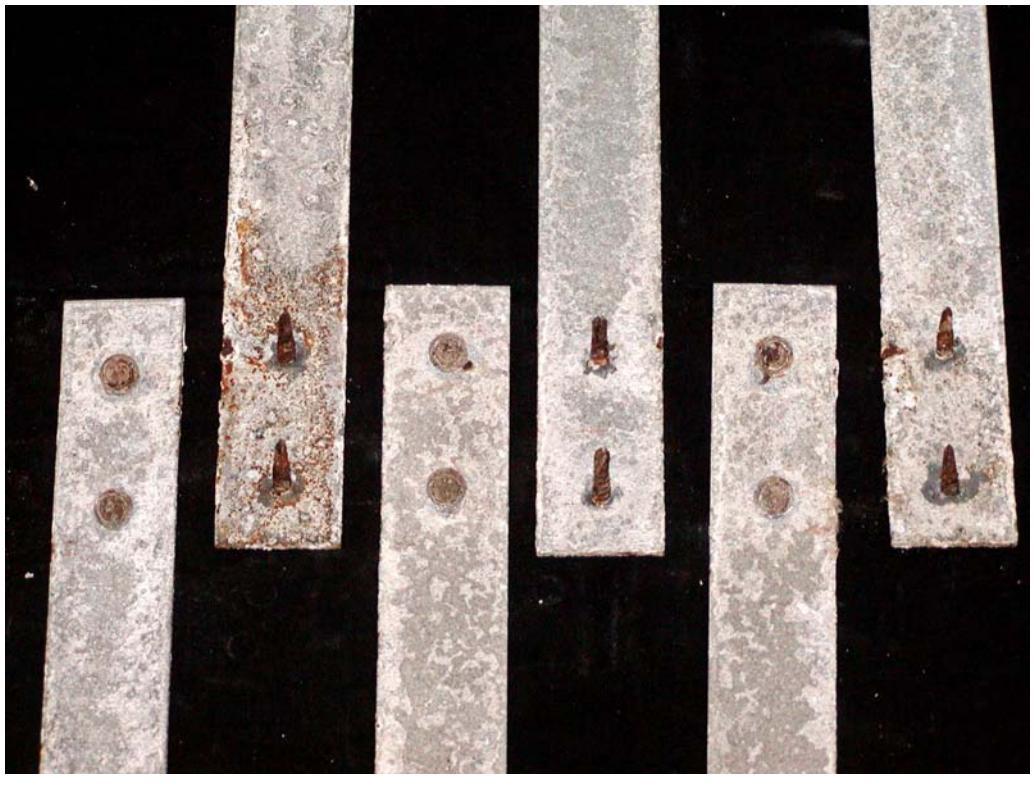
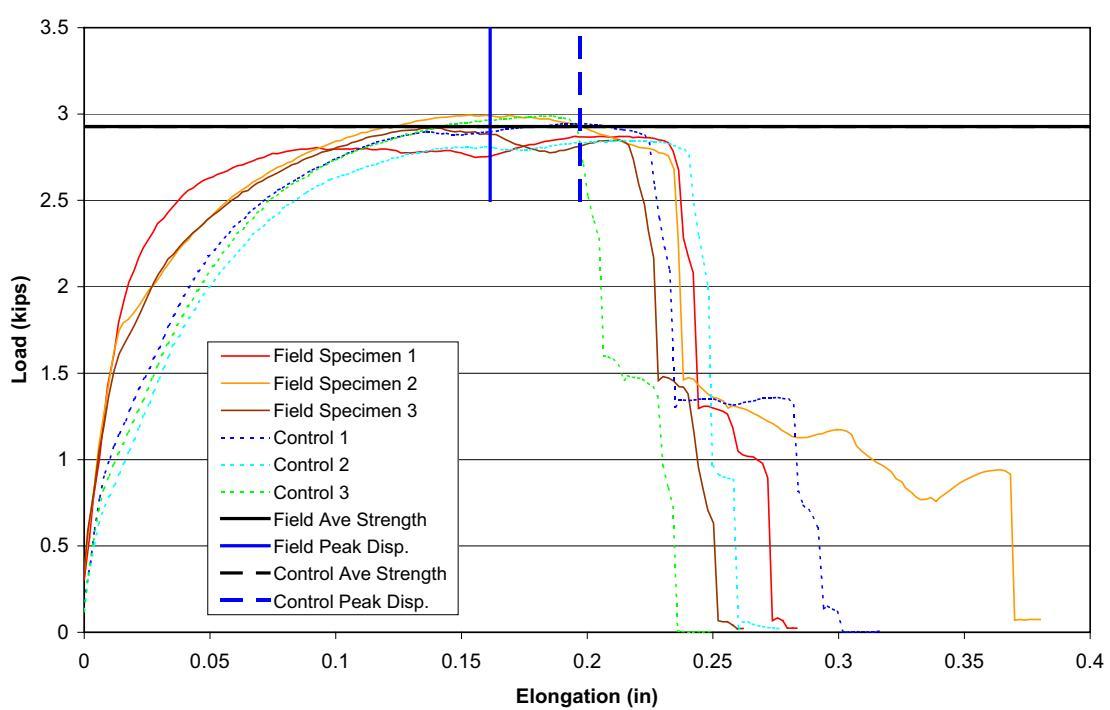
Figure 6.7: MCBH Coastal – 7 Months Open Crawl Exposure

Figure 6.8: MCBH Coastal – 7 Months Open Crawl Exposure – Test Results

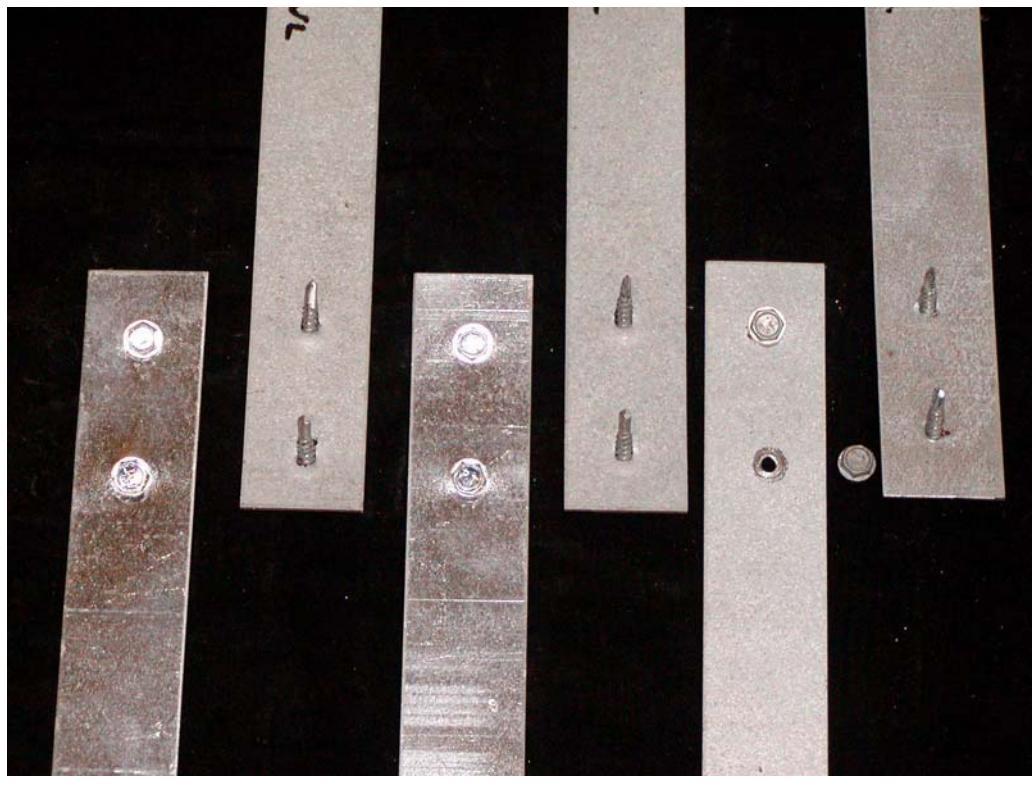
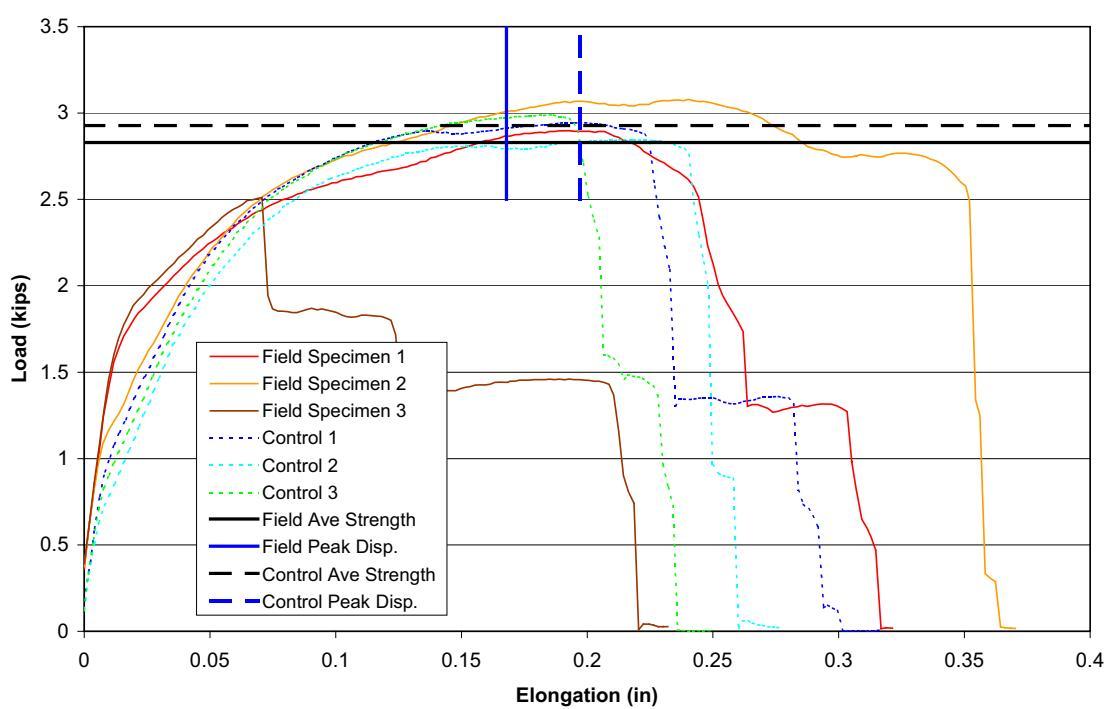
Figure 6.9: MCBH Coastal – 7 Months Covered Crawl Exposure

Figure 6.10: MCBH Coastal – 7 Months Covered Crawl Exposure – Test Results

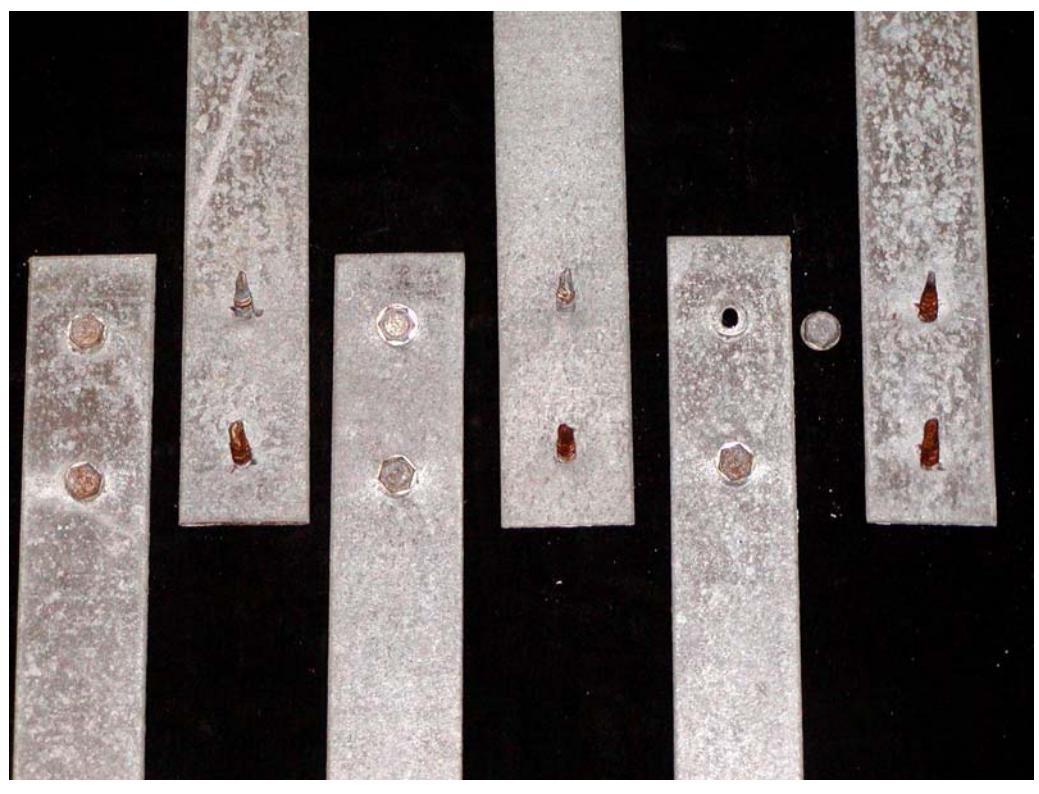
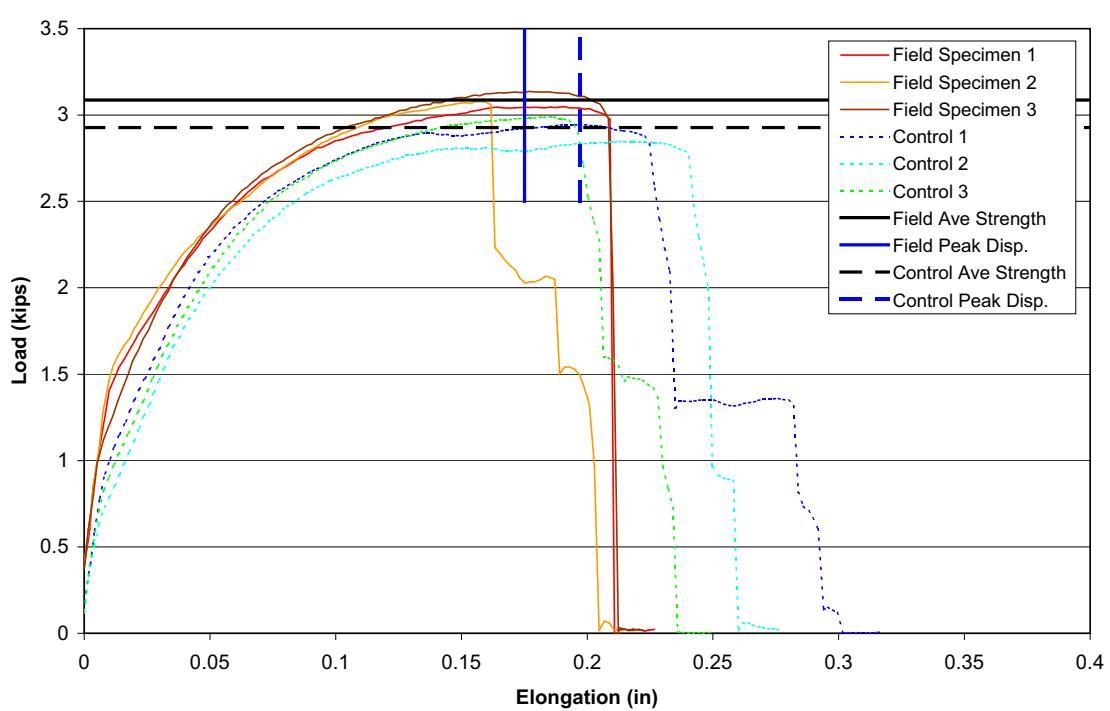
Figure 6.11: MCBH Inland – 7 Months Exterior Exposure

Figure 6.12: MCBH Inland – 7 Months Exterior Exposure – Test Results

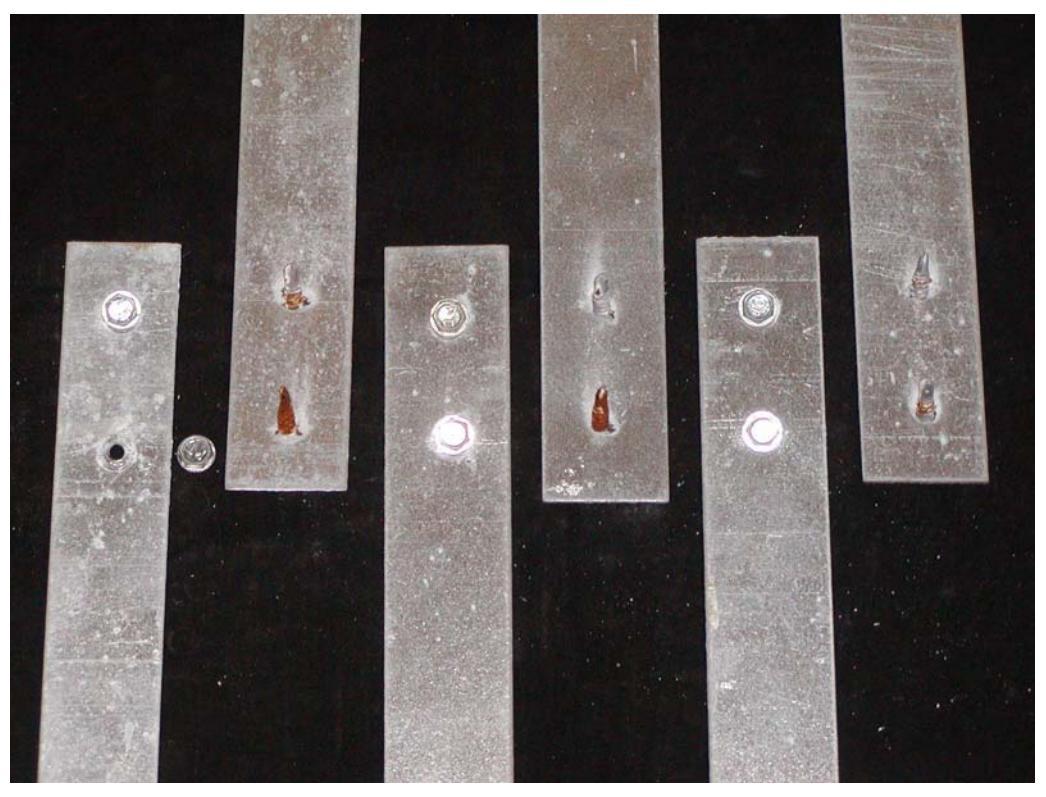
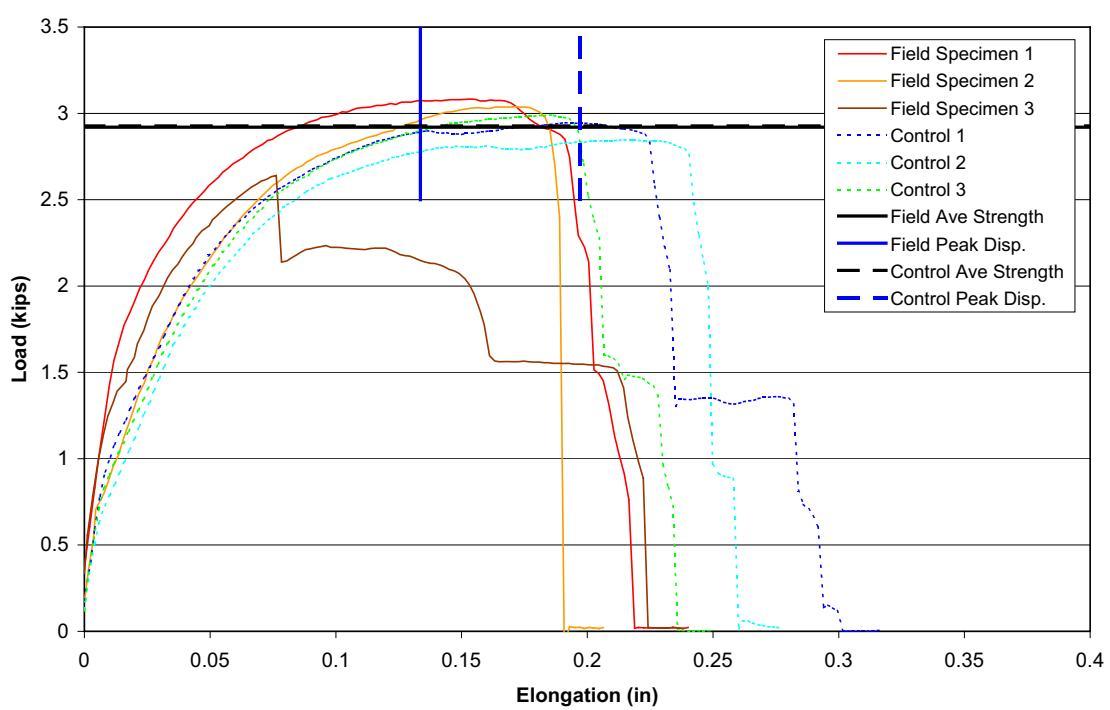
Figure 6.13: Iroquois Coastal – 7 Months Exterior Exposure

Figure 6.14: Iroquois Coastal – 7 Months Exterior Exposure – Test Results

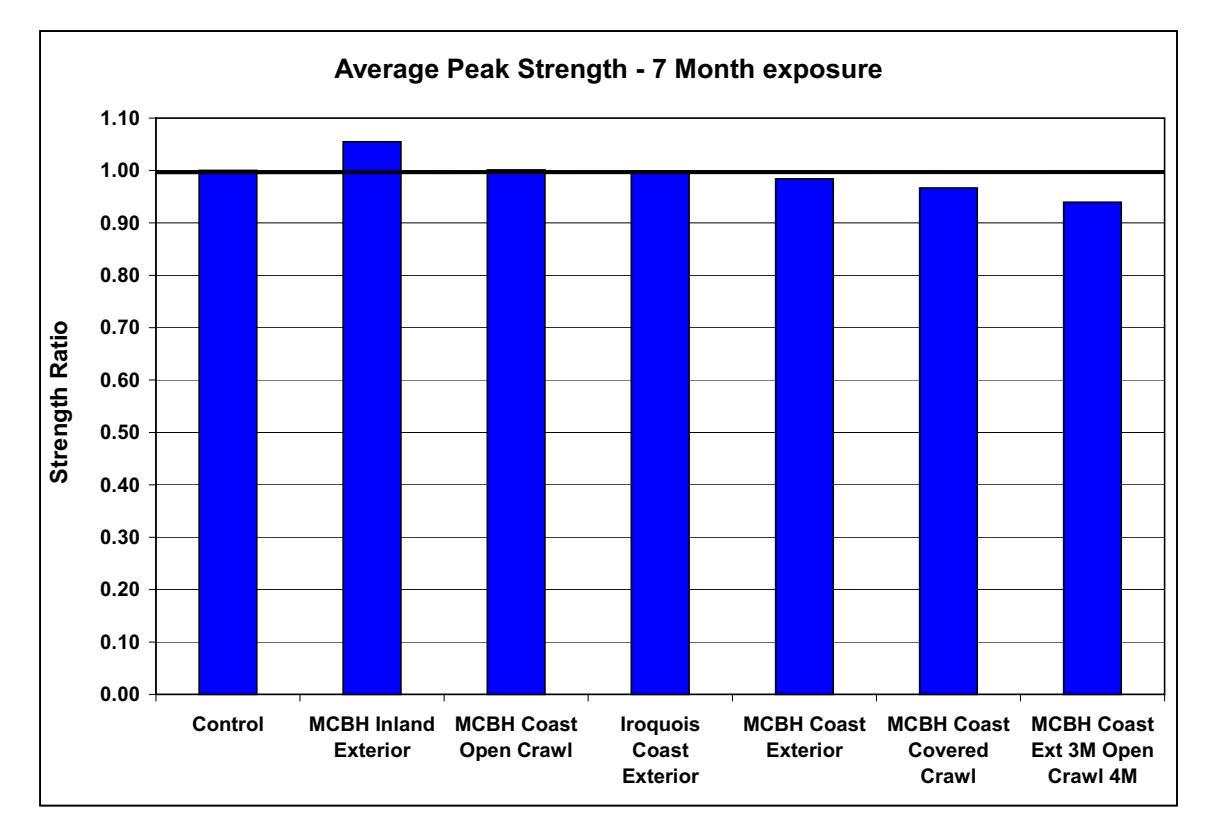
The strength ratios in Table 6-1 are plotted in Figure 6.15, and show that there has been no change in the average failure strength of the lap connections recovered from the field after 7 months exposure. The average strength ratio is 0.99 for all 6 connection sets tested.

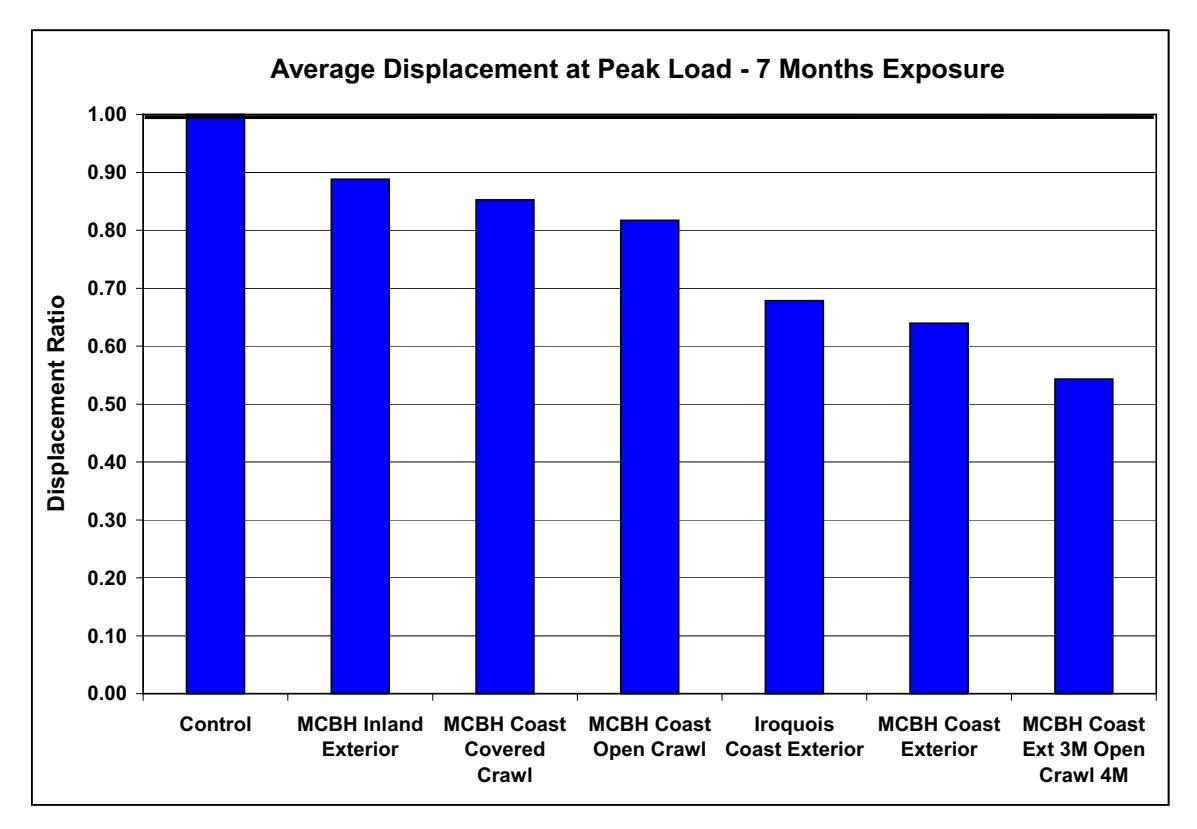
Figure 6.16: Average Displacement at Peak Load for field specimens exposed for 7 months.

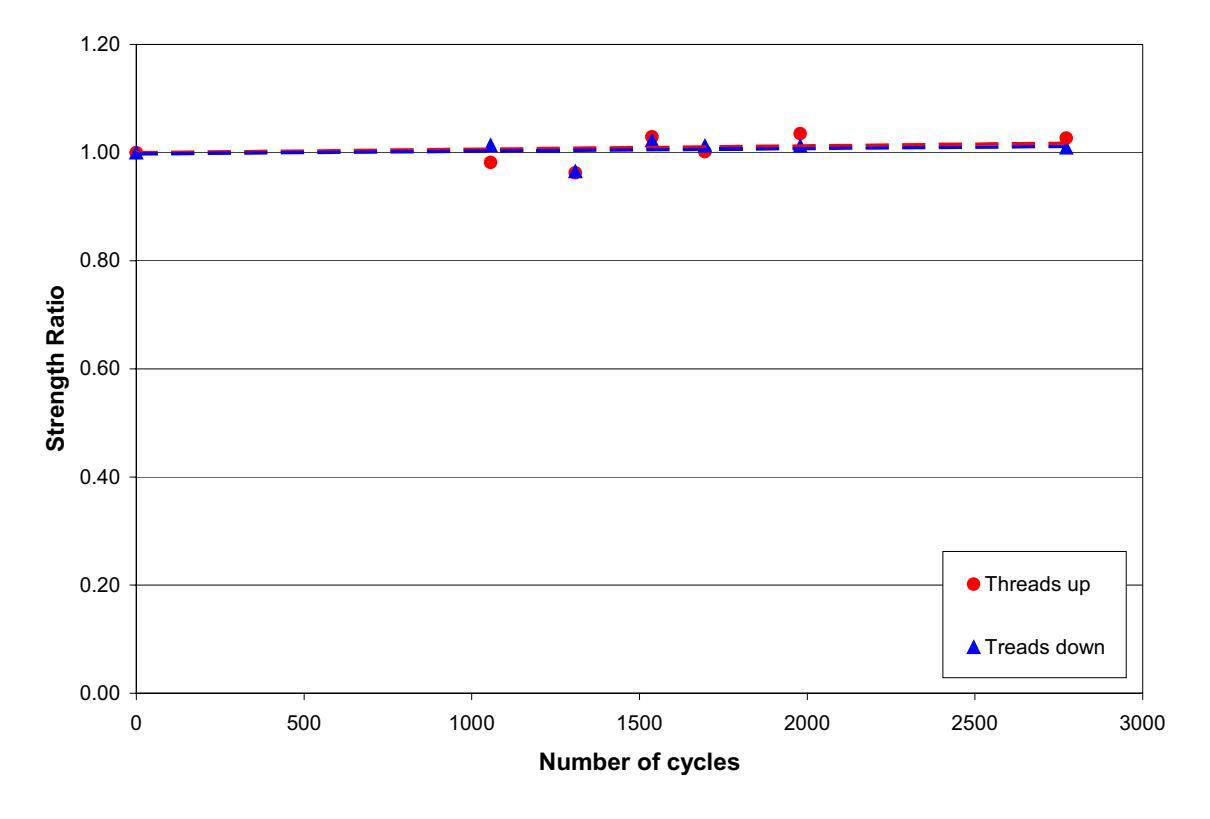
After 2772 cycles in the corrosion chamber, the galvanized screws showed significant surface corrosion (Figure 6.32). Nevertheless, the average connection strength had not decreased, regardless of whether the threads were oriented up or down in the corrosion chamber (Figure 6.35). However, the average specimen elongation at the peak load had decreased to around 80% of that for the control specimen (Figure 6.36). This decrease was larger for the connections stored with threads up. It appears that the connection ductility is affected by this level of corrosion, though the strength is not. Figure 6.37 to Figure 6.40 show microscopic images of the screw threads for control and 1537 cycle test specimens before and after testing. Although the surface corrosion appears significant, it has not yet penetrated the shaft of the screw, and hence has not affected the screw failure strength (Figure 6.40).

Figure 6.35: Strength Ratio versus Number of Cycles in corrosion chamber

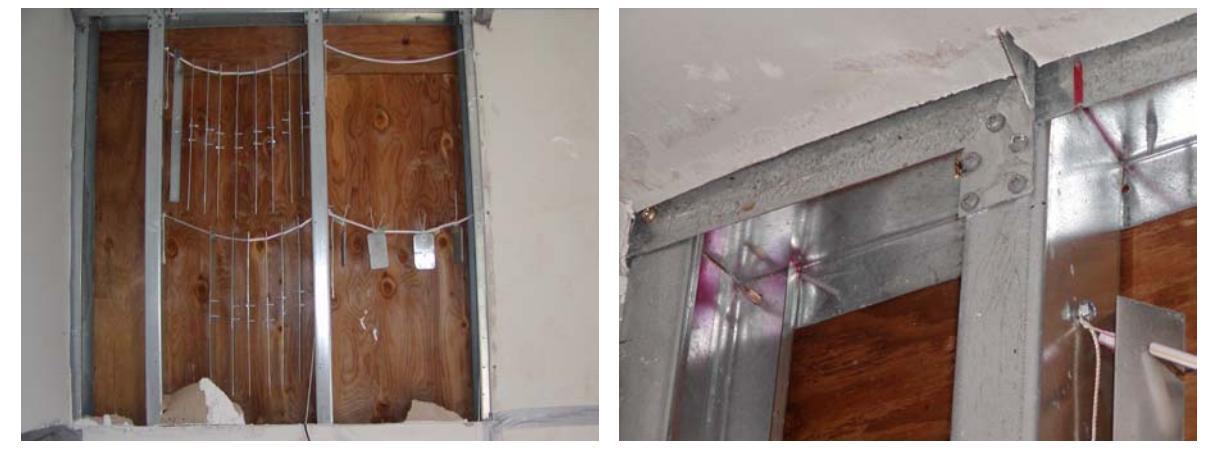
As seen in Figure 7.1, there were no signs of corrosion on the CFS framing or fasteners in the enclosed wall framing for these three sites.

Figure 7.1: Interior wall framing and fasteners at Iroquois Coastal site after 20 months exposure

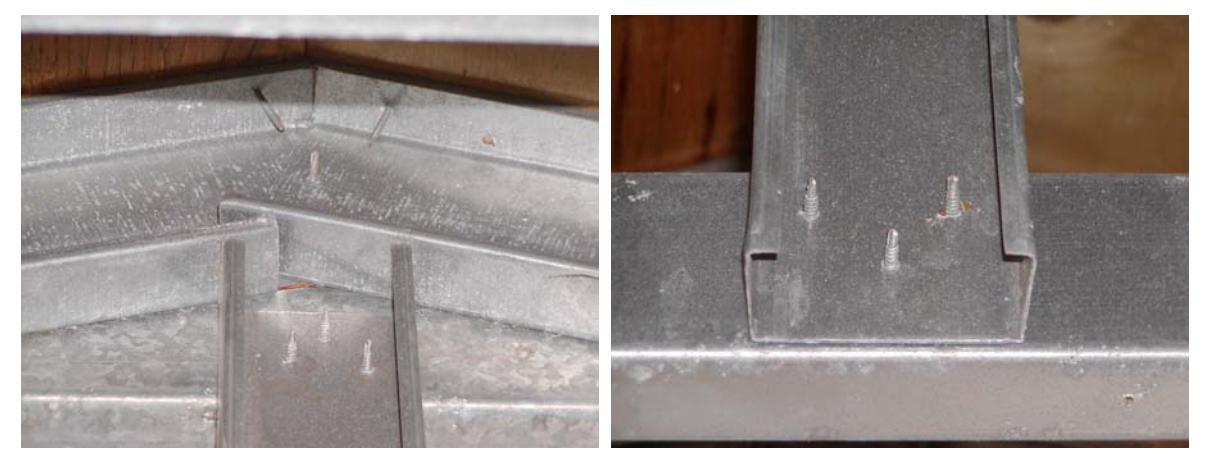
Initiation of corrosion was evident at the cut edges of the CFS framing and on some of the fasteners in the vented attics of the two Iroquois sites as shown in Figure 7.2. The fasteners in the vented attic at the Wheeler site showed no corrosion as seen in Figure 7.3.

Figure 7.3: Attic framing at Wheeler site after 20 months exposure.

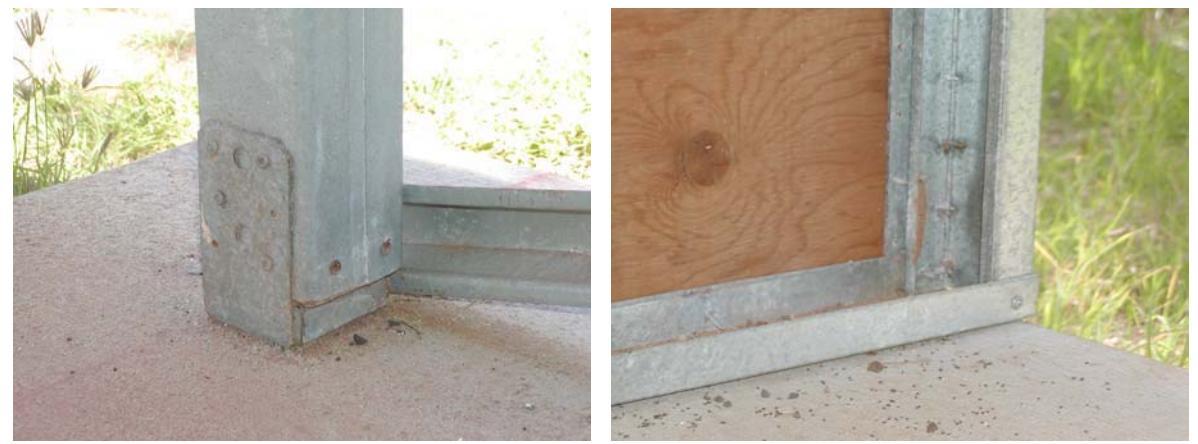
Figure 7.4: Crawl space post and cripple wall framing at Iroquois Coastal after 20 months.

Almost no signs of corrosion were noted in the crawl space framing of these three sites after 20 months of exposure. Initiation of corrosion was evident on a few of the fasteners with full exposure to the elements as shown in the post base connection in Figure 7.4. The floor joists showed no evidence of corrosion whether exposed (Figure 7.5) or covered with plywood sheathing.

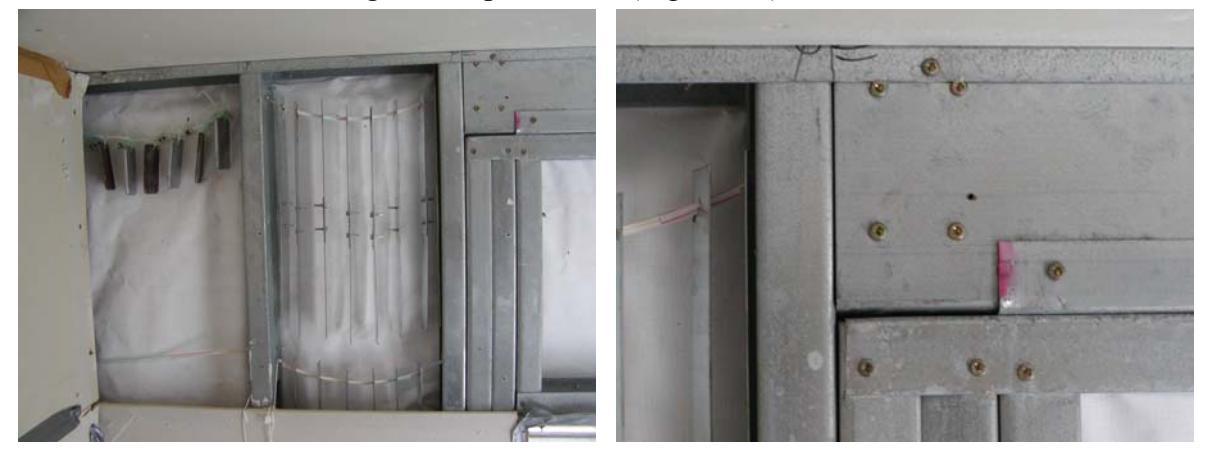
Figure 7.6: Wall framing with vapor barrier at MCBH Inland after 28 months exposure.

After 28 months of exposure, no evidence of corrosion was noted on the framing members or fasteners in the wall framing with vapor barrier (Figure 7.6).

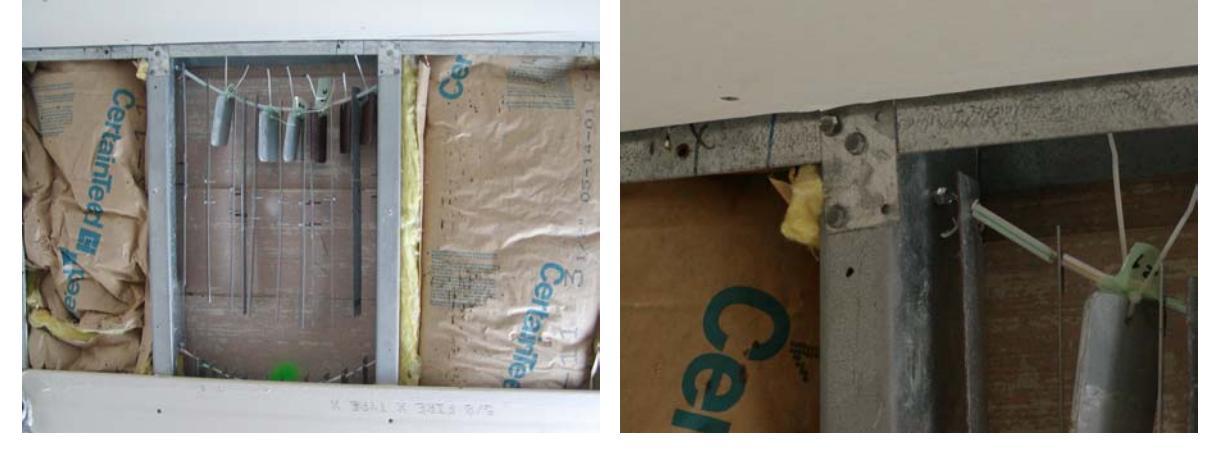
Figure 7.7: Wall framing without vapor barrier at MCBH Inland after 28 months.

After 28 months of exposure, no evidence of corrosion was noted on the framing members or fasteners in the wall framing with lap siding but no vapor barrier (Figure 7.7).

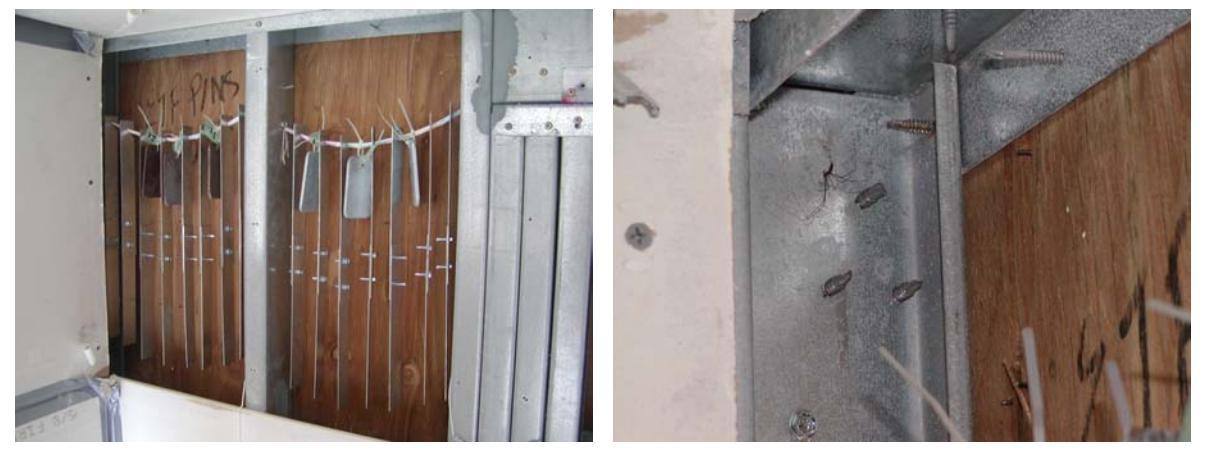
Figure 7.8: Wall framing with plywood sheathing at MCBH Inland after 28 months.

After 28 months of exposure, no evidence of corrosion was noted on the framing members or fasteners in the wall framing with plywood sheathing and no vapor barrier (Figure 7.8).

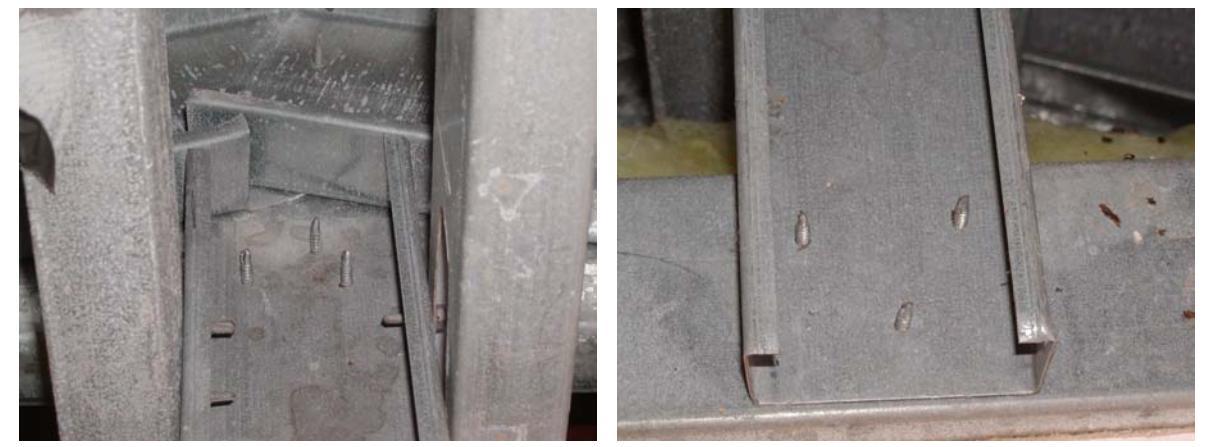
Figure 7.9: Vented attic framing at MCBH Inland after 28 months exposure.

Portions of the CFS framing in the vented attic showed signs of tarnishing due to zinc coating corrosion, but all fasteners were free of ferrous oxide (Figure 7.9).

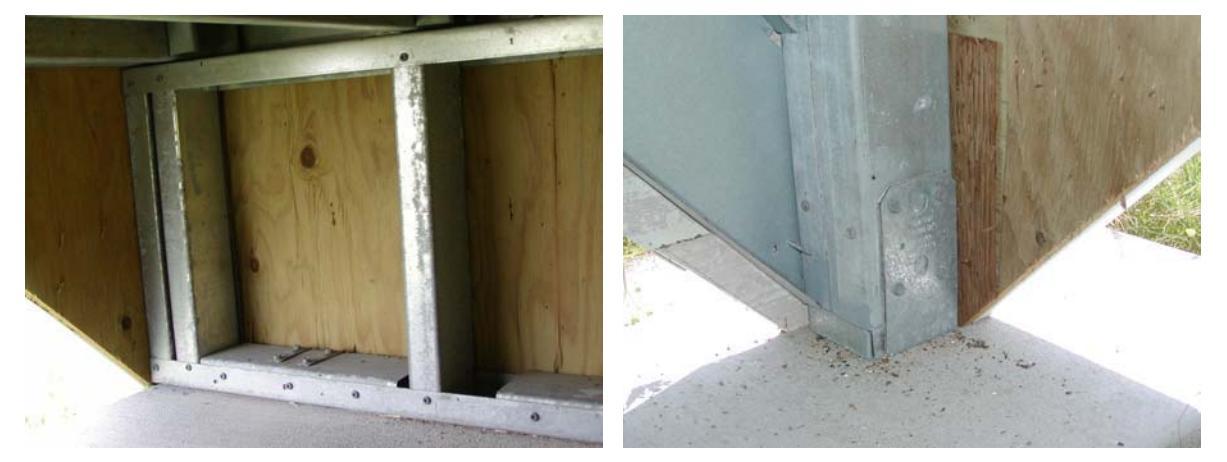
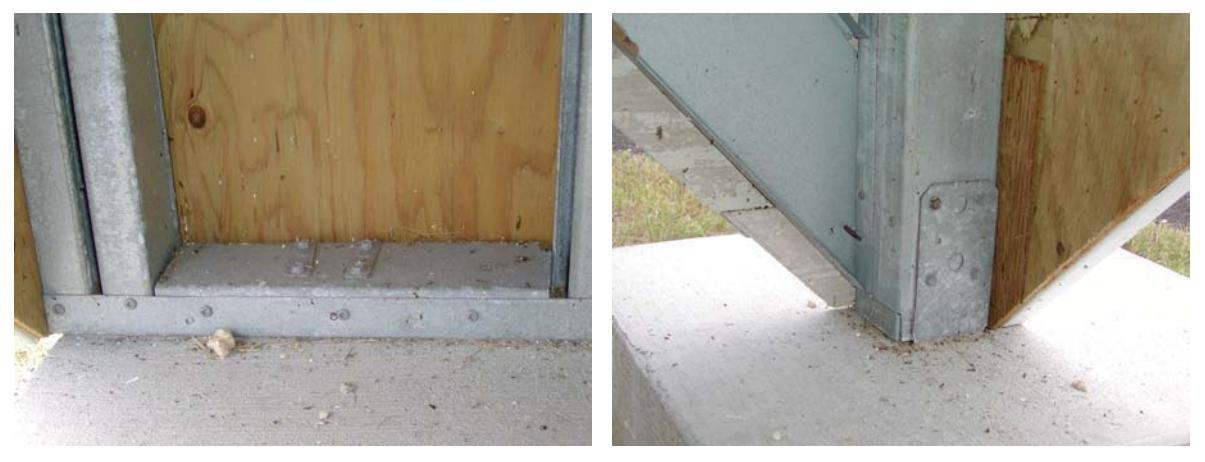
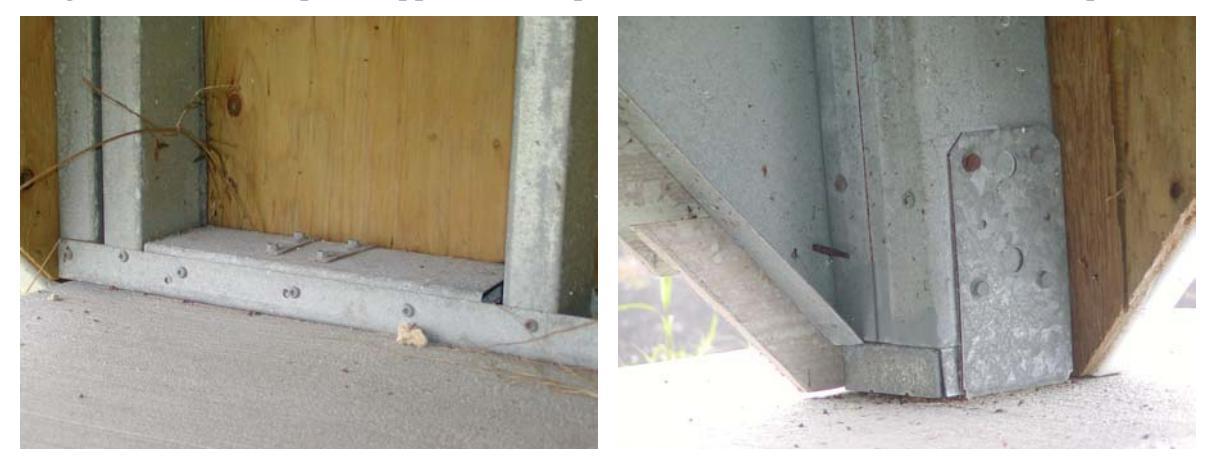
Figure 7.10, Figure 7.11 and Figure 7.12 show a progression of the corrosion on the cripple wall and post supports in the crawl space of the MCBH Inland enclosure. After 5 months there were signs of tarnishing of the zinc galvanizing, but no evidence of ferrous oxide on the fastener heads or threads. By 16 months, the galvanizing was fully tarnished and ferrous oxide was evident on some of the fastener heads and threads. By 28 months, there was more significant corrosion on the same fasteners and initiation of corrosion at other fasteners elsewhere in the crawl space support framing.

Figure 7.10: Crawl space cripple wall and post at MCBH Inland after 5 months exposure.

Figure 7.11: Crawl space cripple wall and post at MCBH Inland after 16 months exposure.

Figure 7.12: Crawl space cripple wall and post at MCBH Inland after 28 months exposure.
