Corrosion of Galvanized Fasteners used in Cold-Formed Steel Framing

RESEARCH REPORT RP04-4

FINAL REPORT

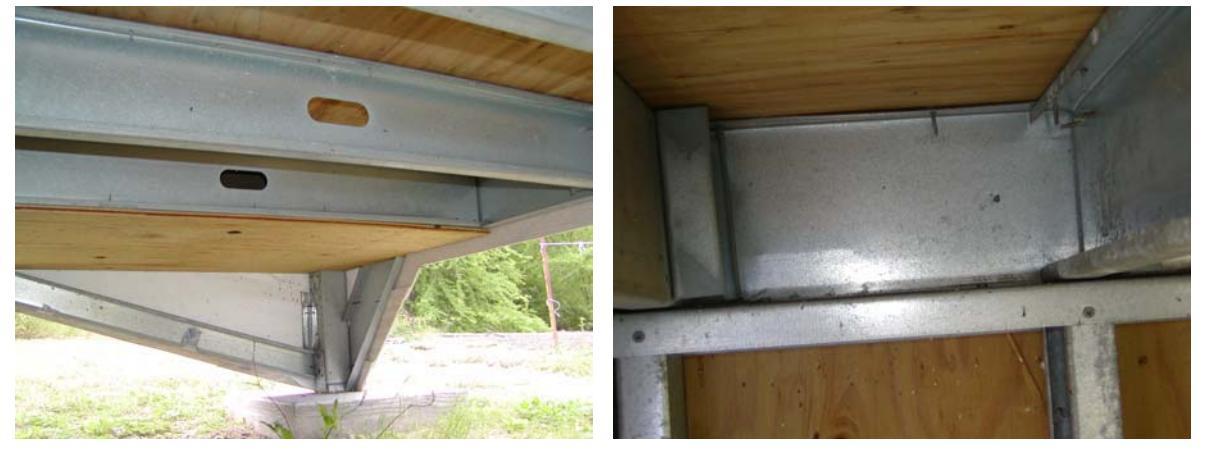
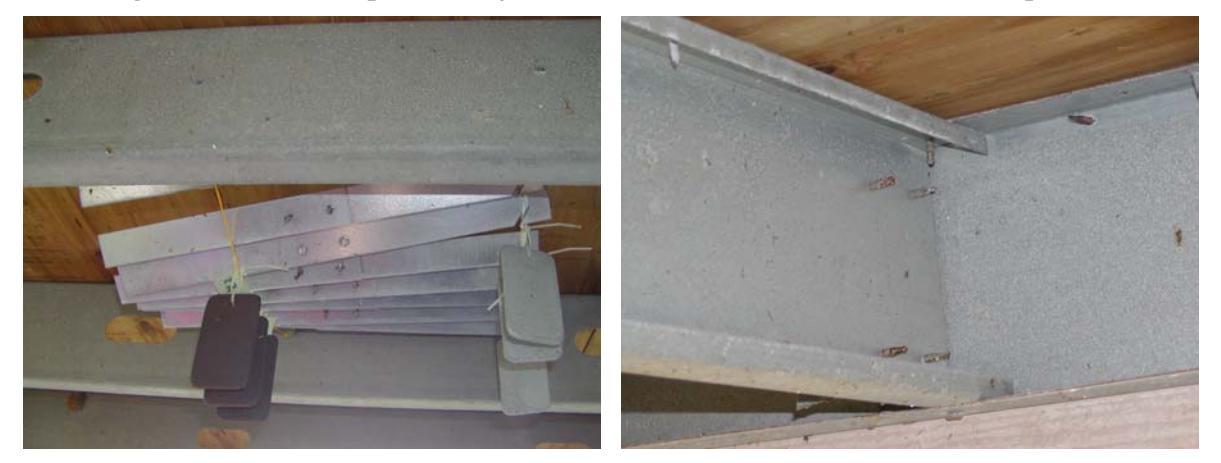
Figure 7.13 and Figure 7.14 show the exposed floor joist framing in the crawl space of the MCBH Inland enclosure. After 16 months, there was some tarnishing of the joists, but no evidence of ferrous oxide on the fasteners. By 28 months, the joists were fully tarnished and minor ferrous oxide was noted on some of the fastener threads. For the floor joists enclosed by plywood sheathing, there were no signs of corrosion after 28 months of exposure (Figure 7.15).

Figure 7.13: Crawl space floor joists at MCBH Inland after 16 months exposure.

Figure 7.14: Crawl space floor joists at MCBH Inland after 28 months exposure.

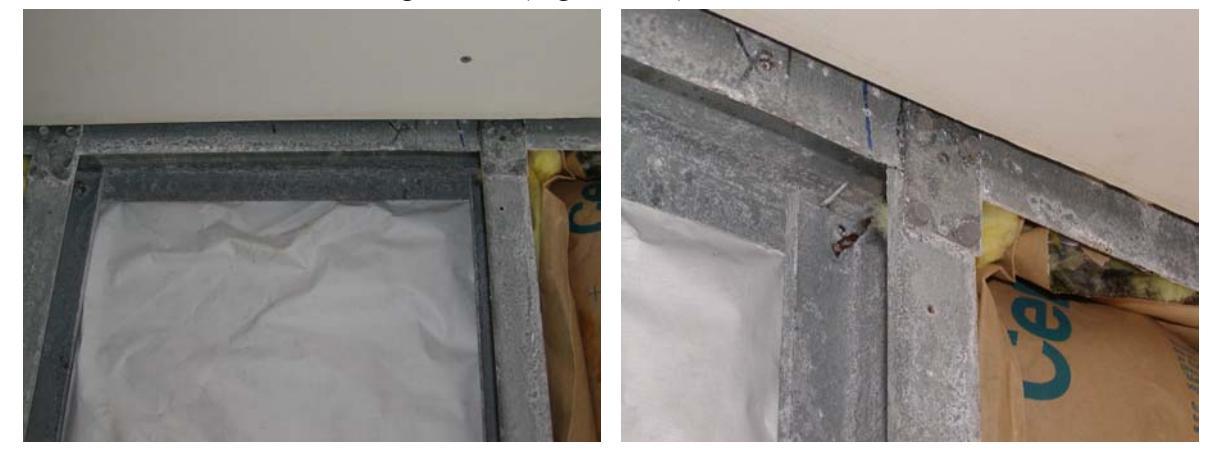
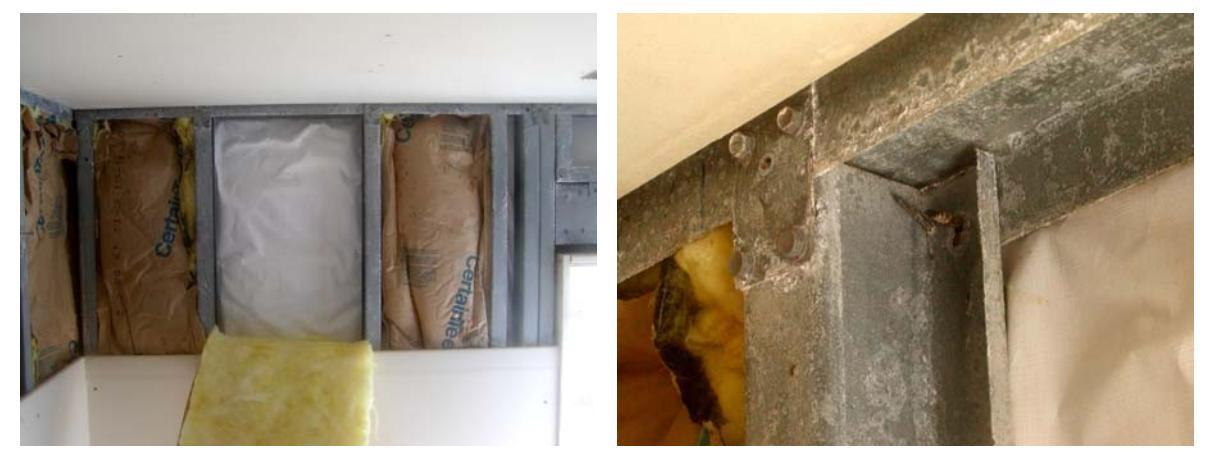
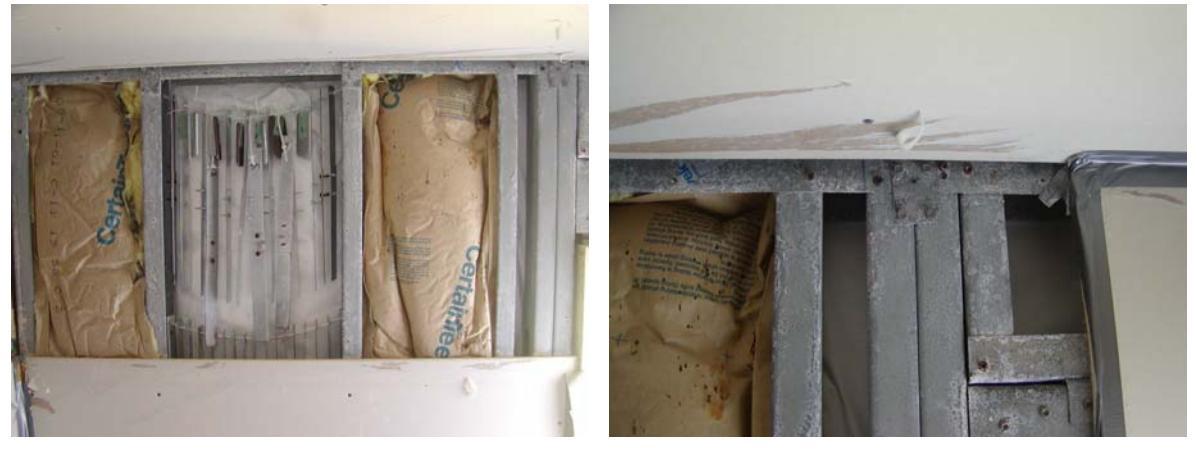
After 16 months of exposure, there was evidence of corrosion of both the CFS members and framing fasteners at the top plate of the wall with vapor barrier (Figure 7.16). This corrosion appeared limited to the top plate and top section of the studs. There was considerably less corrosion further down the stud. This conditioned worsened after 21 months (Figure 7.17) and 28 months (Figure 7.18), by which time most of the framing fasteners in the top plate connections showed signs of ferrous oxide. There was still very little sign of corrosion on the studs at mid-height of the wall. It appeared that humid, chloride rich air was passing from the vented attic to the top plate connections, resulting in the localized corrosion. No seal had been provided between the top plate and the attic space. For the first 16 months, the interior drywall had also not been taped, so humidity could also have entered the wall cavity through the drywall joints. It was noted that the ETF pins used to secure the Hardie Board had less ferrous oxide corrosion than the framing screws (Figure 7.16).

Figure 7.16: Wall framing with lap siding and vapor barrier, MCBH Coastal after 16 months.

Figure 7.17: Wall framing with lap siding and vapor barrier, MCBH Coastal after 21 months.

Figure 7.18: Wall framing with lap siding and vapor barrier, MCBH Coastal after 28 months.

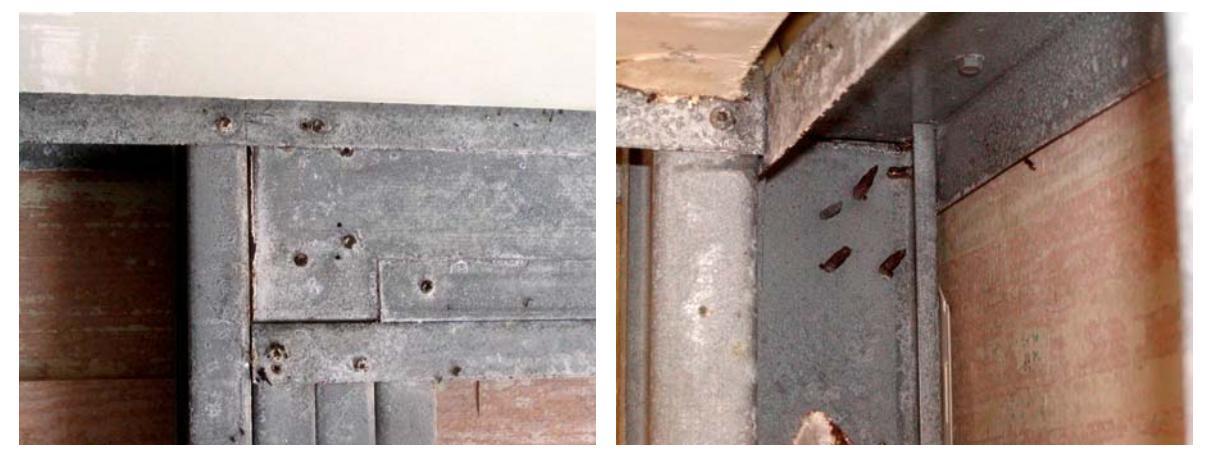
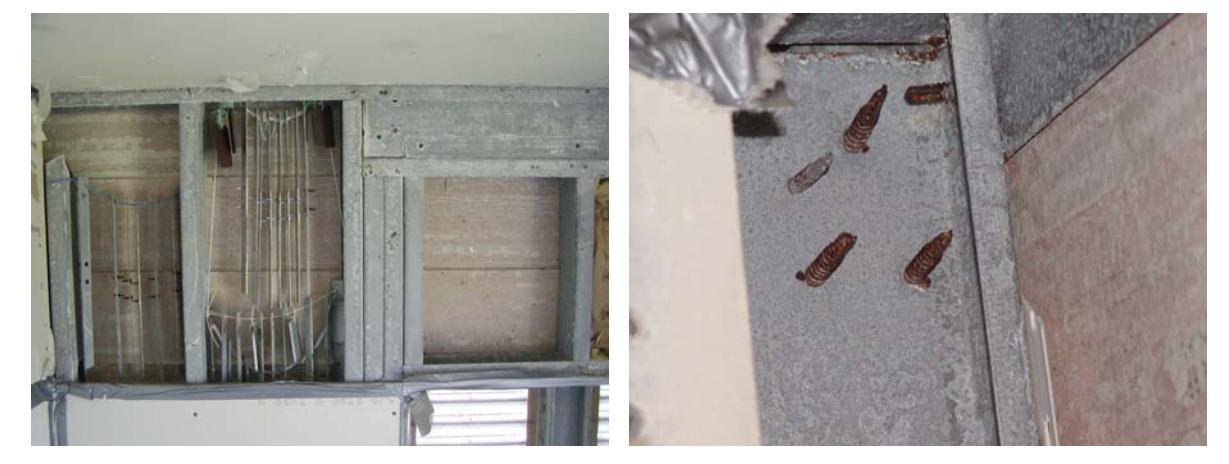
After 16 months of exposure, there was evidence of ferrous oxide on the cut ends of CFS sections and on both heads and threads of the framing fasteners in the wall with lap siding but without a vapor barrier (Figure 7.19). This corrosion was particularly severe at the top plate and top section of the studs, but was evident throughout the height of the studs. This conditioned worsened after 21 months (Figure 7.20) and 28 months (Figure 7.21). In addition to any exterior air entering through the vented attic to the top of the wall, there was now easy access for exterior air through the lap siding itself (Figure 7.19). The corrosion in this wall was considerably worse than that in either the lap siding wall with vapor barrier or the plywood sheathed wall without vapor barrier.

Figure 7.20: Wall framing with lap siding without vapor barrier, MCBH Coastal after 21 months.

Figure 7.21: Wall framing with lap siding without vapor barrier, MCBH Coastal after 28 months.

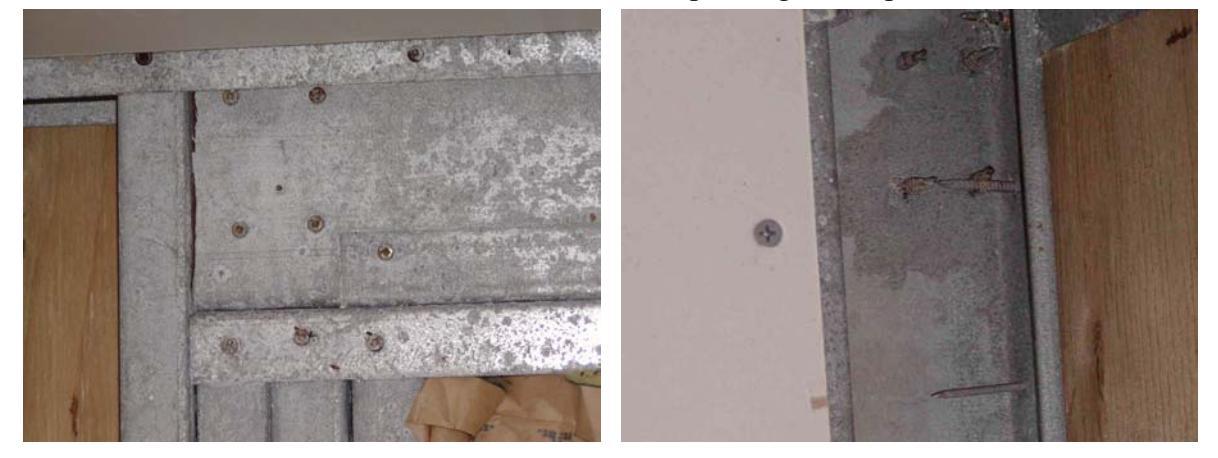
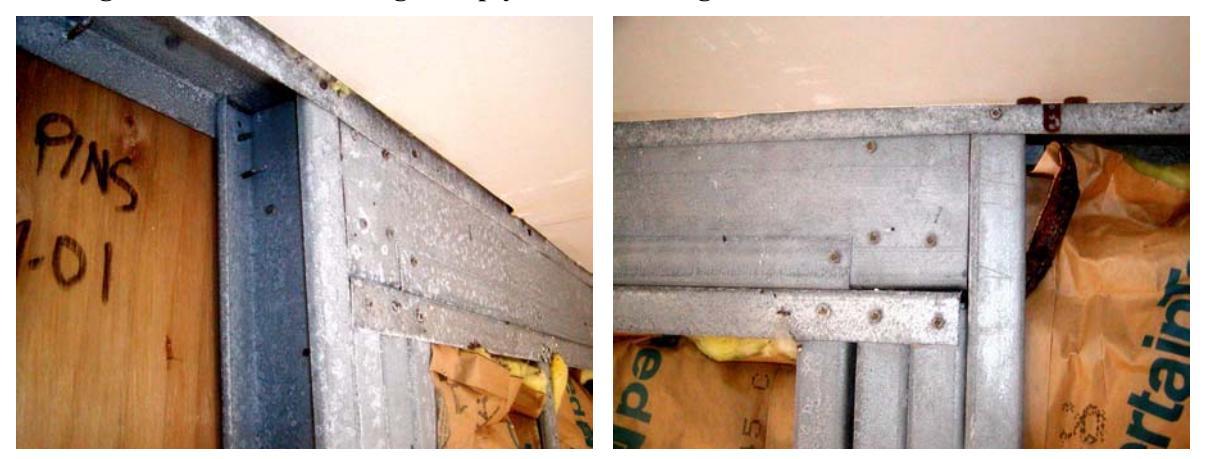
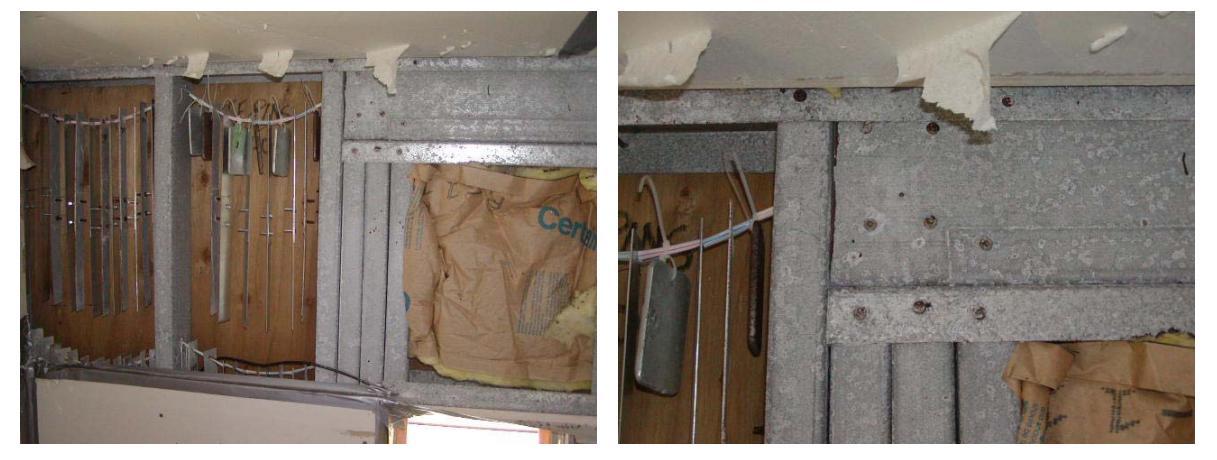
After 16 months of exposure, there was some evidence of ferrous oxide on the cut ends of CFS sections and on the heads and threads of the framing fasteners at the top of the wall with plywood siding but without a vapor barrier (Figure 7.22). There were many framing fasteners, and virtually all ETF pin fasteners, that showed no signs of corrosion. There were also many

areas of the CFS that were untarnished. There was some progression of the corrosion after 21 months (Figure 7.23) and 28 months (Figure 7.24), including on the ETF pin fasteners used to secure the plywood sheathing, particularly at the top of the wall. In general the observed condition was similar to or better than the wall with lap siding and vapor barrier.

Figure 7.22: Wall framing with plywood sheathing, MCBH Coastal after 16 months.

Figure 7.23: Wall framing with plywood sheathing, MCBH Coastal after 21 months.

Figure 7.24: Wall framing with plywood sheathing, MCBH Coastal after 28 months.

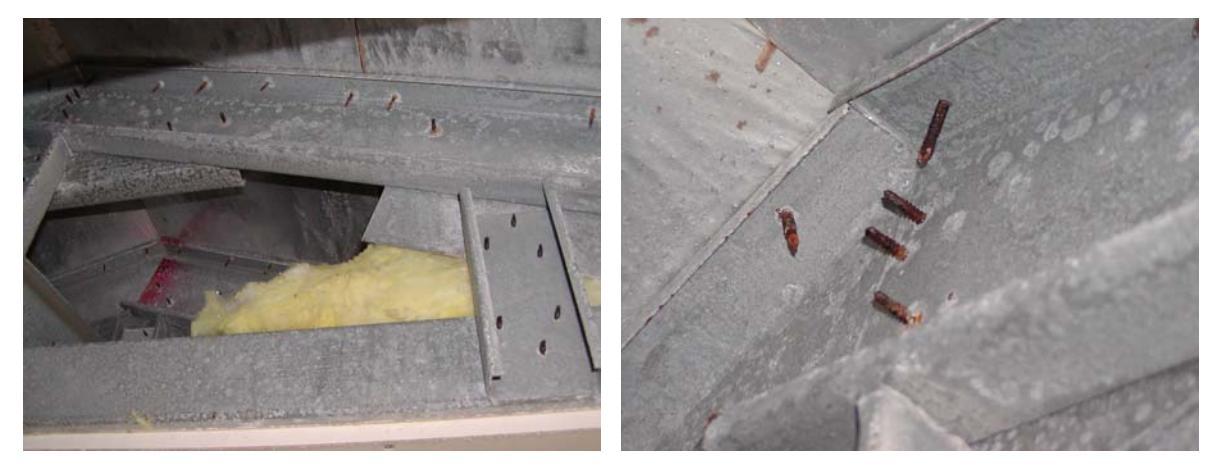
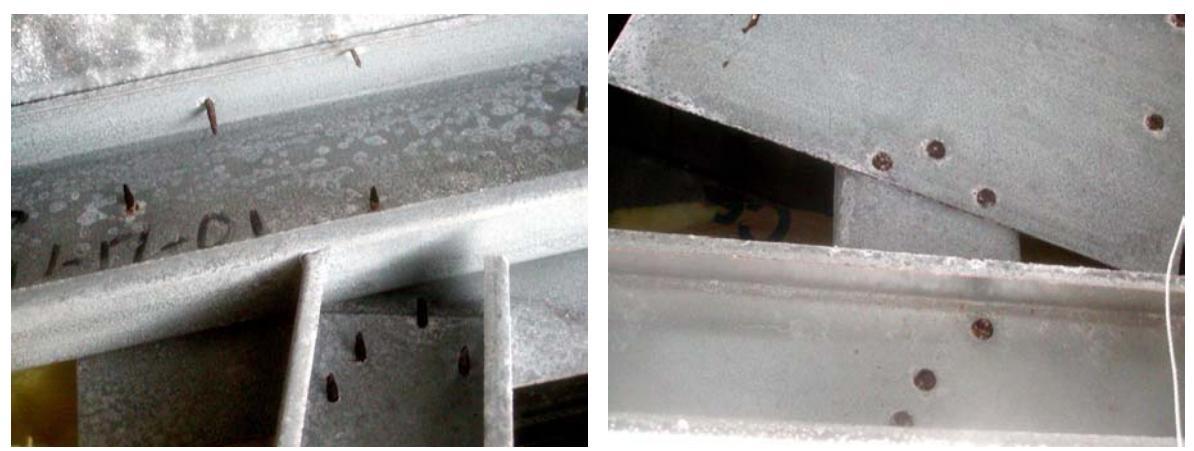
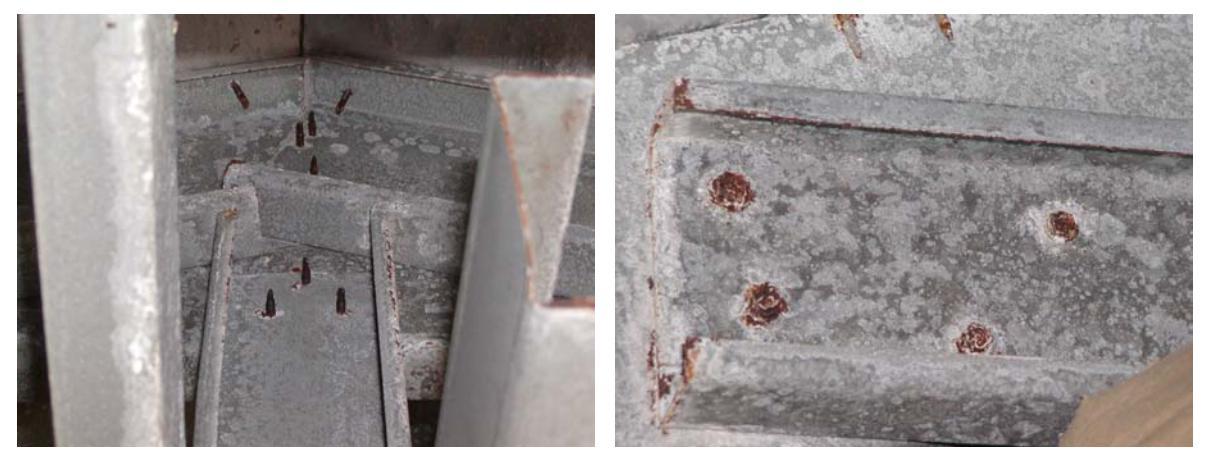
After 16 months there was already significant ferrous oxide on virtually all of the fasteners in the vented attic (Figure 7.25). This conditioned worsened at 21 months (Figure 7.26) and 28 months (Figure 7.27), by which time there was also significant ferrous oxide at cut ends of the CFS framing members (Figure 7.27).

Figure 7.25: Vented attic framing at MCBH Coastal after 16 months.

Figure 7.26: Vented attic framing at MCBH Coastal after 21 months.

Figure 7.27: Vented attic framing at MCBH Coastal after 28 months.

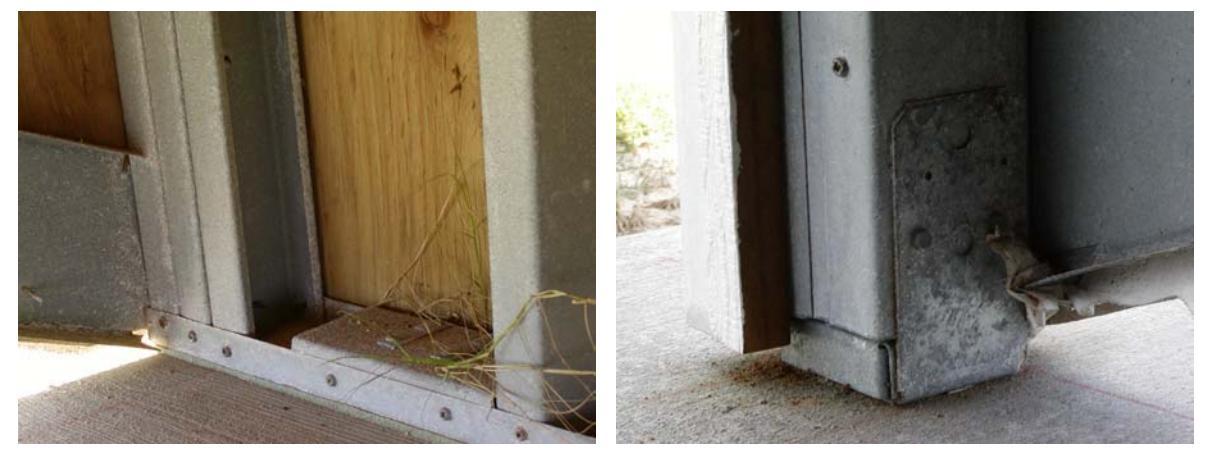
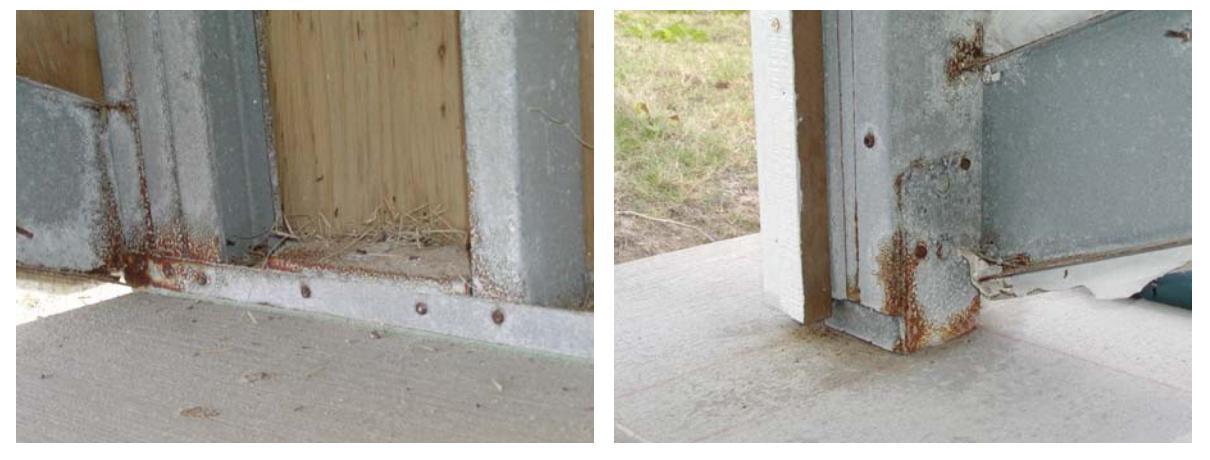
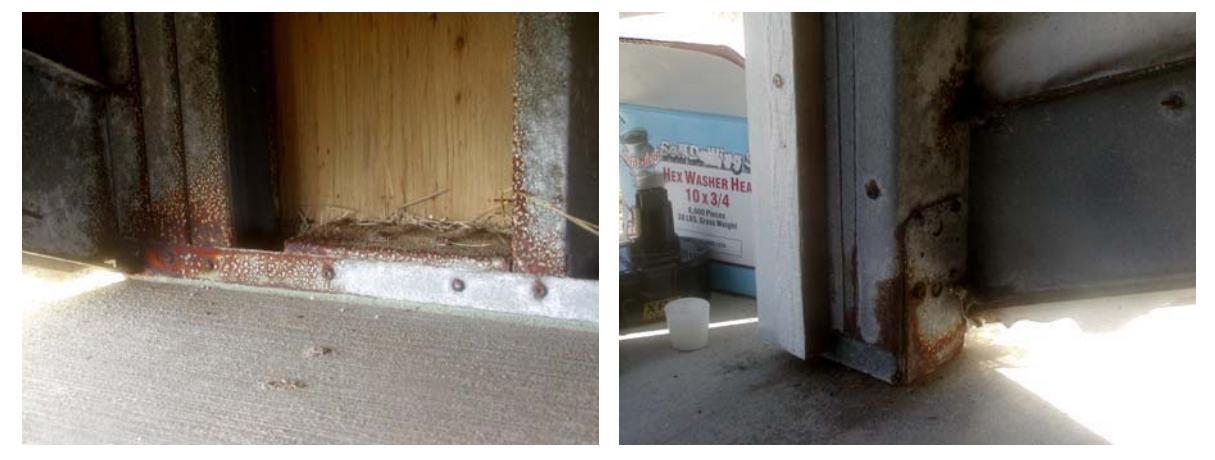
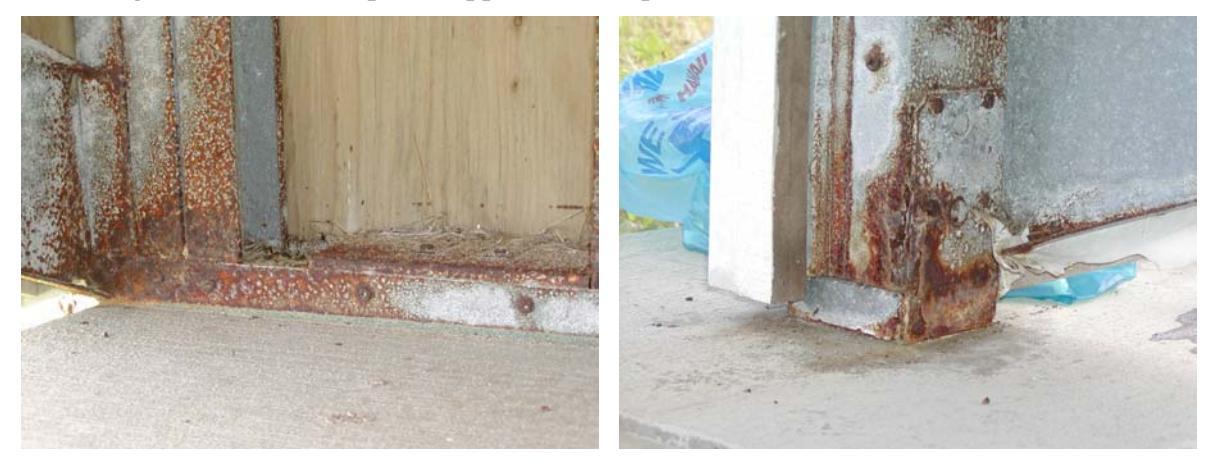
Figure 7.28, Figure 7.29, Figure 7.30 and Figure 7.31 show a progression of the corrosion on the cripple wall and post supports in the crawl space of the MCBH Coastal enclosure. After 5 months there were signs of tarnishing of the zinc galvanizing, and ferrous oxide on some of the fastener heads or threads, and cut ends of the CFS members (Figure 7.28). By 16 months, the zinc coating on portions of the CFS framing had corroded completely and ferrous oxide was forming on end regions of the CFS members and galvanized anchor hardware. There was also significant ferrous oxide on the exposed fastener heads (Figure 7.29). At the 21 month inspection it was clear that this corrosion had progressed rapidly (Figure 7.30) and after 28 months there was clear indication that the corrosion had compromised the integrity of the CFS studs, post and post base hardware (Figure 7.31). The corrosion appeared to concentrate in regions exposed directly to through flow of chloride laden air from the nearby coastline.

Figure 7.28: Crawl space cripple wall and post, MCBH Coastal after 5 months.

Figure 7.29: Crawl space cripple wall and post, MCBH Coastal after 16 months.

Figure 7.30: Crawl space cripple wall and post, MCBH Coastal after 21 months.

Figure 7.31: Crawl space cripple wall and post, MCBH Coastal after 28 months.

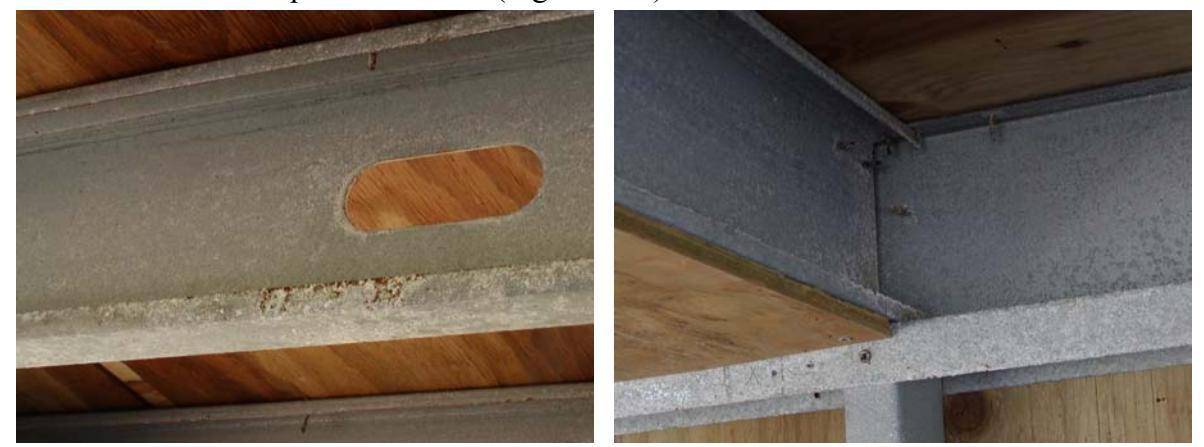
Figure 7.32: Crawl space exposed floor joists, MCBH Coastal after 5 months.

Figure 7.32 through Figure 7.38 show the exposed floor joist framing in the crawl space of the MCBH Coastal enclosure. After 5 months, the surface of the joists was tarnished and there was evidence of ferrous oxide on cut edges and some of the exposed fasteners (Figure 7.32). After 10 months exposure, this corrosion had progressed significantly with considerable ferrous oxide at the joist bottom flange and at cut ends and punchouts. There were also signs of ferrous oxide on most of the exposed fasteners (Figure 7.33).

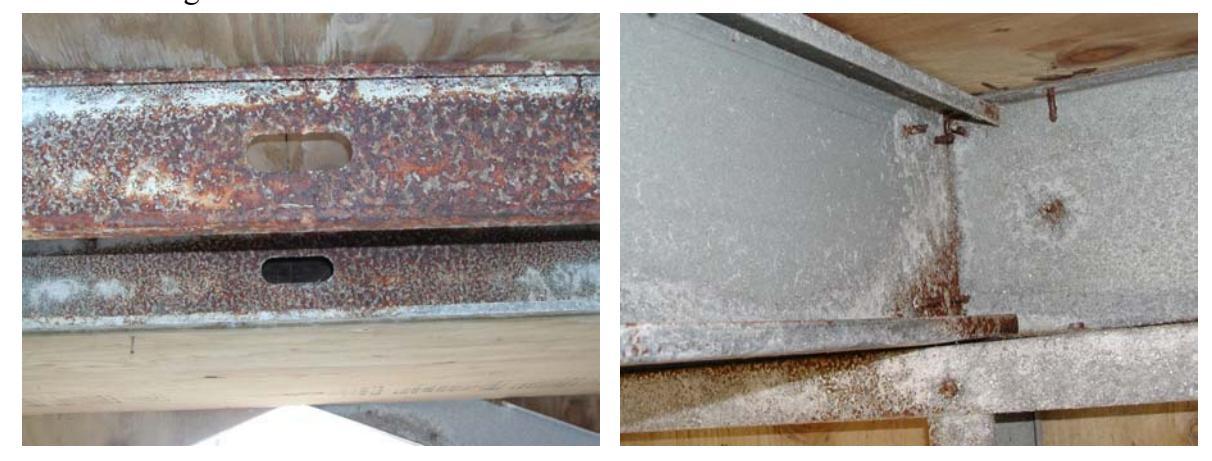
Figure 7.34: Crawl space exposed floor joists, MCBH Coastal after 16 months.

After 16 months, large sections of the exposed floor joists were almost entirely devoid of galvanizing with ferrous oxide extending the full height of the web (Figure 7.34). Ferrous oxide was evident on all of the exposed fasteners in the joist end connections and between the plywood flooring and the joist top flange. However, the joists covered by plywood sheathing showed no signs of corrosion (Figure 7.35). Fasteners in this enclosed floor framing also exhibited no signs of corrosion.

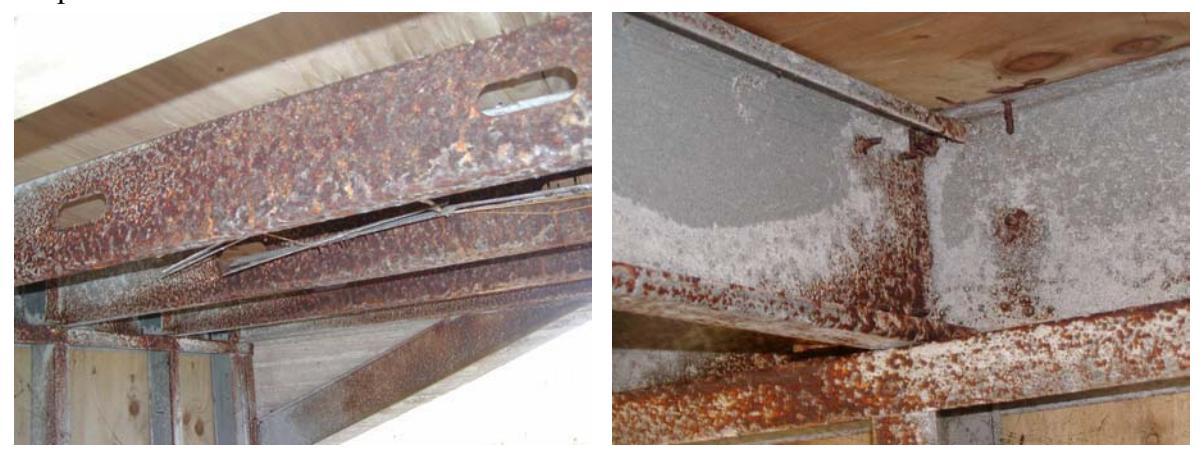
Figure 7.38: Crawl space exposed floor joists, MCBH Coastal after 28 months.

After 28 months, corrosion of the exposed floor joists had extended over virtually the entire length and depth of each joist (Figure 7.38). Connection fasteners had significant ferrous oxide on exposed heads and threads.
