Wheeler Army Airfield - Field Enclosure Photographs

HUD CONTRACT No.:	H-21248CA
PROJECT TITLE:	“Corrosion of Galvanized Fasteners used in Cold-Formed Steel Framing”
CONTRACTOR:	North American Steel Framing Alliance 1726 M Street, NW, Suite 601 Washington, DC 20036
Principal Investigator:	Tim Waite
Co/Investigators:	Don Moody, Kevin Bielat
SUB-CONTRACTOR:	University of Hawaii Dept. of Civil Engineering 2540 Dole Street, Holmes Hall 383 Honolulu, HI 96822
Principal Investigator	Dr. Ian N. Robertson
PROJECT PERIOD:	From 9/26/2000 to 11/25/2003
LITERATURE REVIEW REPORT:	December 27, 2000

CORROSION OF GALVANIZED FASTENERS USED IN COLD-FORMED STEEL FRAMING

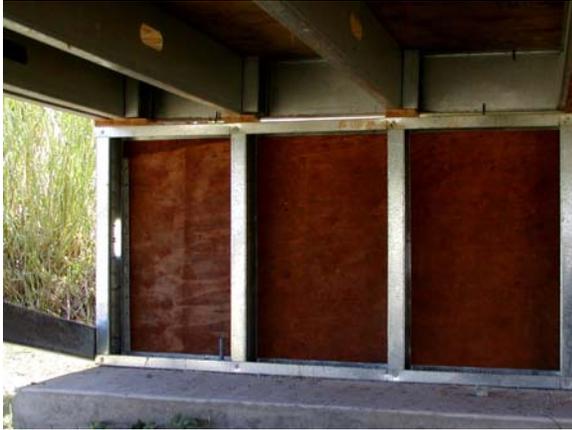
Figure A.5: Cripple Wall – NE end

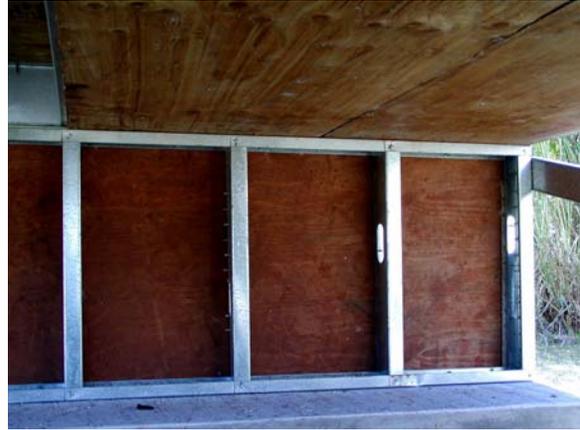
Figure A.6: Cripple Wall – SE end

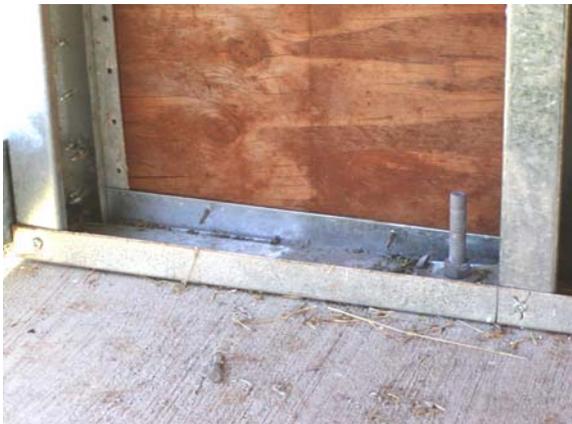
Figure A.7: Cripple Wall base – NE end

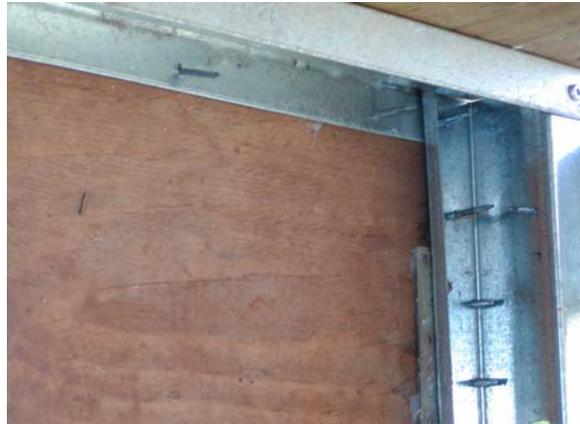
Figure A.8: Cripple Wall top – SE end

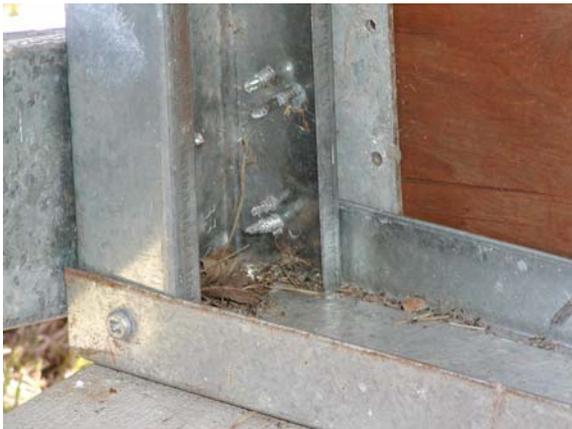
Figure A.9: Cripple wall base connection – NE end

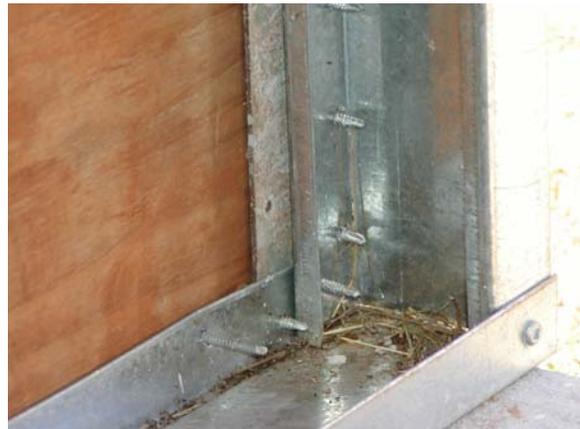
Figure A.10: Cripple wall base – SE end

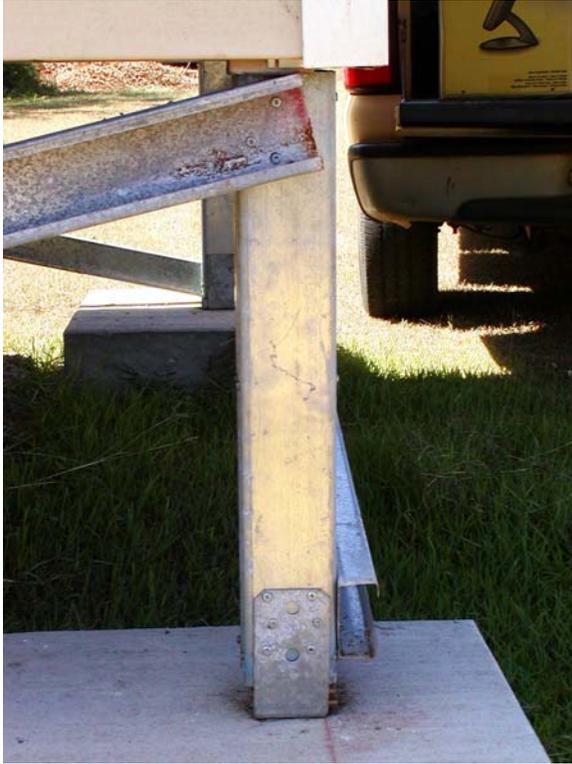
Figure A.11: NW Post

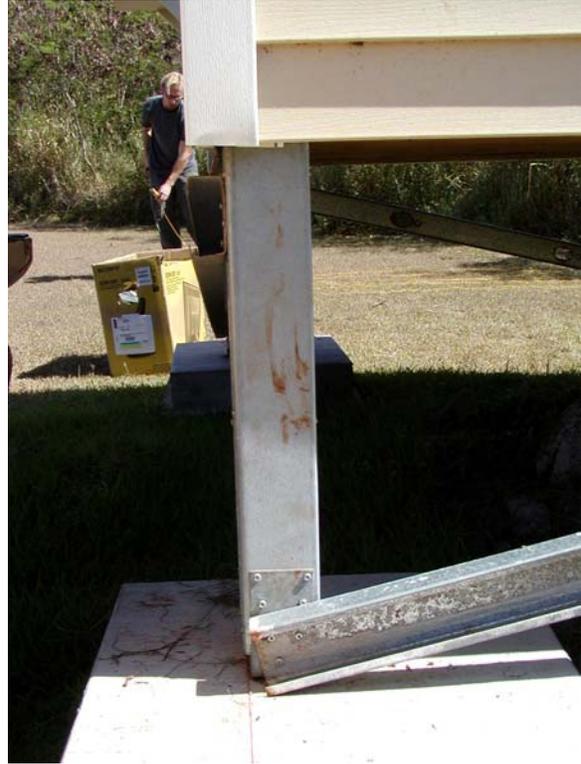
Figure A.12: SW Post

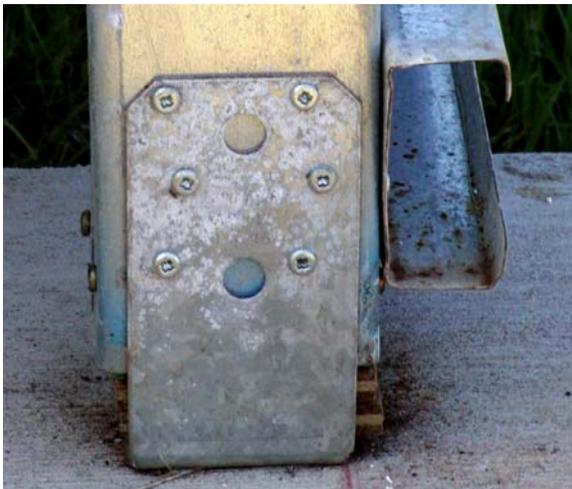
Figure A.13: NW Post base connection

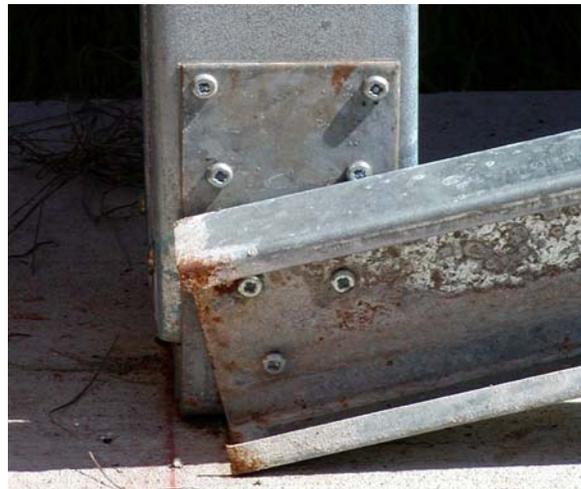
Figure A.14: SW Post base connection

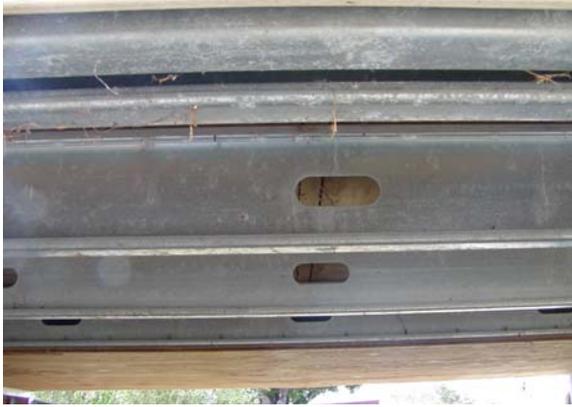
Figure A.15: Exposed floor joists

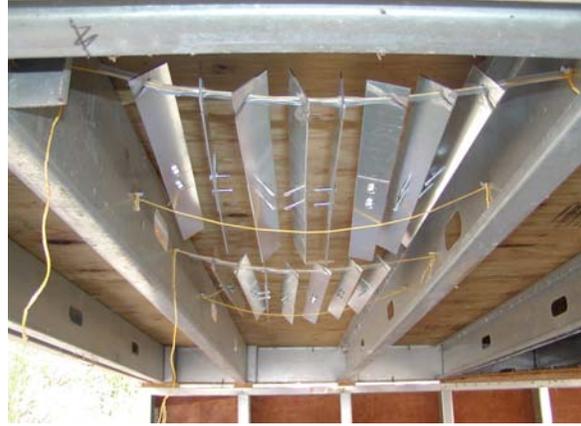
Figure A.16: Exposed test connections – location 3

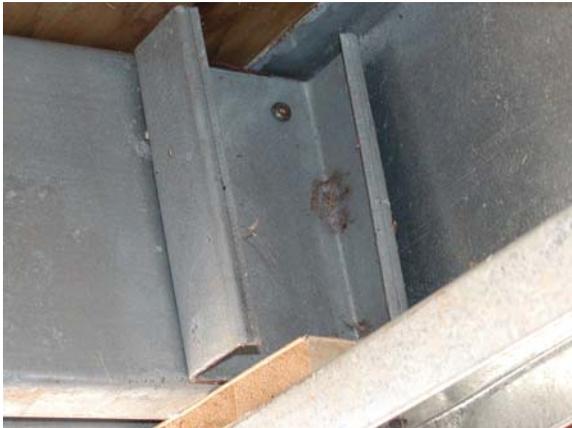
Figure A.17: Joist stiffener over cripple wall

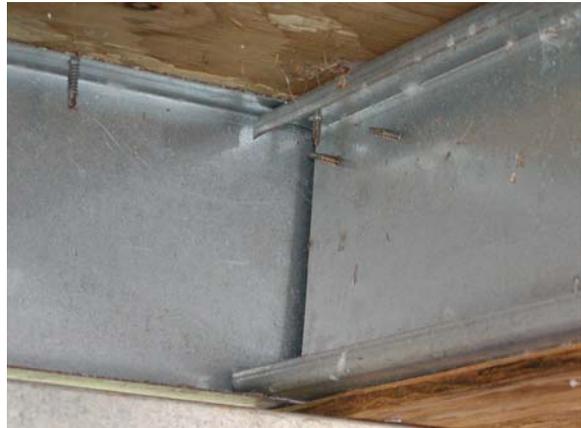
Figure A.18: Joist connection over cripple wall

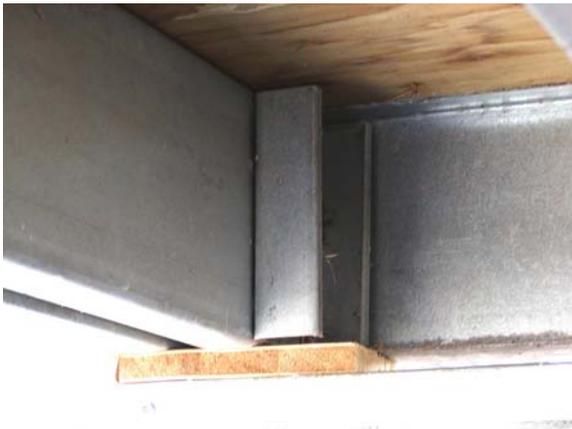
Figure A.19: Double edge joist with stiffener

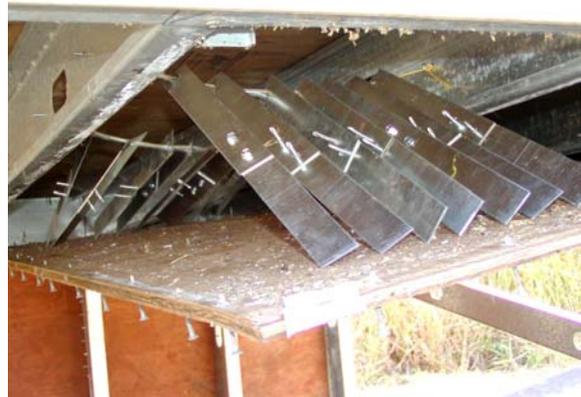
Figure A.20: Covered crawl coupons – location 4

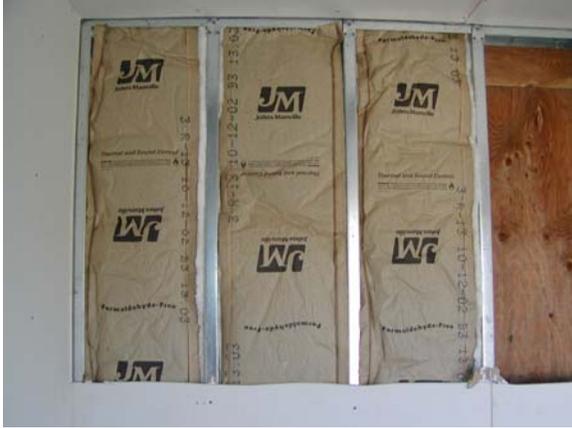
Figure A.21: East wall – North side

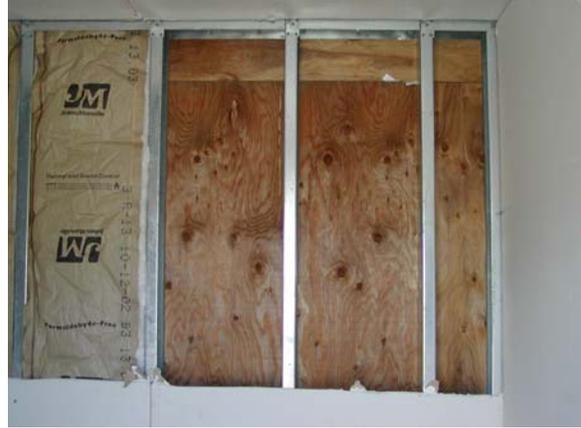
Figure A.22: East wall – South side

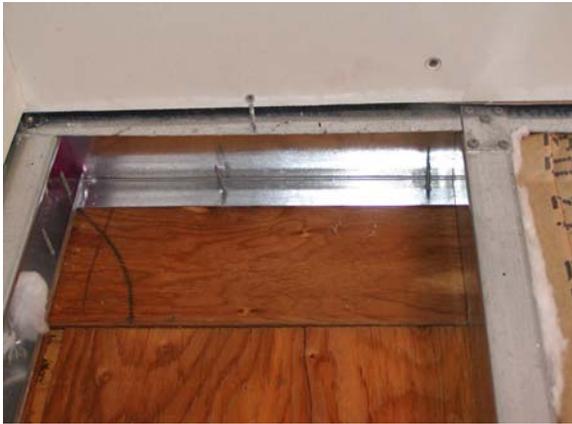
Figure A.23: East Wall – North Top Track

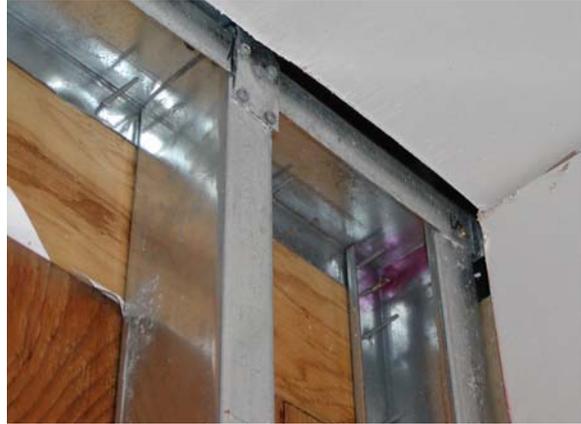
Figure A.24: East Wall – South Top Track

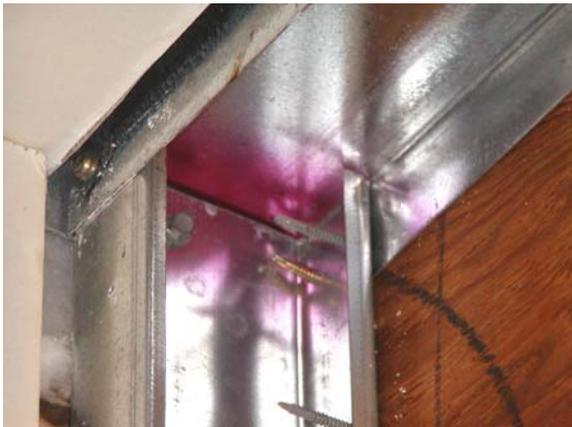
Figure A.25: East Wall – Top Track Connection

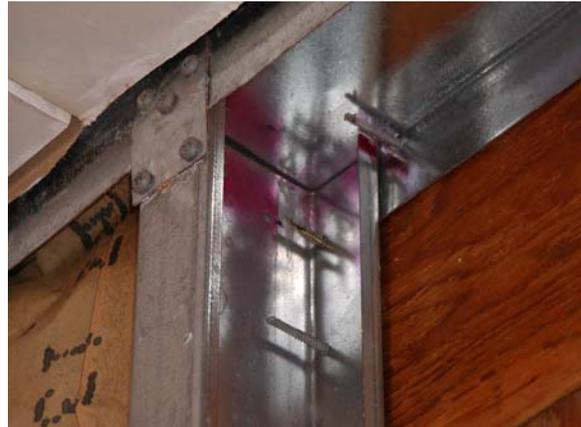
Figure A.26: East wall – Stud-track connection

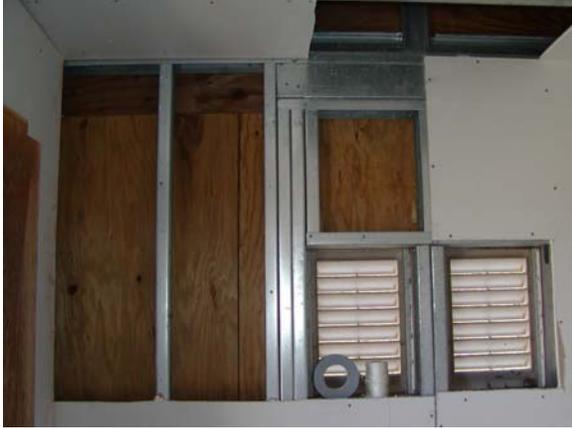
Figure A.27: North Wall – West side

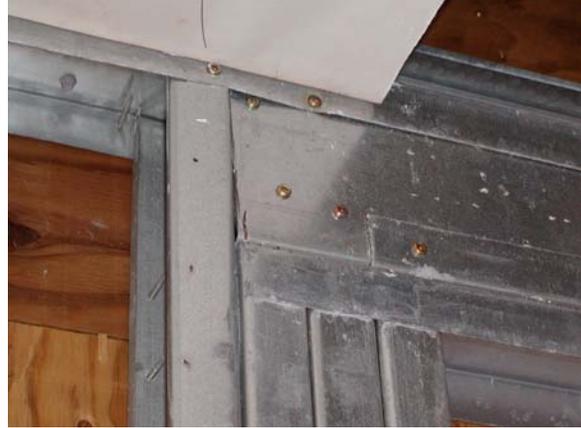
Figure A.28: North wall – Header west connection

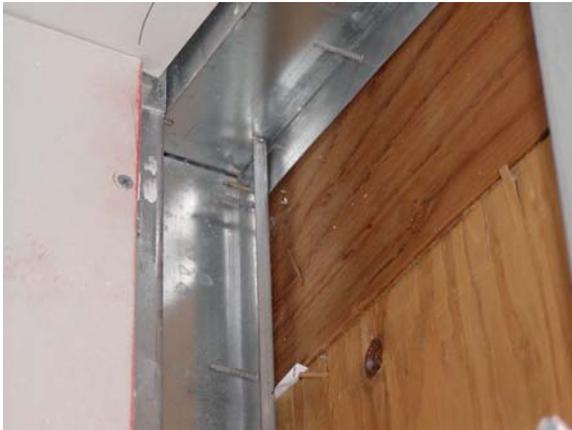
Figure A.29: North Wall – Top track connection

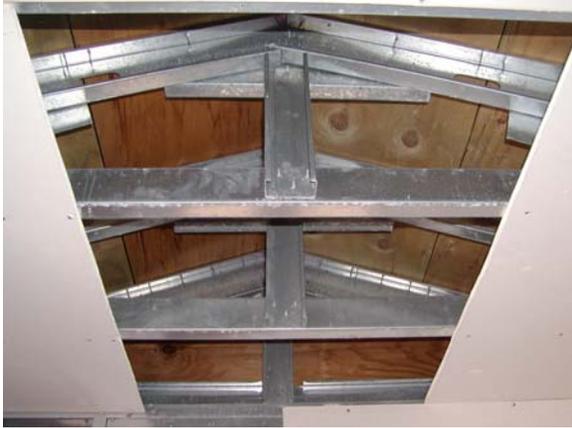
Figure A.30: Roof Trusses

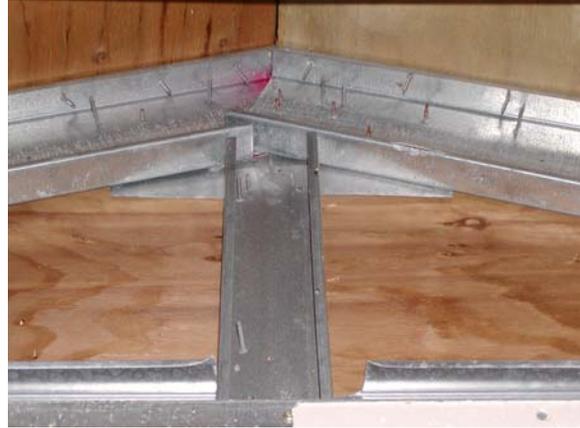
Figure A.31: End Truss

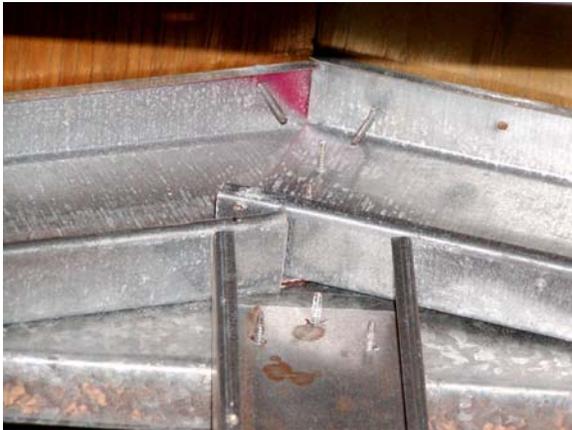
Figure A.32: Ridge connection

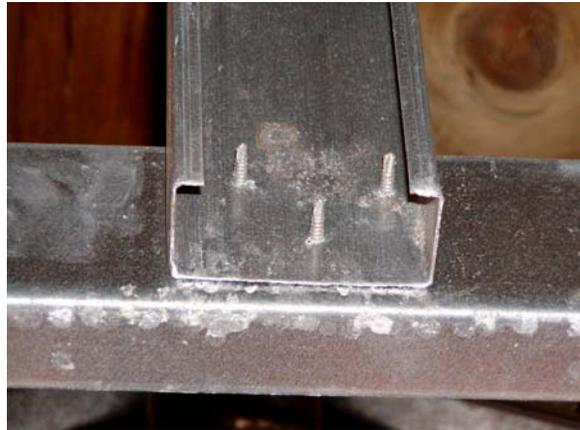
Figure A.33: King post base connection

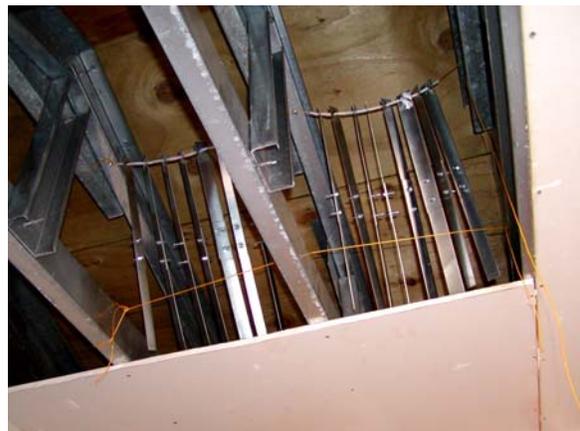
Figure A.35: Location 2 – Attic test connections

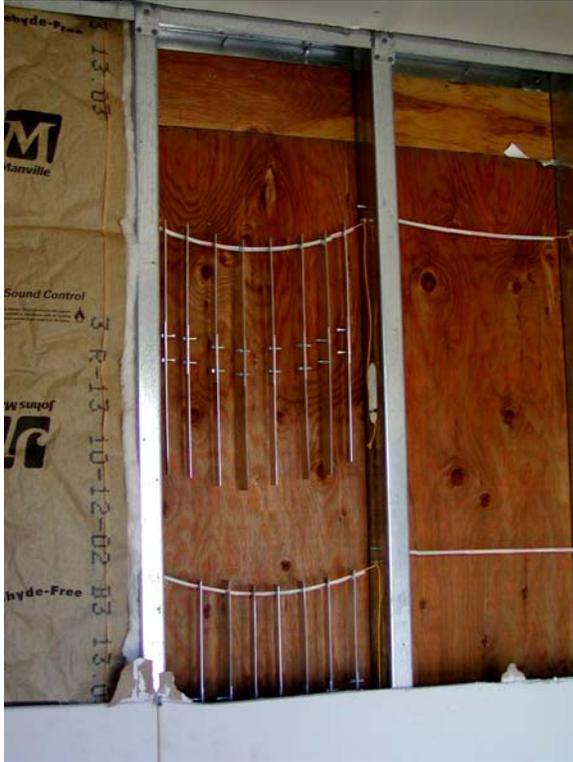
Figure A.36: Location 1 – Interior wall

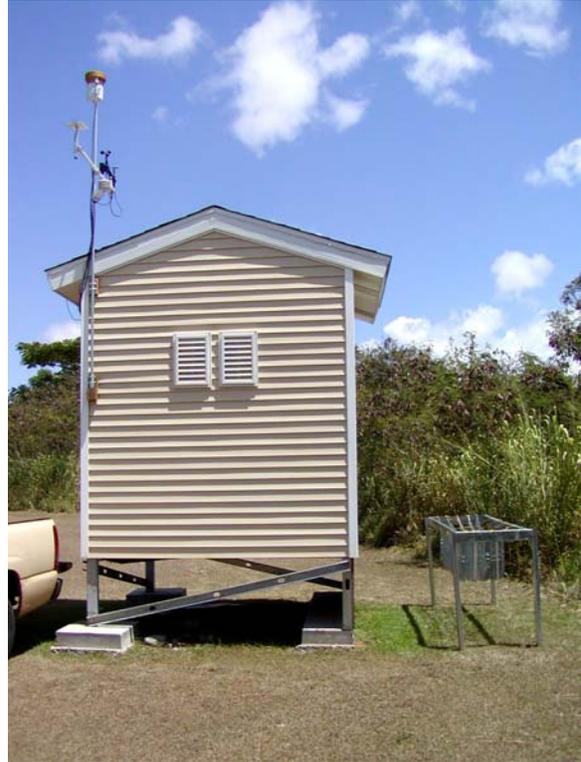
Figure A.37: Location 5 – Exterior exposure

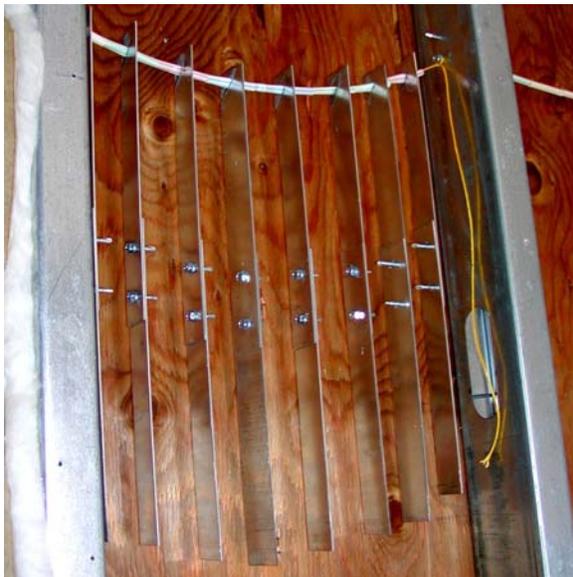
Figure A.39: Location 1 – Interior test connections

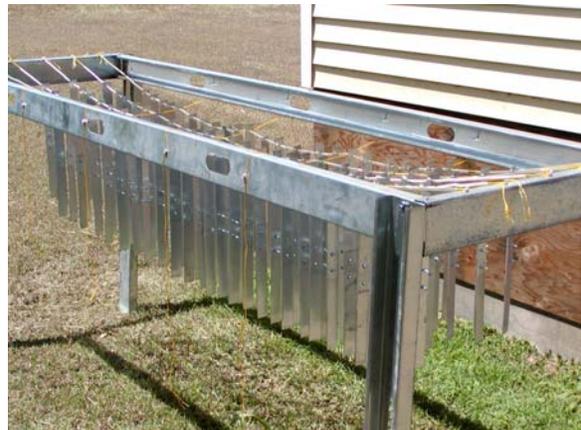
Figure A.38: Exterior test connection rack

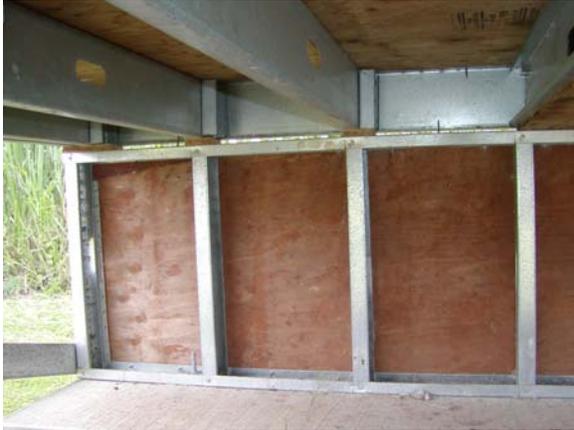
Figure A.40: Cripple Wall – NE corner

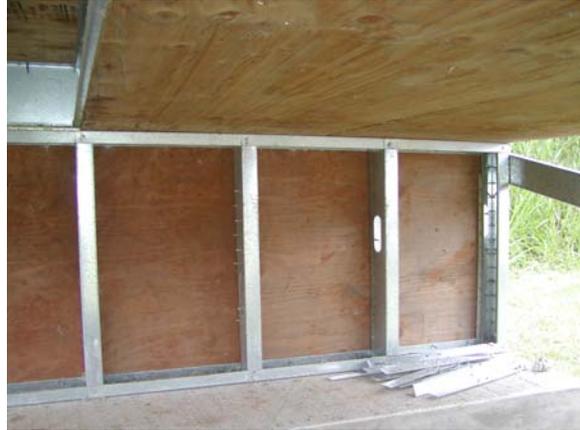
Figure A.41: Cripple Wall – SE corner

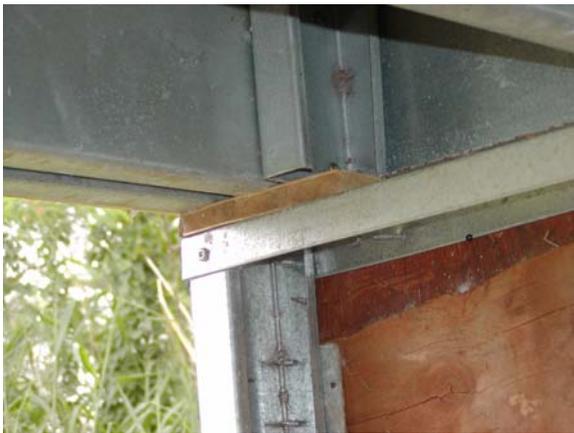
Figure A.42: Cripple Wall – NE corner top

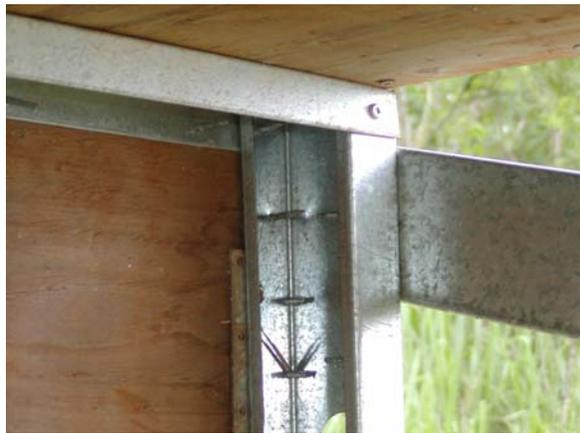
Figure A.43: Cripple Wall – SE corner top

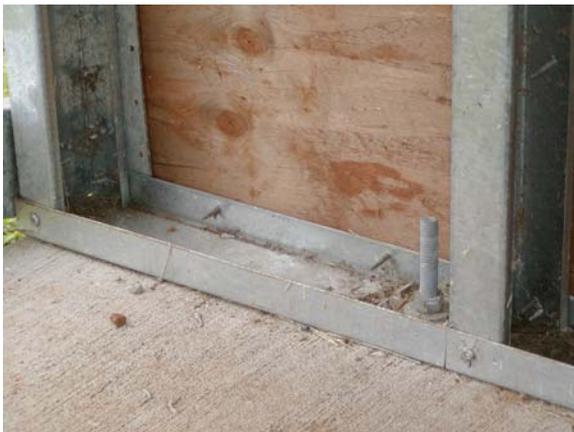
Figure A.44: Cripple Wall – NE corner bottom

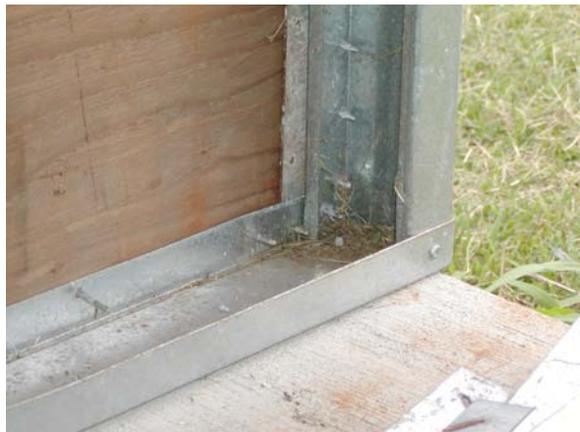
Figure A.45: Cripple Wall – SE corner bottom

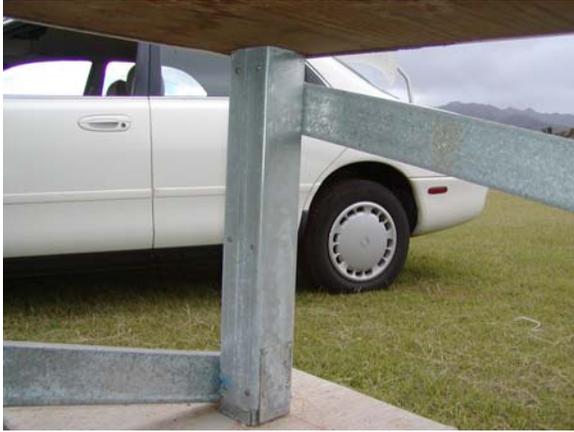
Figure A.46: SW Post

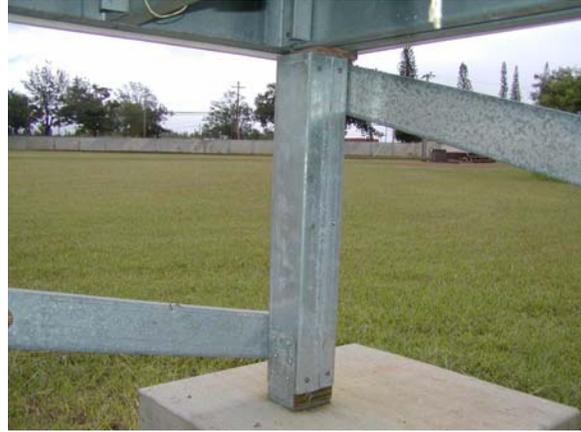
Figure A.47: NW Post

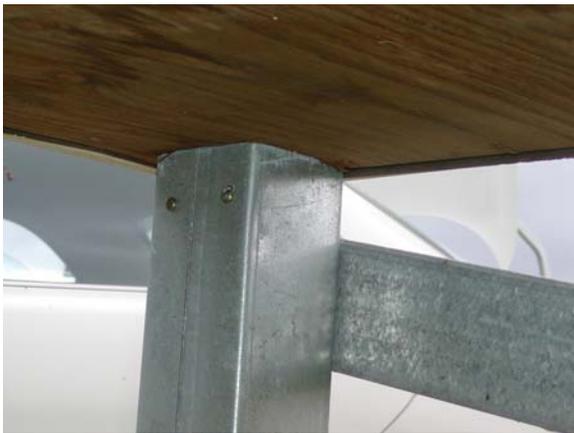
Figure A.48: SW Post top

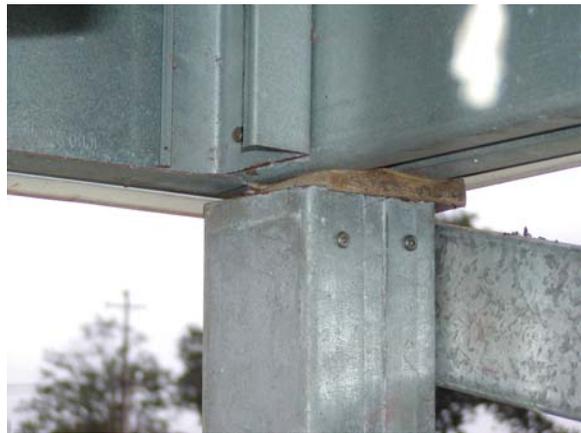
Figure A.49: NW Post top

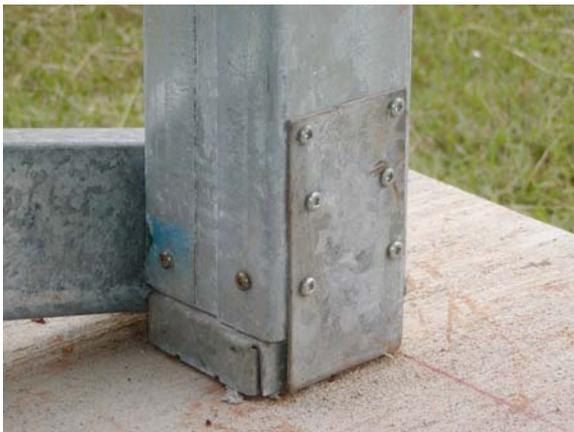
Figure A.50: SW Post base

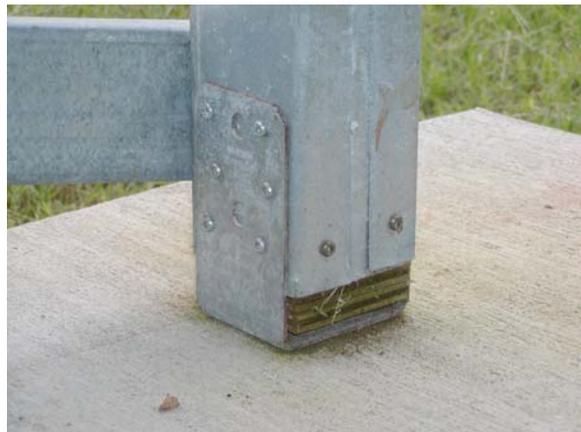
Figure A.51: NW Post base

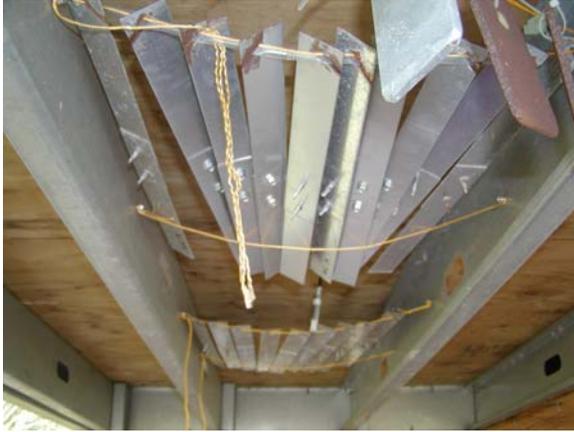
Figure A.52: Location 3 – Uncovered joists

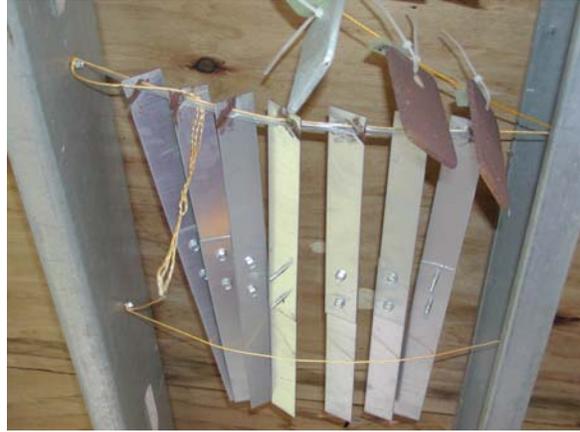
Figure A.53: Location 3 – test connections

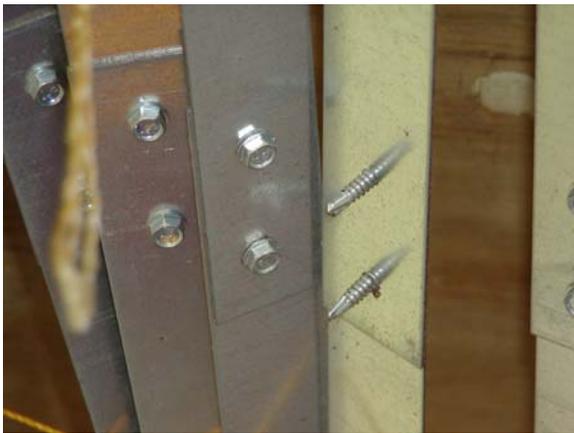
Figure A.54: Location 3 – connection fasteners

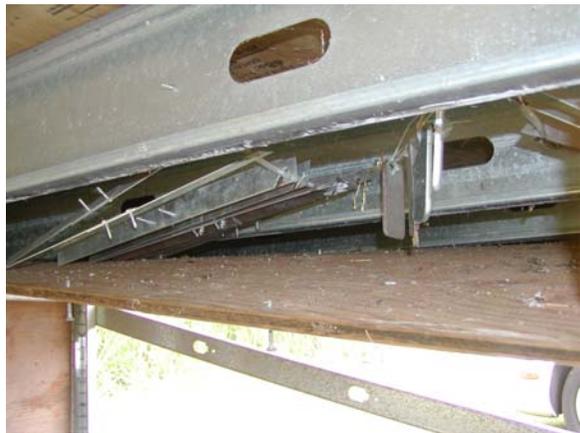
Figure A.55: Location 4 – Enclosed joists

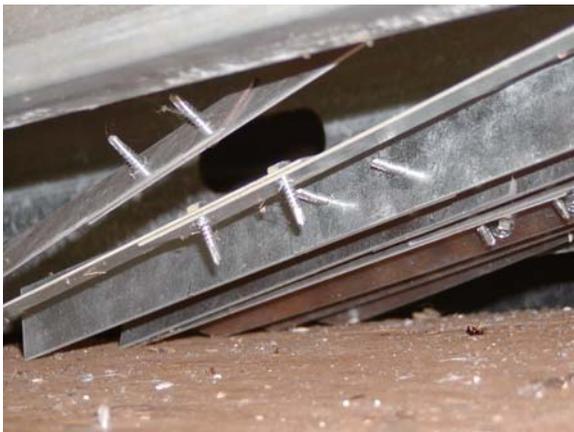
Figure A.56: Location 4 – connection fasteners

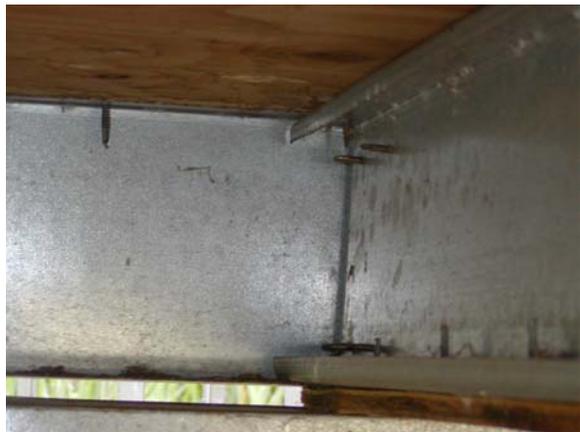
Figure A.57: Joist connection

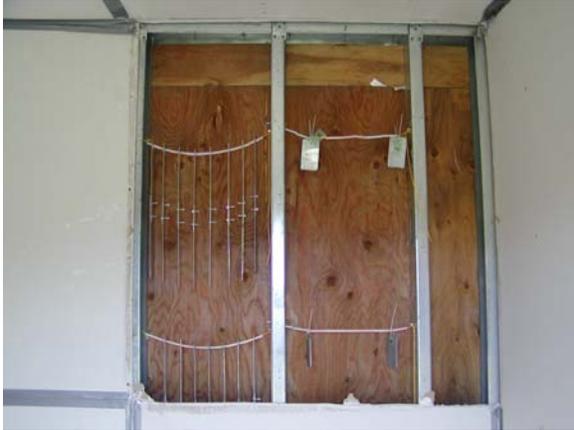
Figure A.58: Location 1 – Interior wall

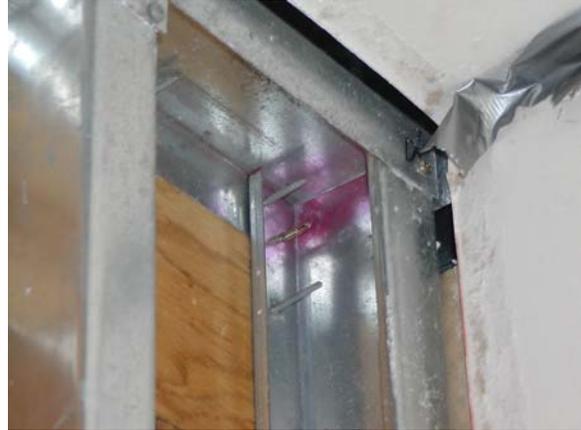
Figure A.59: Location 1 – Top track connections

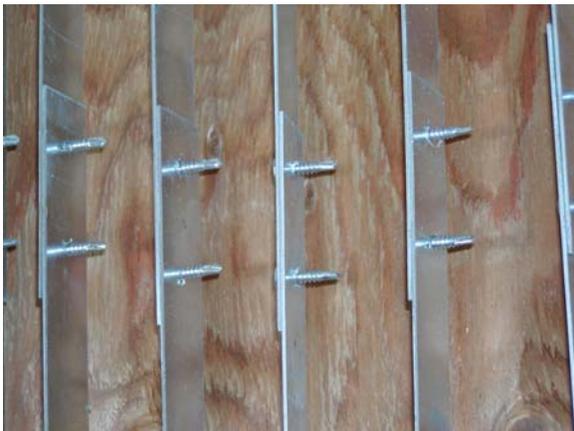
Figure A.60: Location 1 – connection fasteners

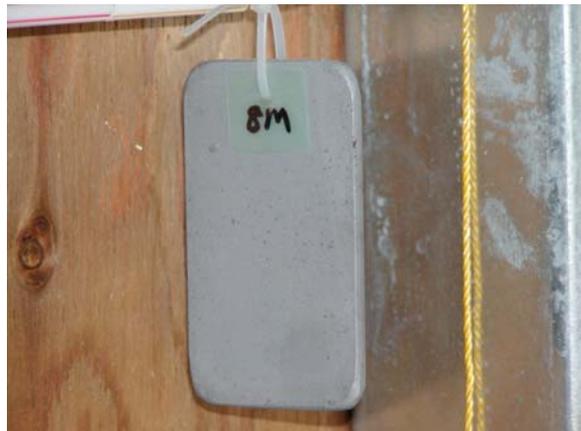
Figure A.61: Location 1 – zinc coupon

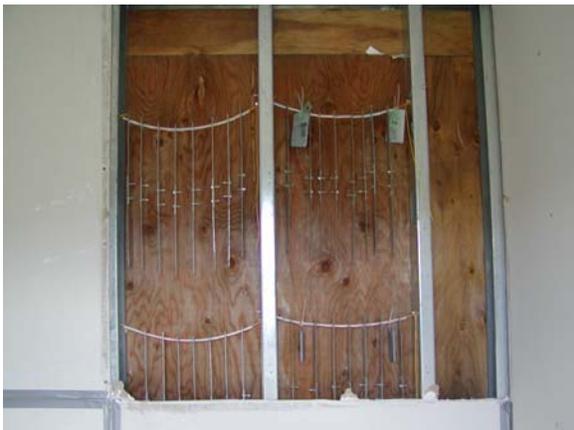
Figure A.62: 7 Month exterior connections added

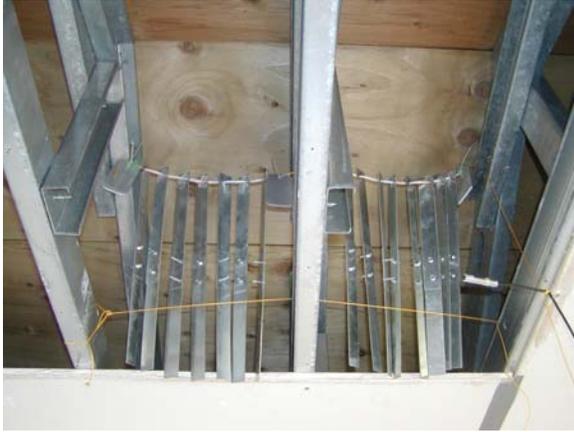
Figure A.63: Location 2 – Attic test connections

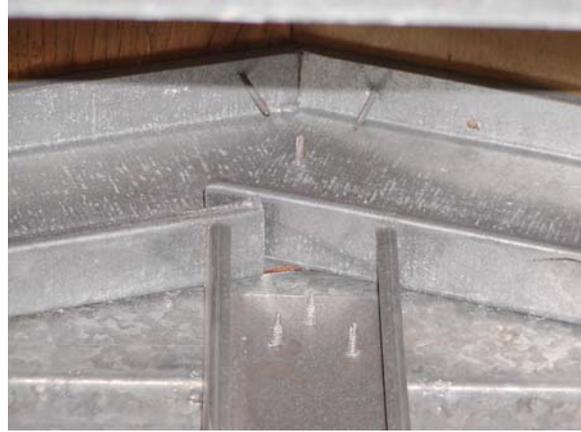
Figure A.64: Location 2 – Truss top connection

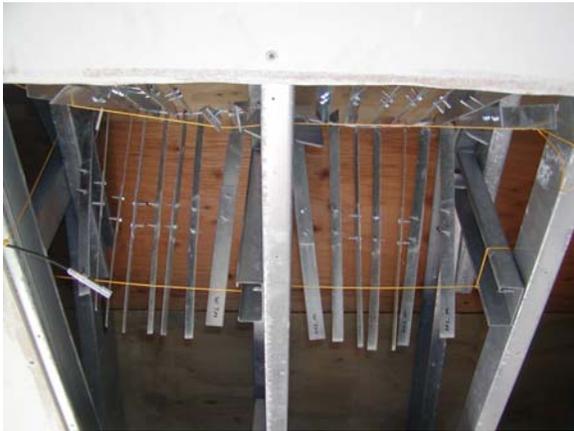
Figure A.65: Location 2 – 7 Month conn. added

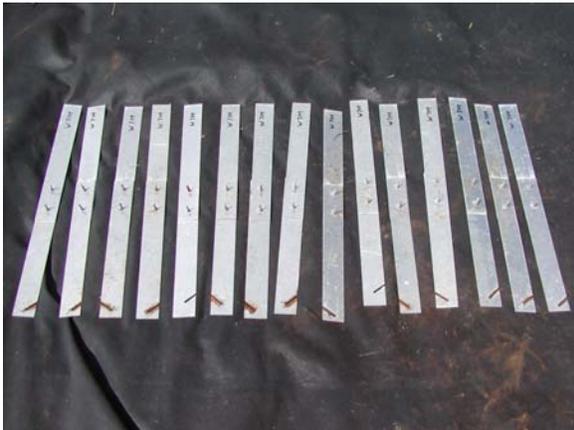
Figure A.67: 7 Month exterior connection set

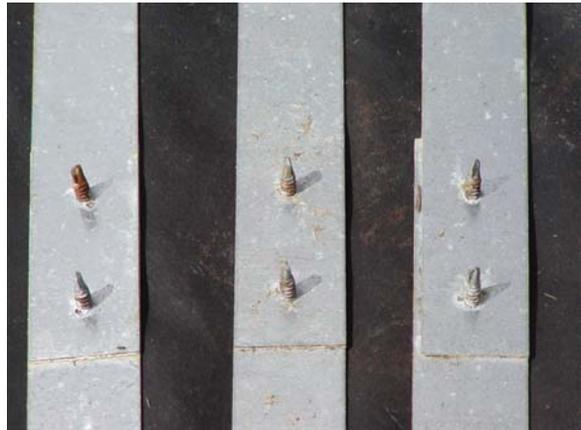
Figure A.68: 7 Month exterior connection fasteners

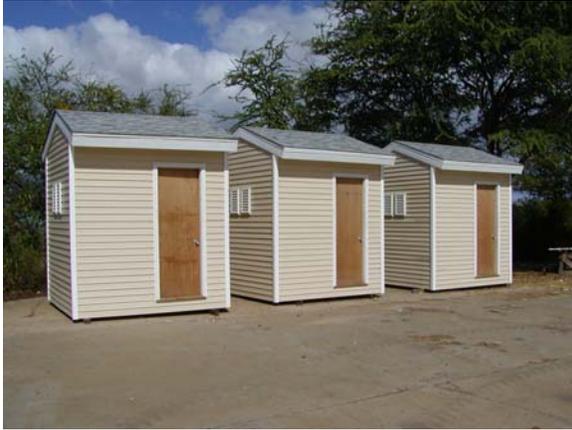
Figure B.1: Pre-fabrication in Pearl City – July 2002

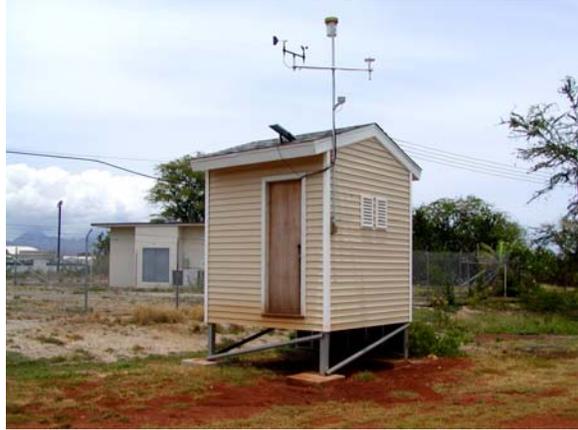
Figure B.2: SW elevation – March 2003

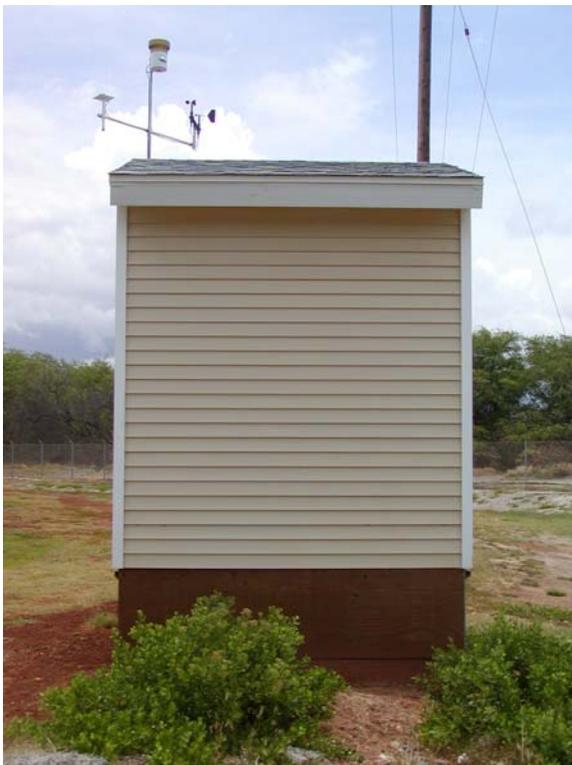
Figure B.3: East Elevation – March 2003

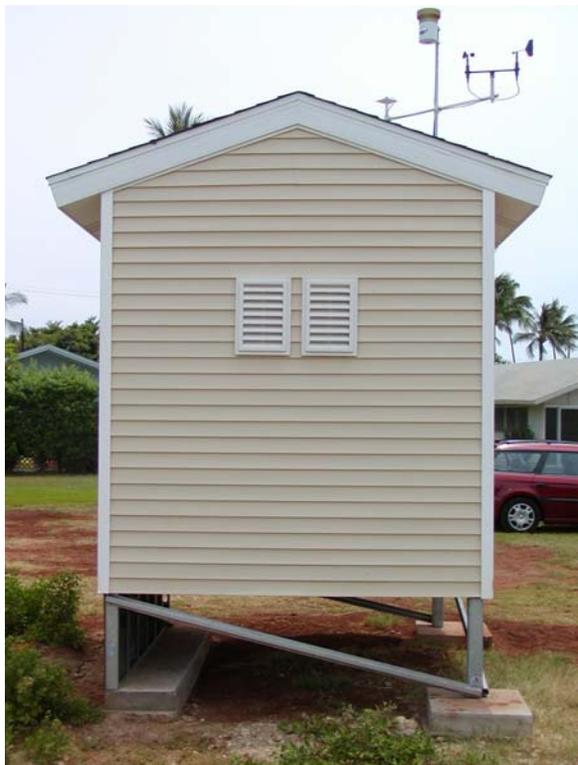
Figure B.4: North Elevation – March 2003

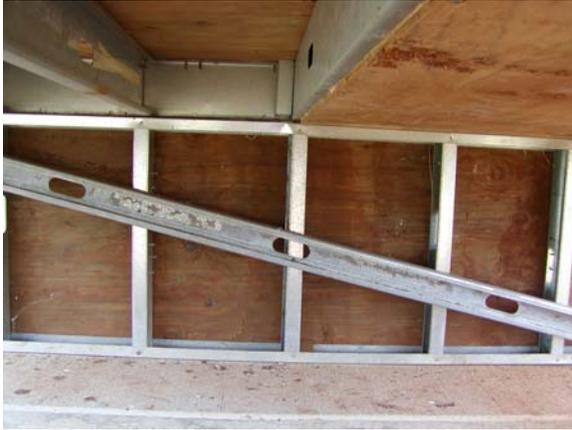
Figure B.5: East Cripple Wall

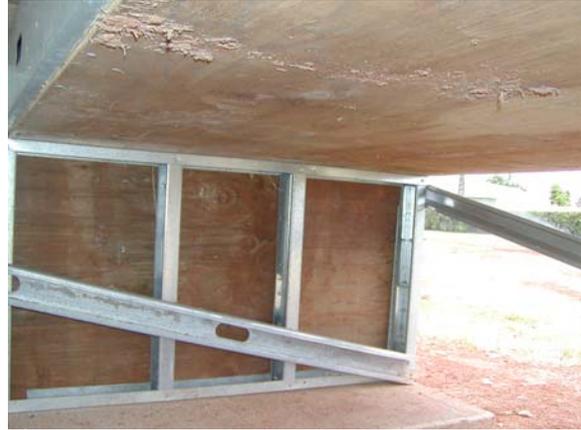
Figure B.6: Cripple Wall – SE end

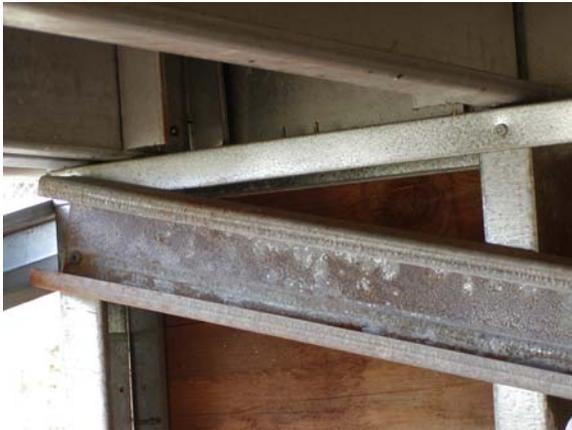
Figure B.7: Cripple Wall – NE end top

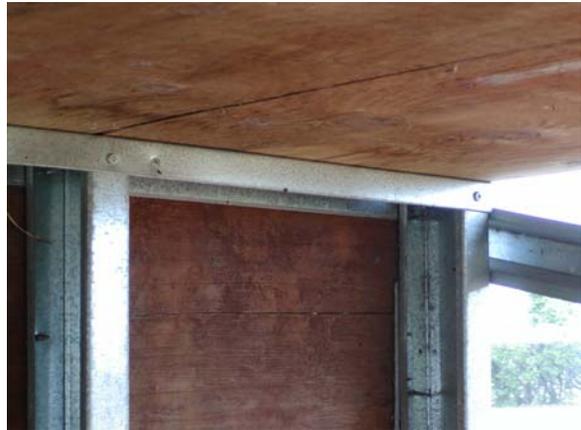
Figure B.8: Cripple Wall – SE end top

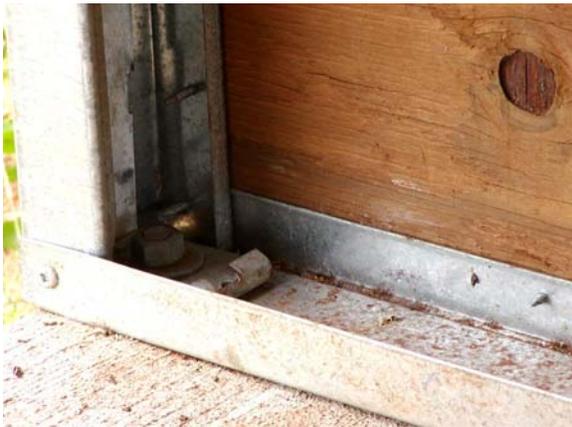
Figure B.9: Cripple Wall – NE end base

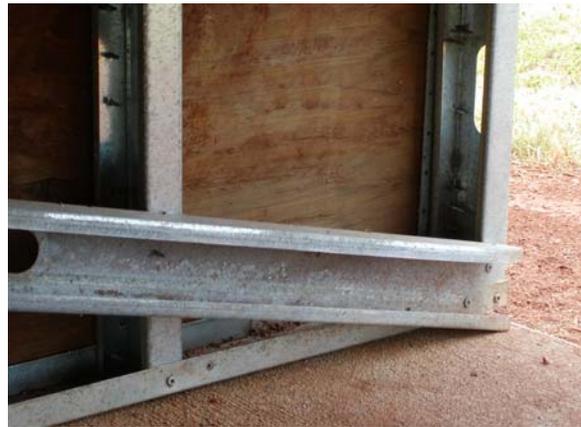
Figure B.10: Cripple Wall – SE end base

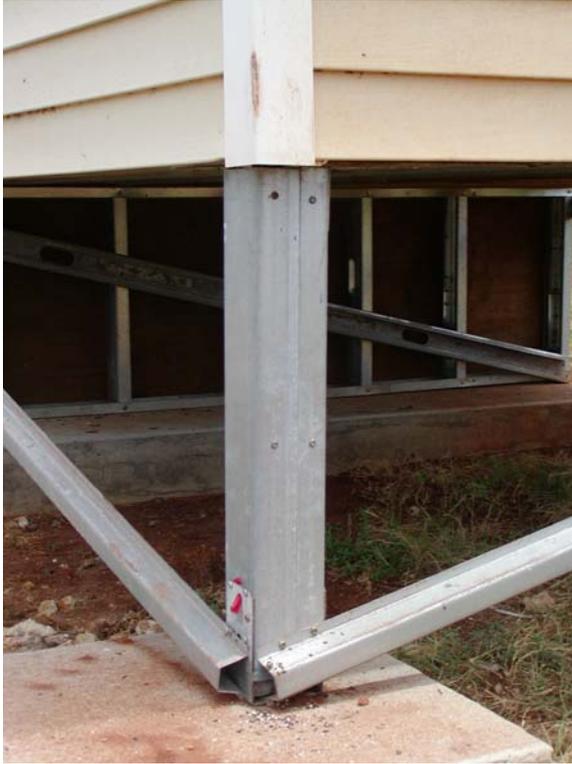
Figure B.11: NW Post

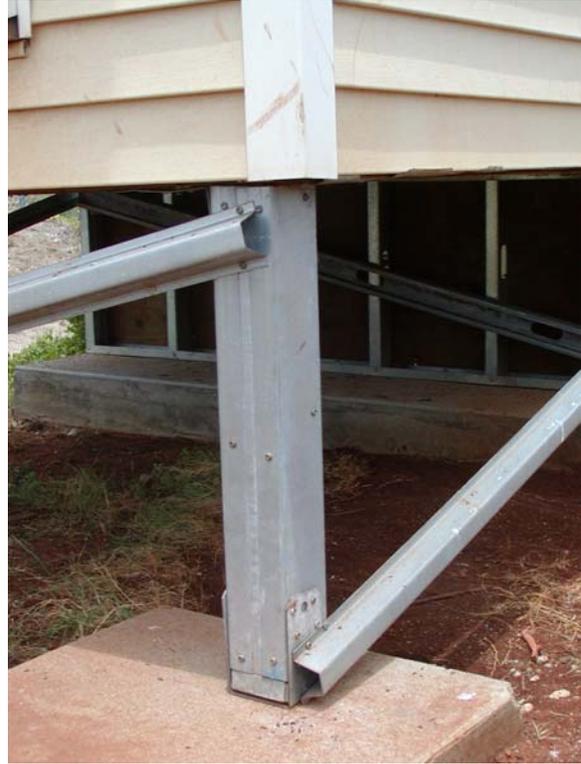
Figure B.12: SW Post

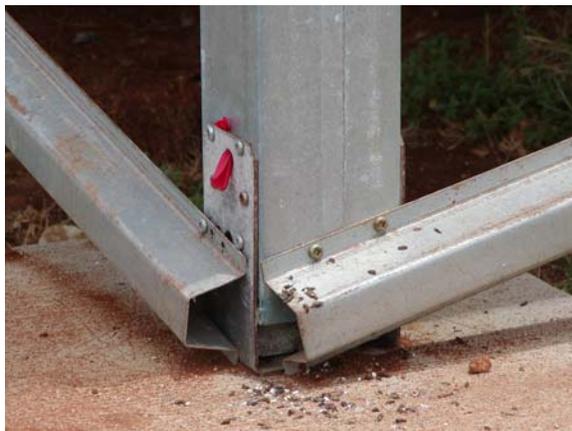
Figure B.13: NW Post Base

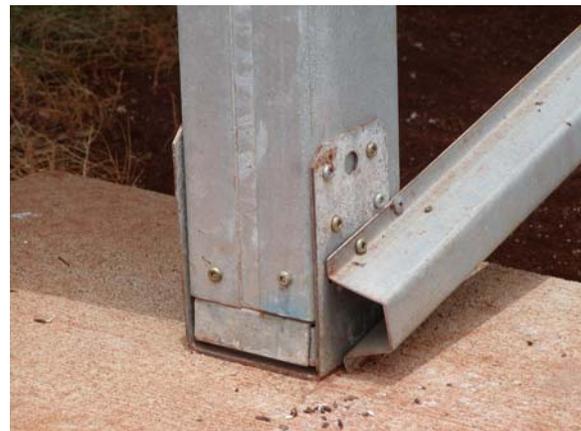
Figure B.14: SW Post Base

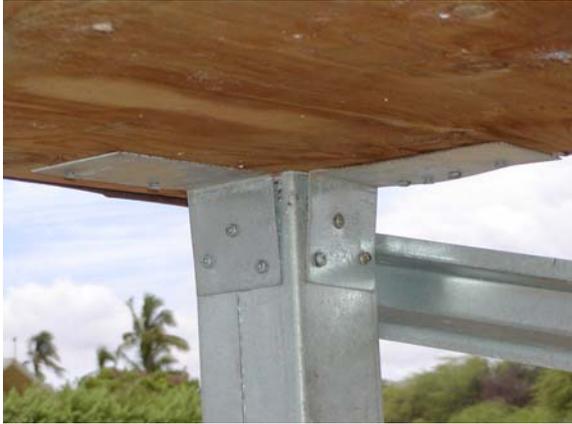
Figure B.15: SW Post Top – Interior view

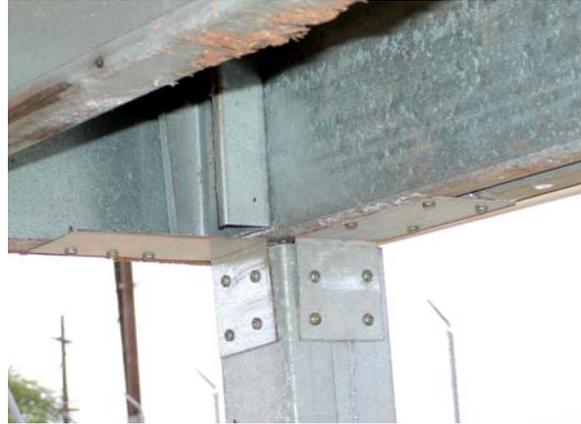
Figure B.16: NW Post Top – Interior view

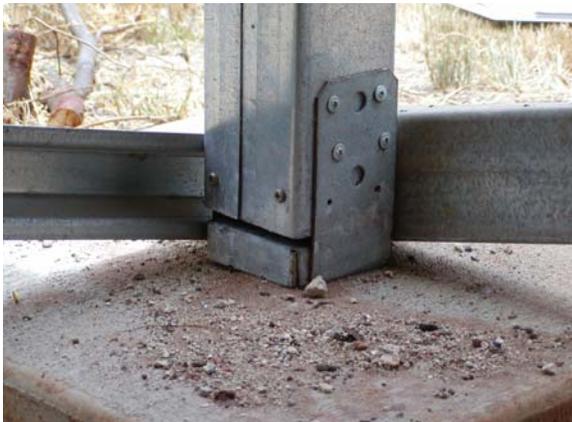
Figure B.17: SW Post Base – Interior view

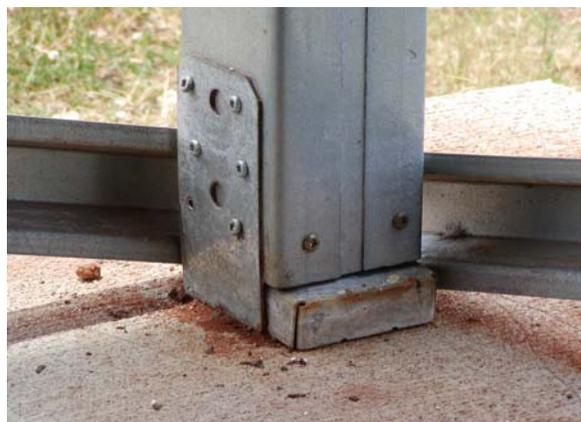
Figure B.18: NW Post Base – Interior view

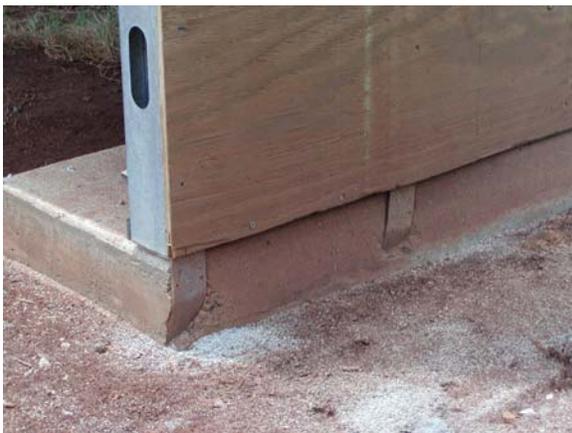
Figure B.19: SE Corner wall tie-downs

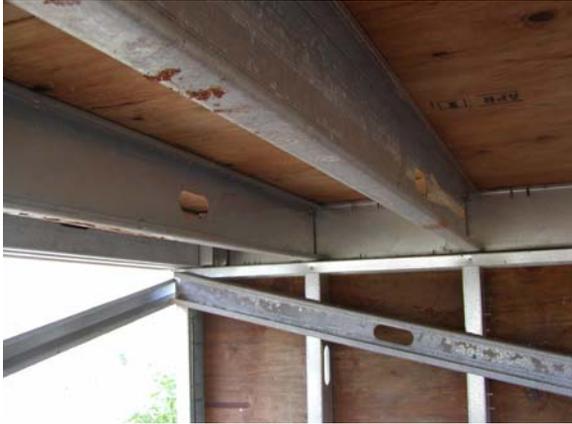
Figure B.20: Joists on Cripple Wall – NE corner

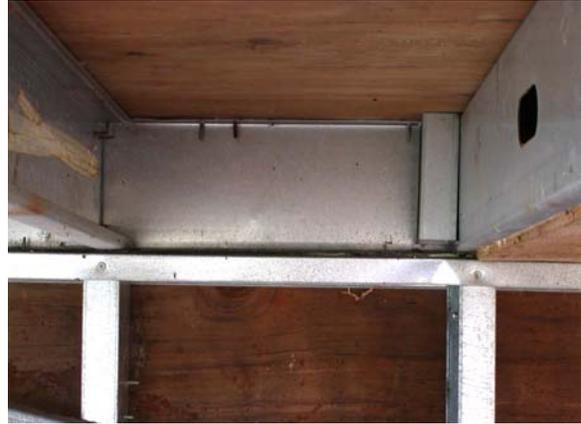
Figure B.21: Joists on cripple wall – East end
