Wheeler Army Airfield - Field Enclosure Photographs

HUD CONTRACT No.:	H-21248CA
PROJECT TITLE:	“Corrosion of Galvanized Fasteners used in Cold-Formed Steel Framing”
CONTRACTOR:	North American Steel Framing Alliance 1726 M Street, NW, Suite 601 Washington, DC 20036
Principal Investigator:	Tim Waite
Co/Investigators:	Don Moody, Kevin Bielat
SUB-CONTRACTOR:	University of Hawaii Dept. of Civil Engineering 2540 Dole Street, Holmes Hall 383 Honolulu, HI 96822
Principal Investigator	Dr. Ian N. Robertson
PROJECT PERIOD:	From 9/26/2000 to 11/25/2003
LITERATURE REVIEW REPORT:	December 27, 2000

CORROSION OF GALVANIZED FASTENERS USED IN COLD-FORMED STEEL FRAMING

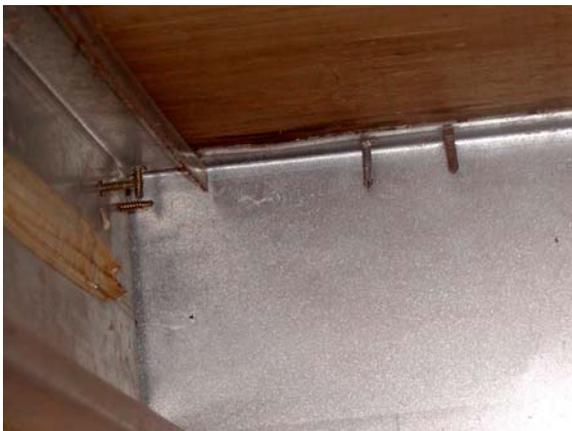
Figure B.22: Joist to track fasteners

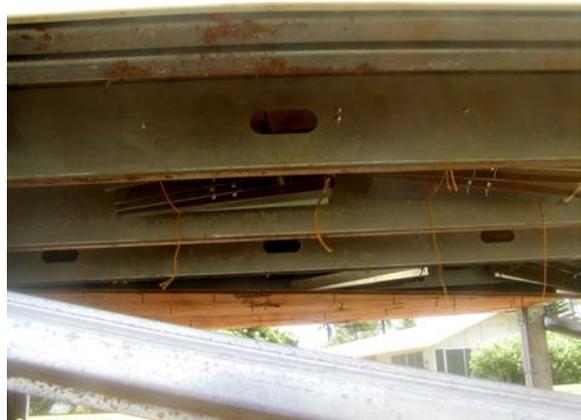
Figure B.23: Exposed Joists

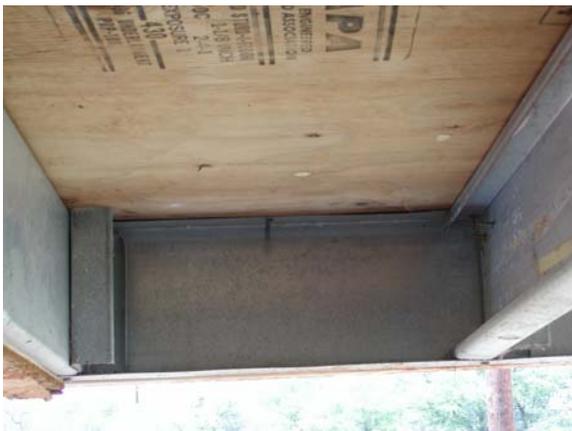
Figure B.24: Joist connections at West end

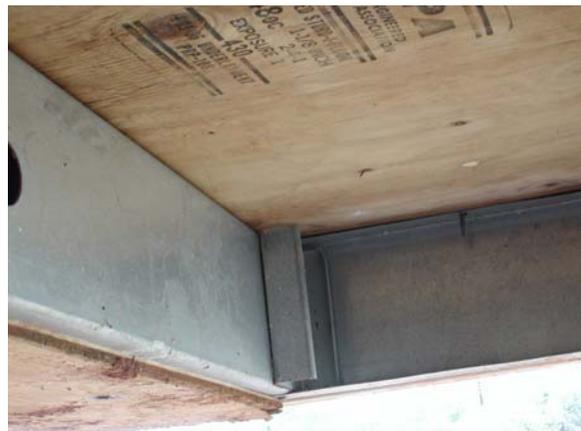
Figure B.25: Joist stiffener at West connection

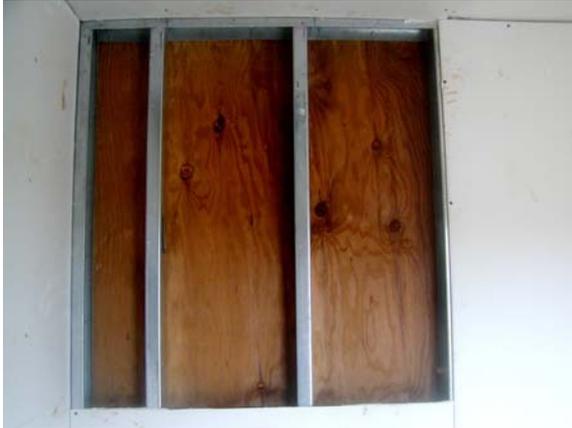
Interior Wall Framing – East wall – Plywood without vapor barrier

Figure B.26: East Wall – North end framing

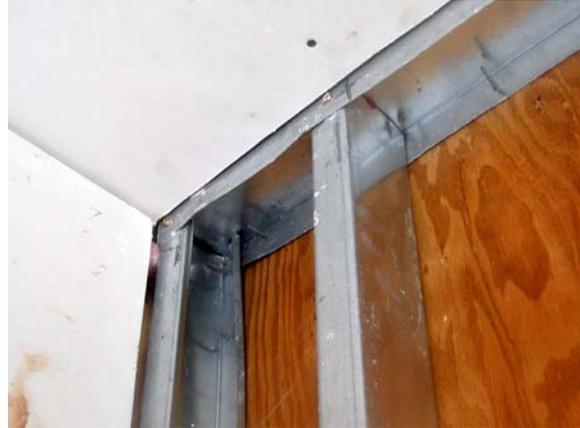
Figure B.27: East Wall – Top Track detail

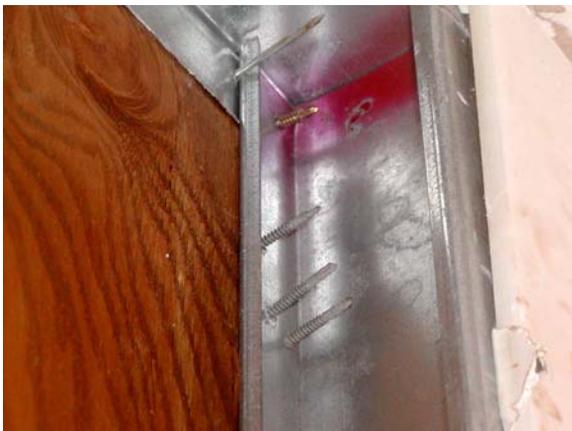
Figure B.28: East Wall – Stud to track detail

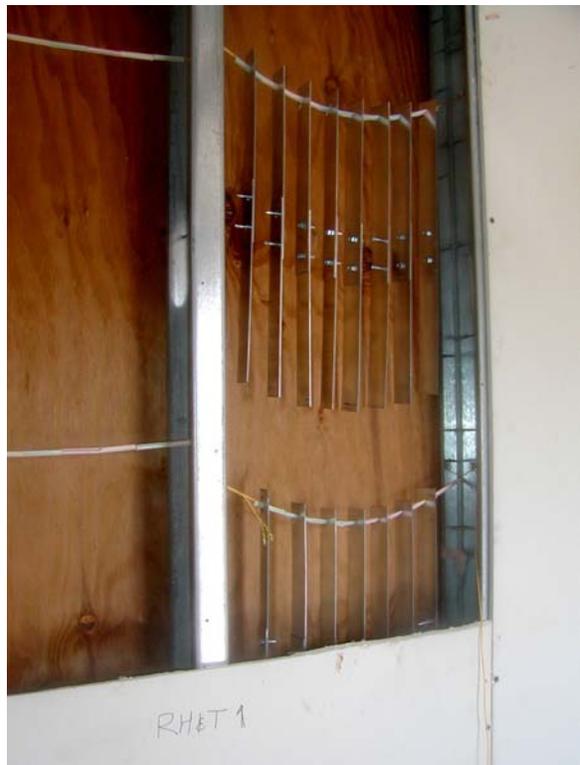
Figure B.29: Test connections in East wall – Loc 1

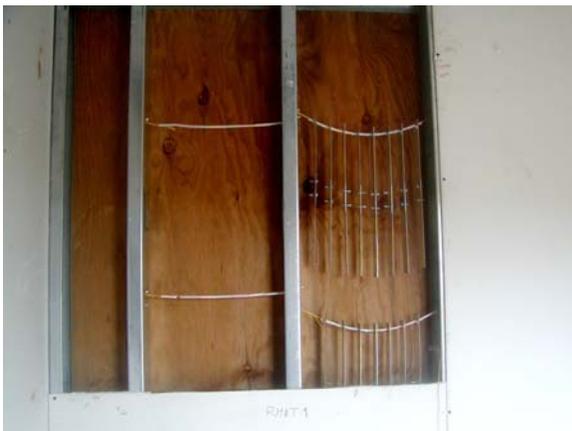
Figure B.30: Test connections in East wall – Loc 1

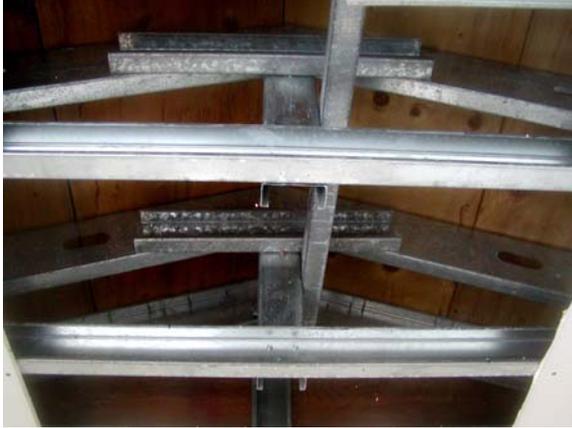
Figure B.31: Attic Framing

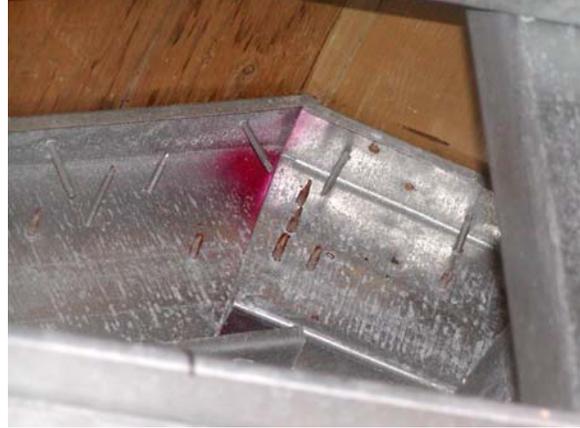
Figure B.32: Ridge connection fasteners

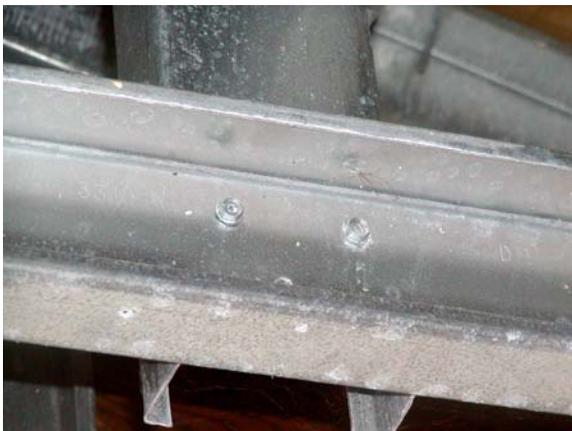
Figure B.33: King post base connection

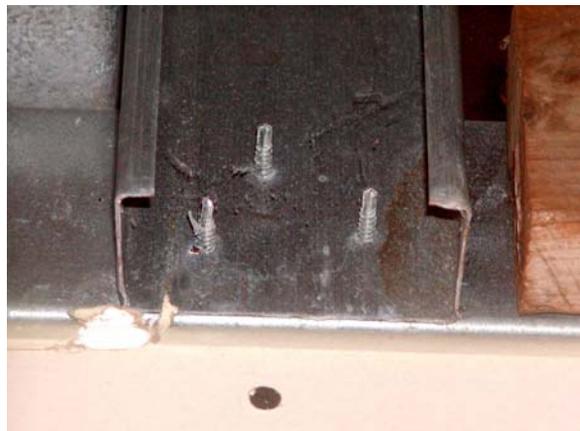
Figure B.34: King post base connection

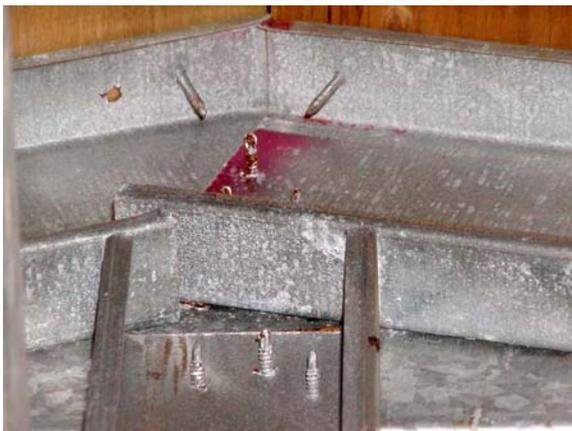
Figure B.35: King post top connection

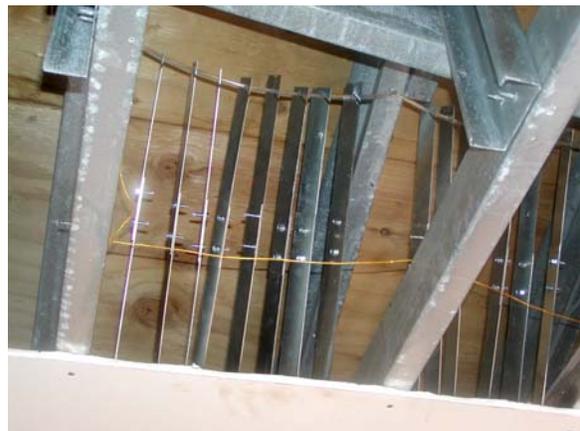
Figure B.36: Test connections in attic – Location 2

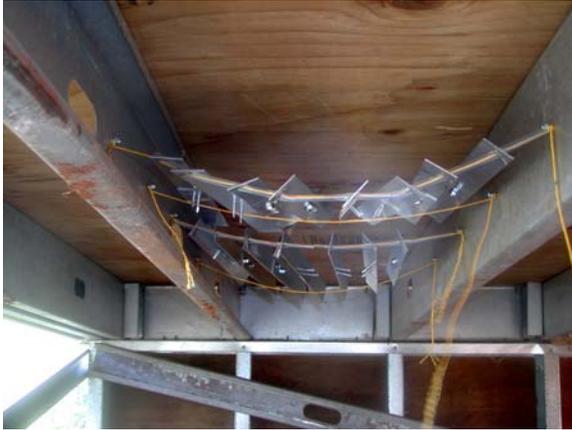
Figure B.37: Location 3 – Exposed crawl space

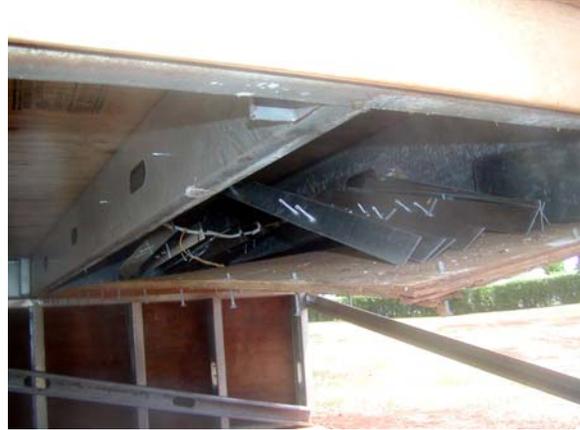
Figure B.38: Location 4 – Covered crawl space

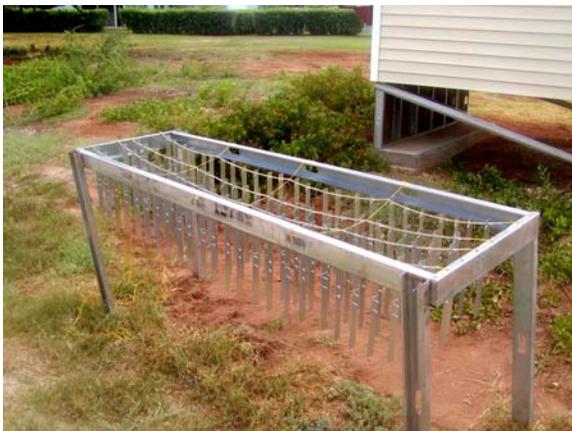
Figure B.39: Location 5 – Exterior rack

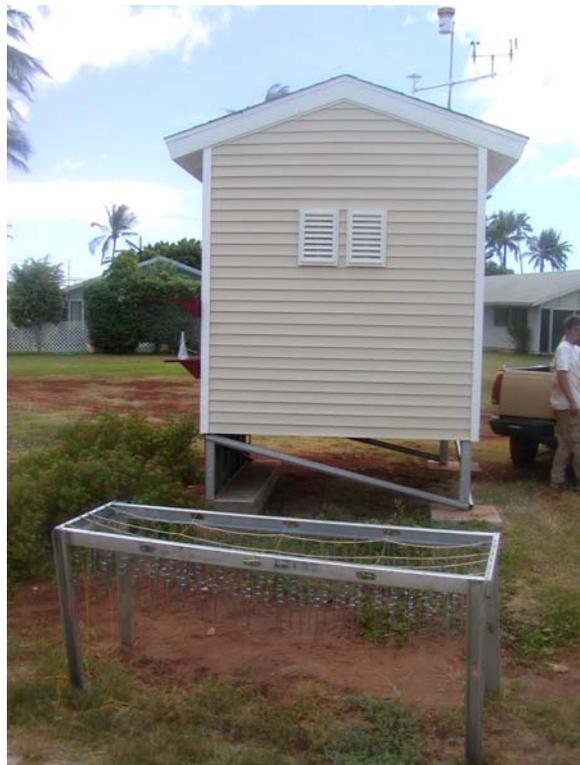
Figure B.40: Location 5 – Exterior rack

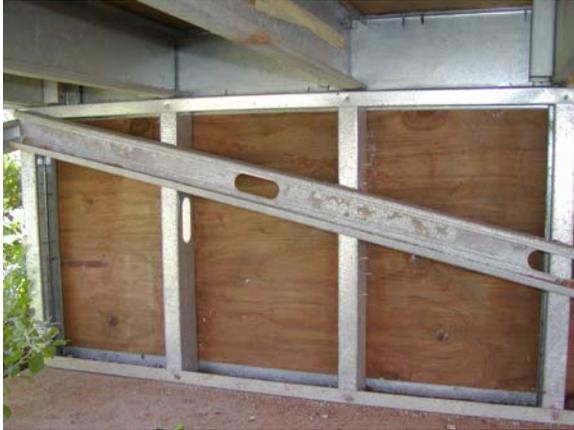
Figure B.41: Cripple Wall – NE corner

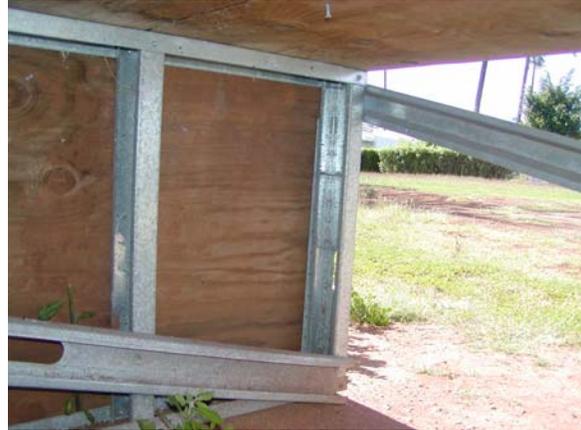
Figure B.42: Cripple Wall – SE corner

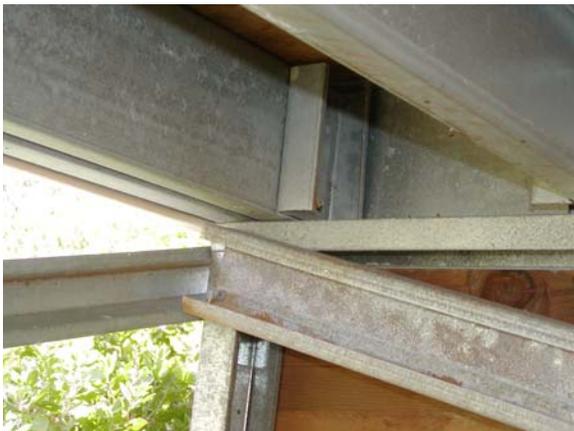
Figure B.43: Cripple Wall – NE corner top

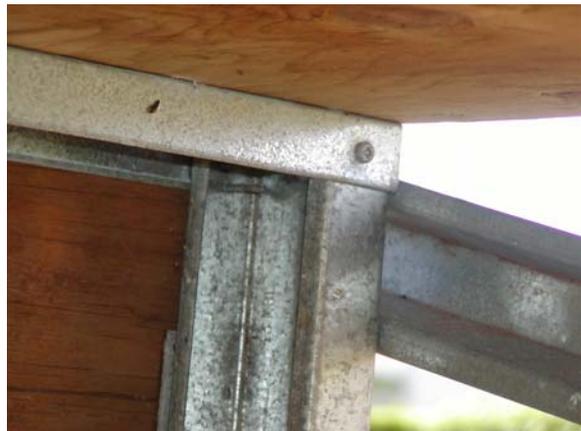
Figure B.44: Cripple Wall – SE corner top

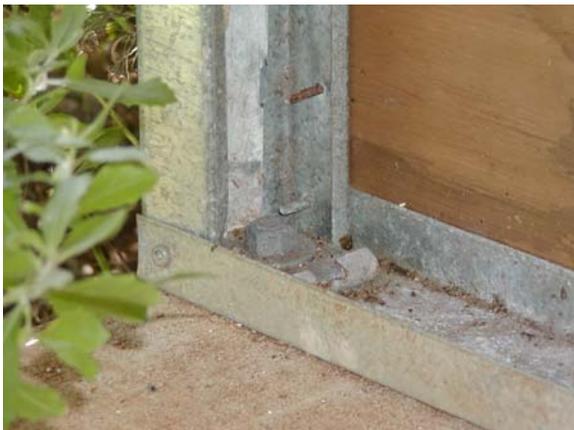
Figure B.45: Cripple Wall – NE corner bottom

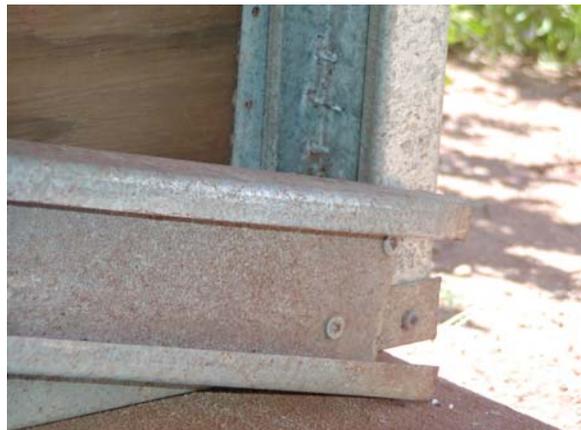
Figure B.46: Cripple Wall – SE corner bottom

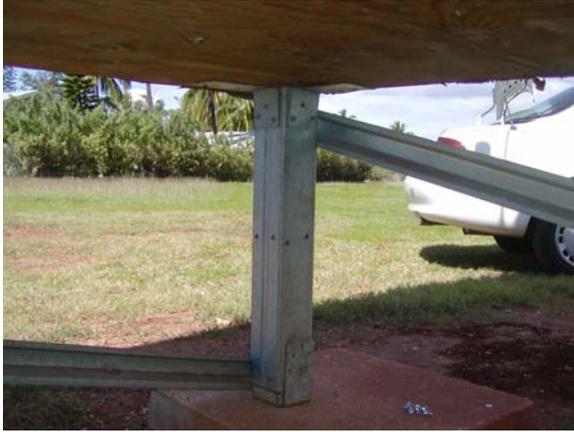
Figure B.47: SW Post

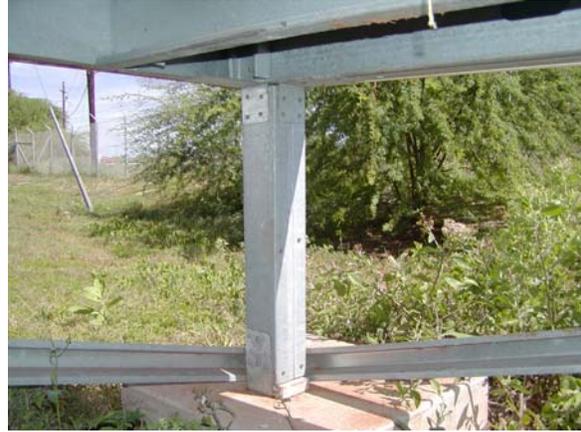
Figure B.48: NW Post

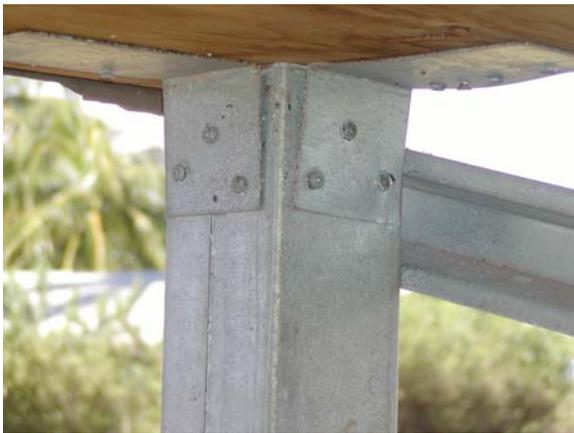
Figure B.49: SW Post top

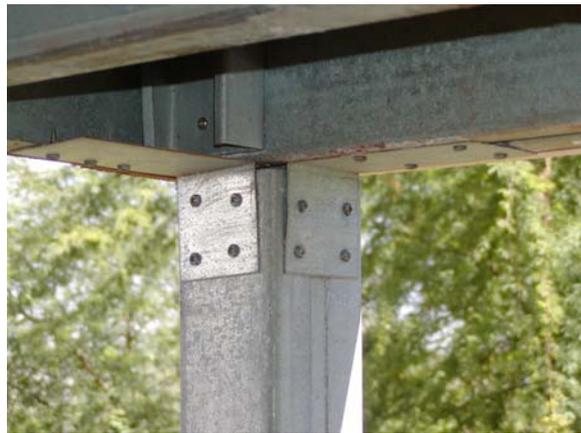
Figure B.50: NW Post top

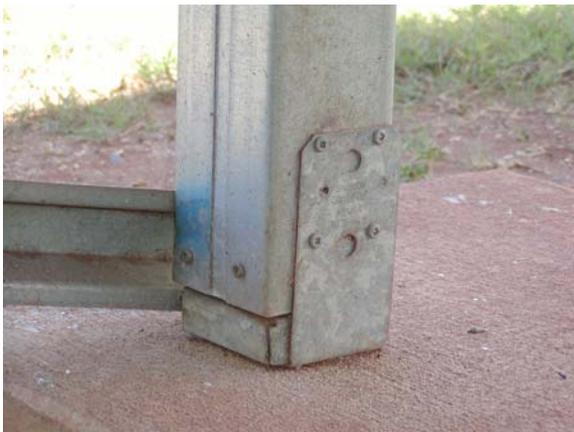
Figure B.51: SW Post base

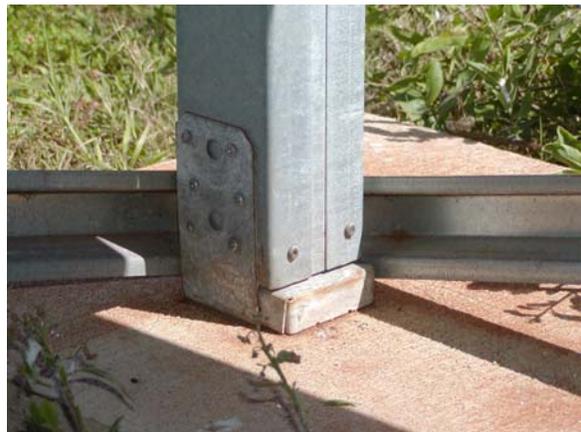
Figure B.52: NW Post base

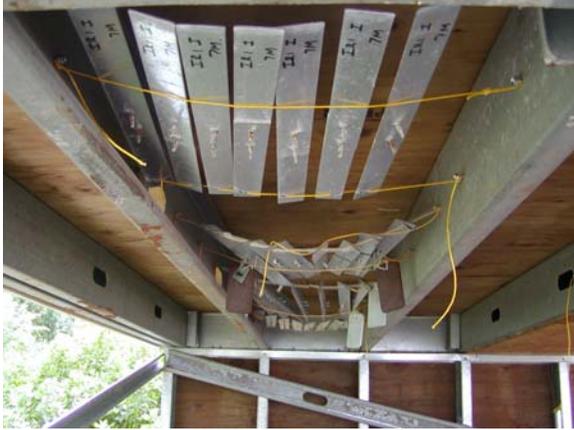
Figure B.53: Location 3 – Uncovered joists

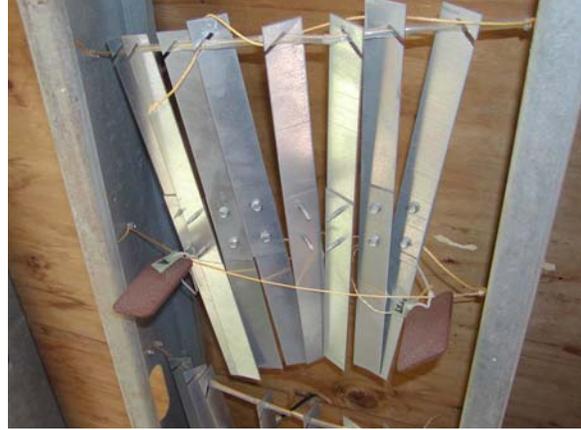
Figure B.54: Location 3 – test connections

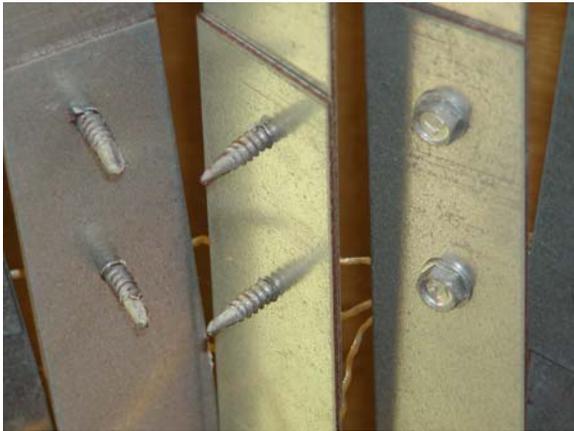
Figure B.55: Location 3 – connection fasteners

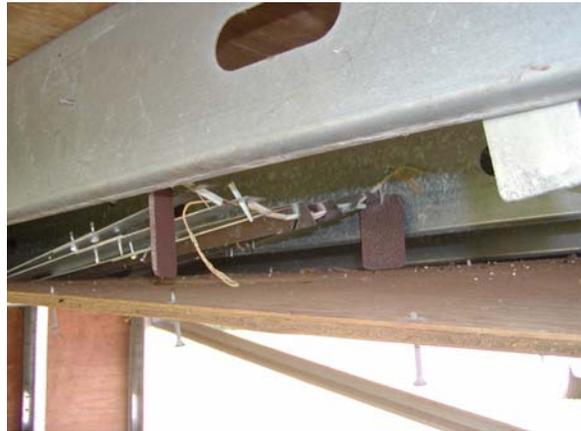
Figure B.56: Location 4 – Enclosed joists

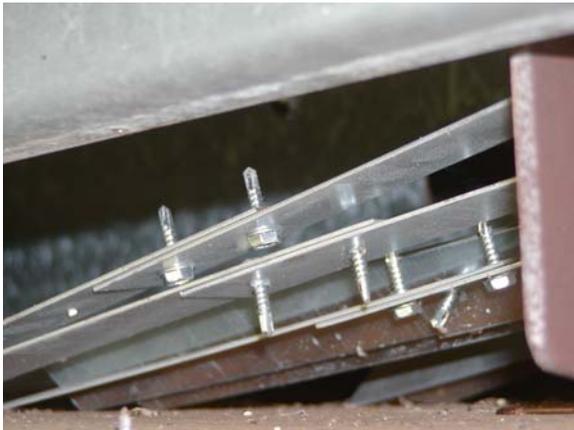
Figure B.57: Location 4 – connection fasteners

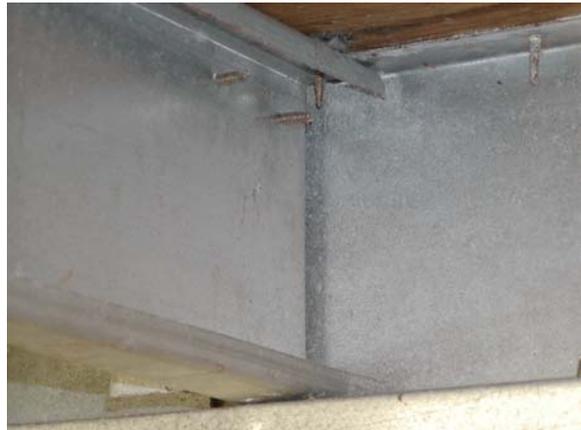
Figure B.58: Joist connection

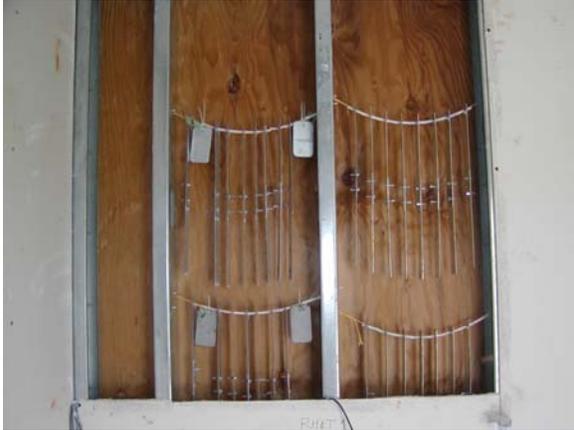
Figure B.59: Location 1 – Interior wall

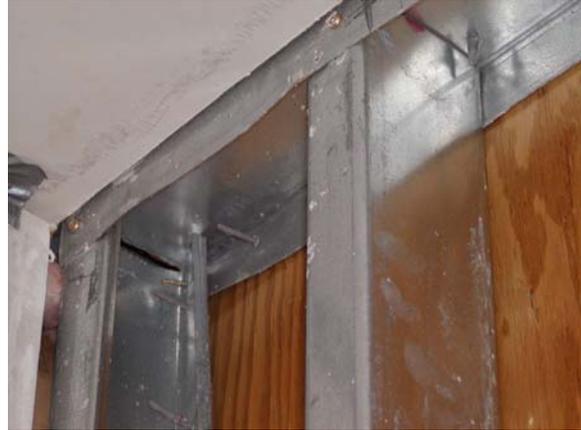
Figure B.60: Location 1 – Top track connections

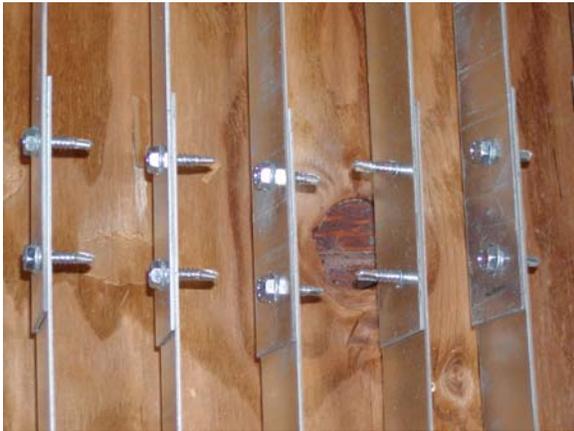
Figure B.61: Location 1 – connection fasteners

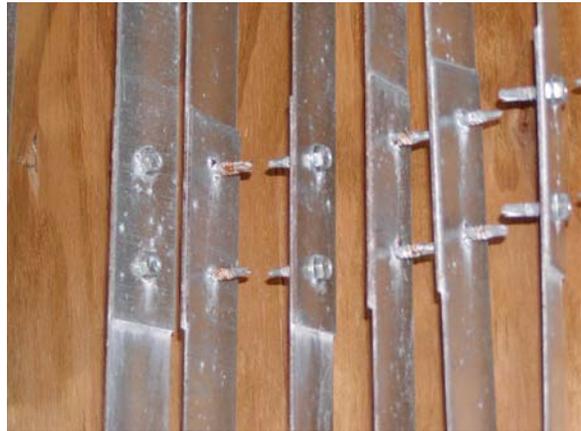
Figure B.62: 7 Month exterior connections added

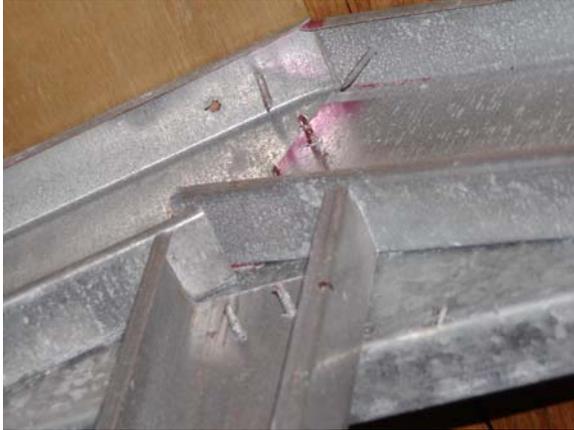
Figure B.63: Location 2 – Attic truss connection

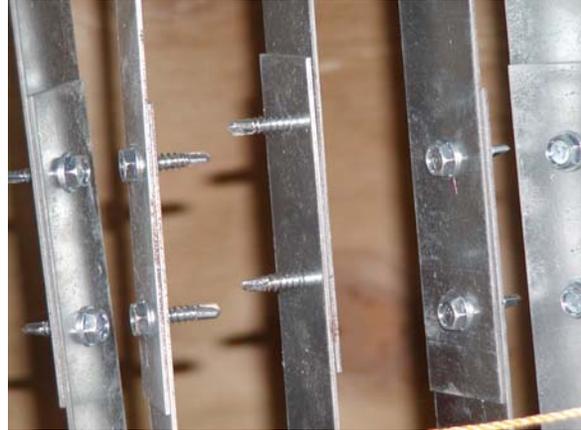
Figure B.64: Location 2 – connection fasteners

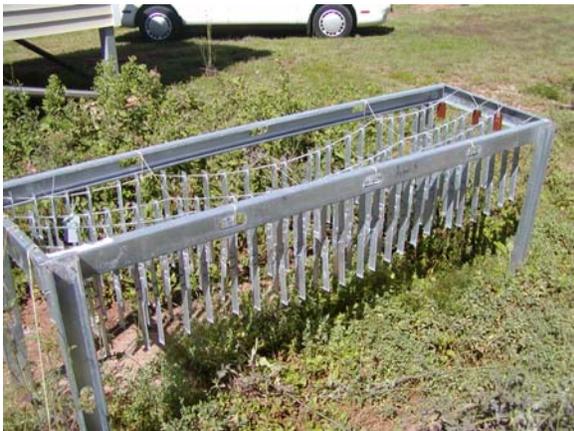
Figure B.65: Location 5 – Exterior connections

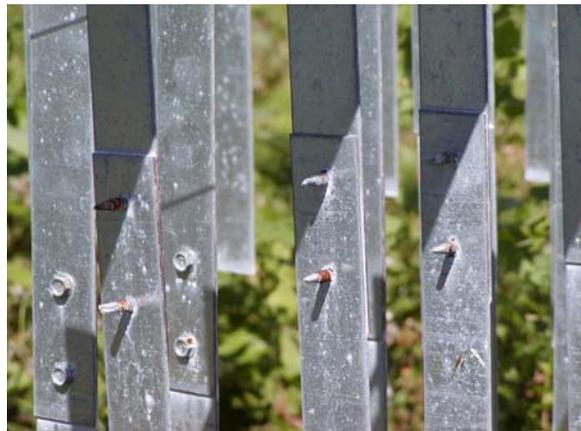
Figure B.66: Location 5 – connection fasteners

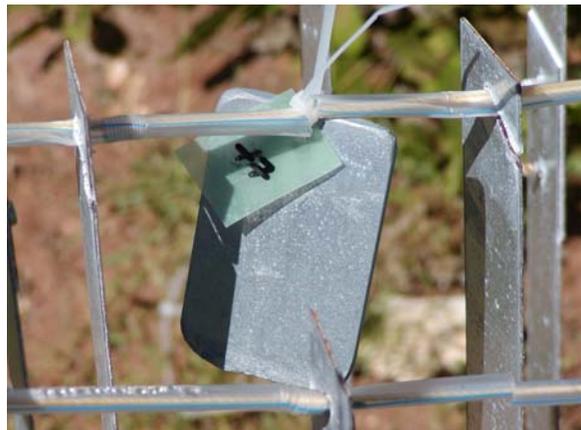
Figure B.68: Location 6 – zinc coupon

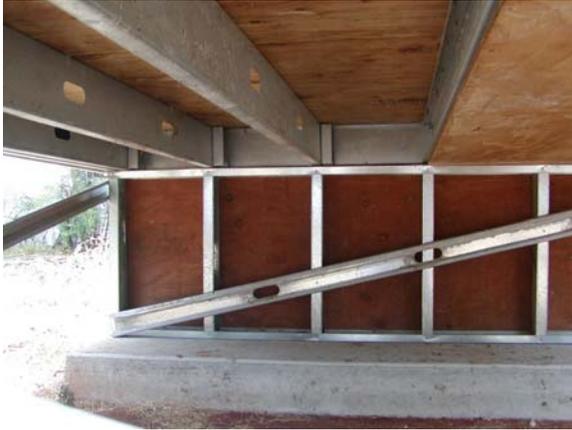
Figure C.5: Cripple Wall NE end

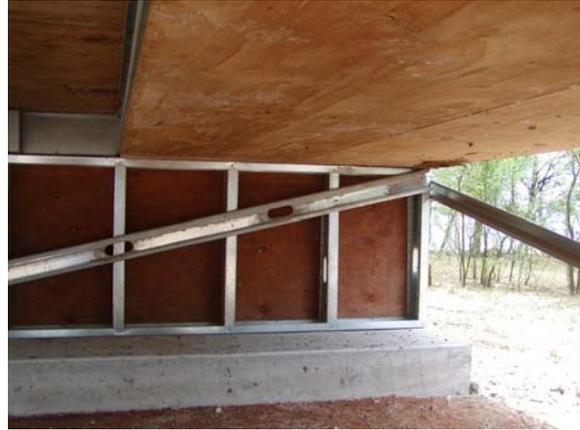
Figure C.6: Cripple Wall SE end

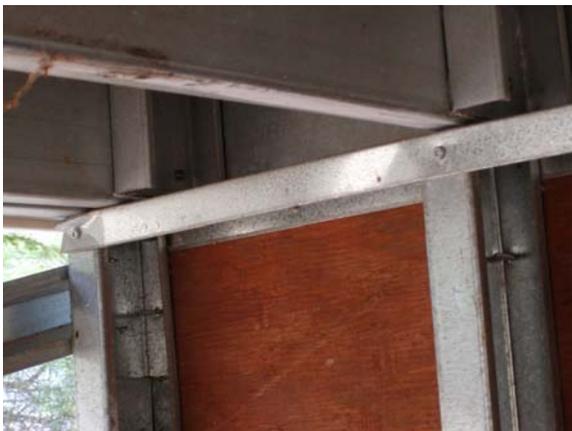
Figure C.7: Exposed joists on cripple wall - NE

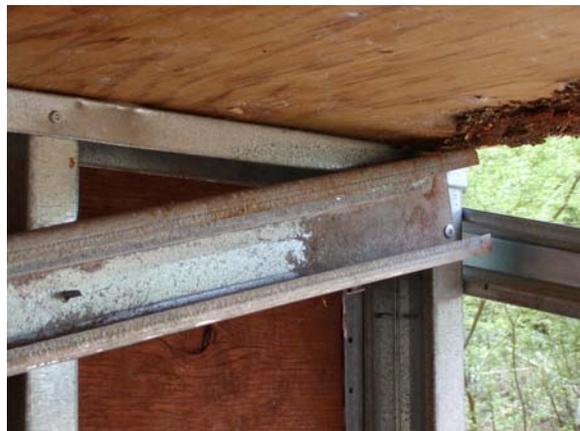
Figure C.8: Covered joists on cripple wall - SE

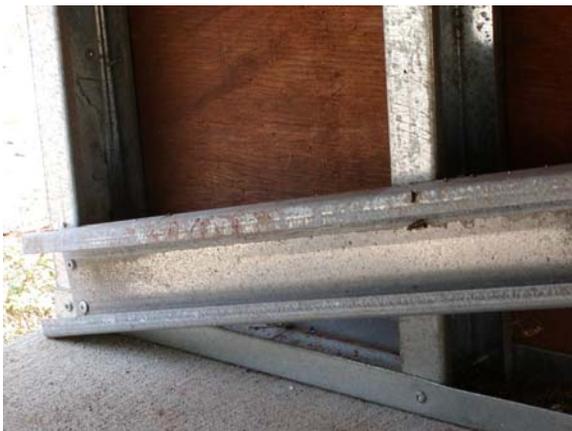
Figure C.9: Cripple wall base - NE

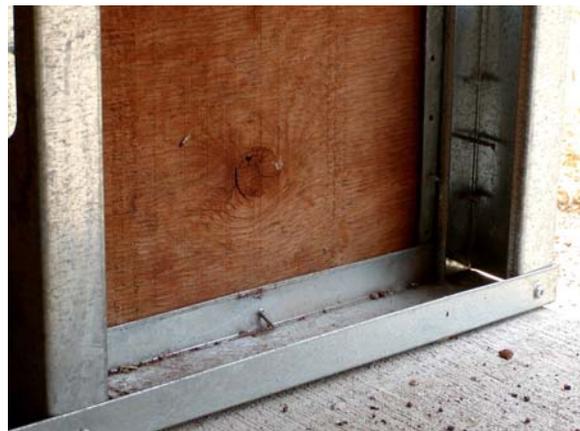
Figure C.10: Cripple wall base - SE

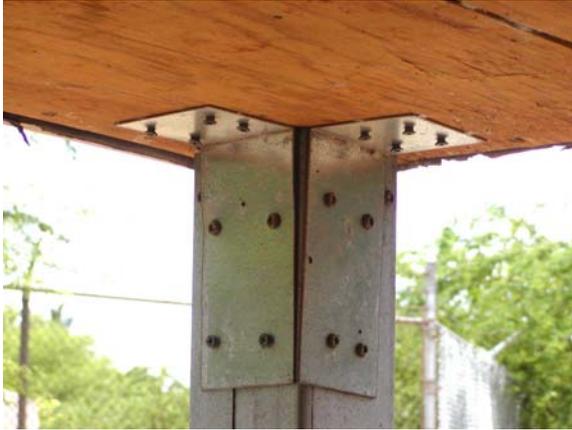
Figure C.11: SW Post top

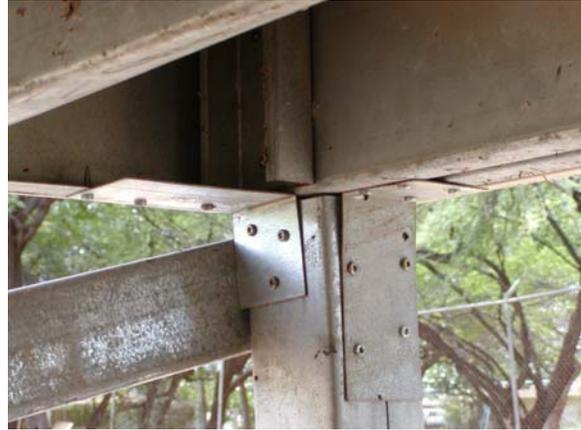
Figure C.12: NW Post top

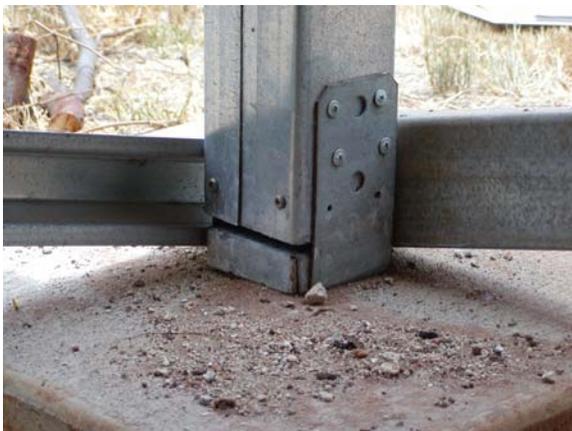
Figure C.13: SW Post base - Interior

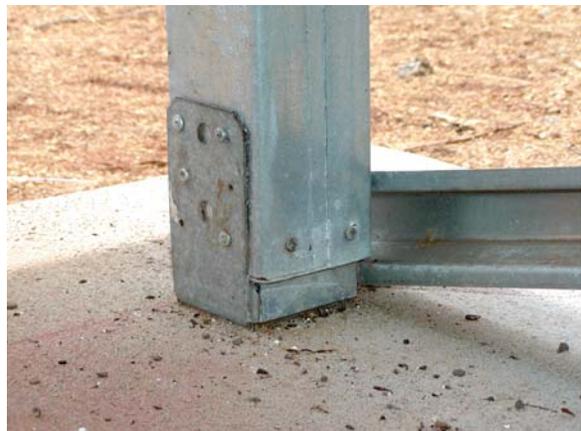
Figure C.14: NW Post base - Interior

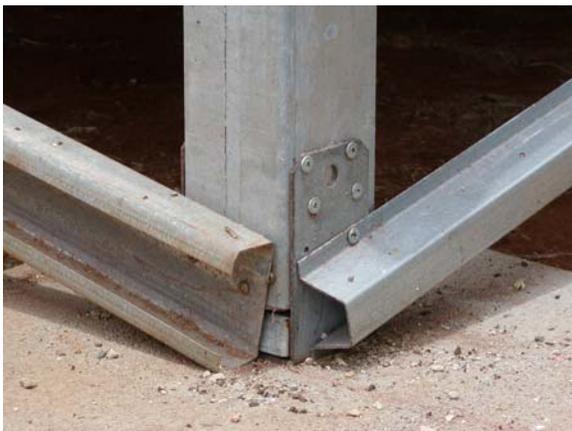
Figure C.15: SW Post base - Exterior

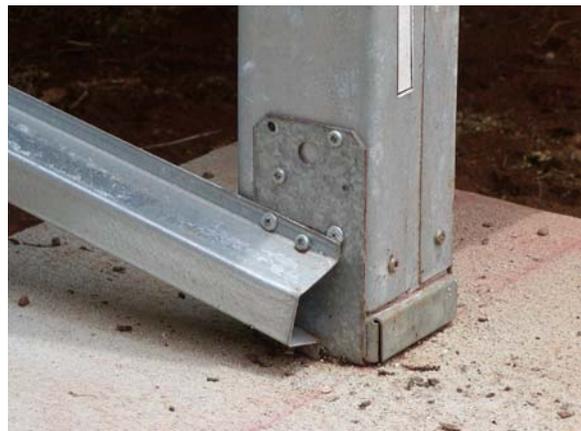
Figure C.16: NW Post base - Exterior

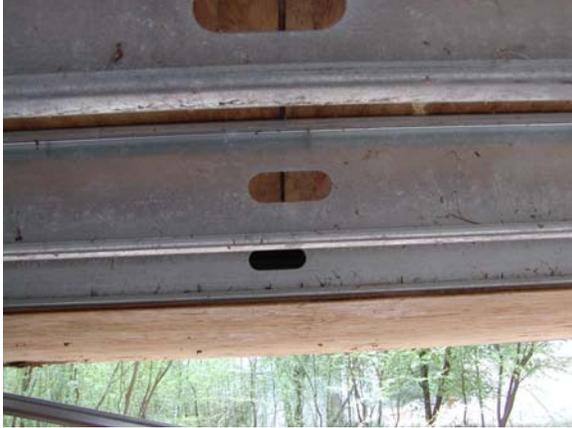
Figure C.17: Exposed and covered floor joists

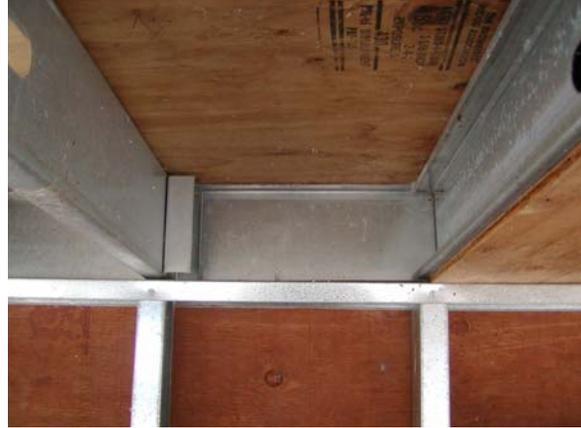
Figure C.18: Joist connection over cripple wall

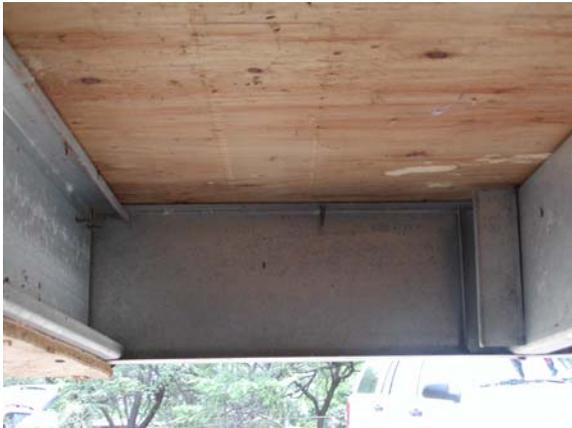
Figure C.19: Joist connection at South elevation

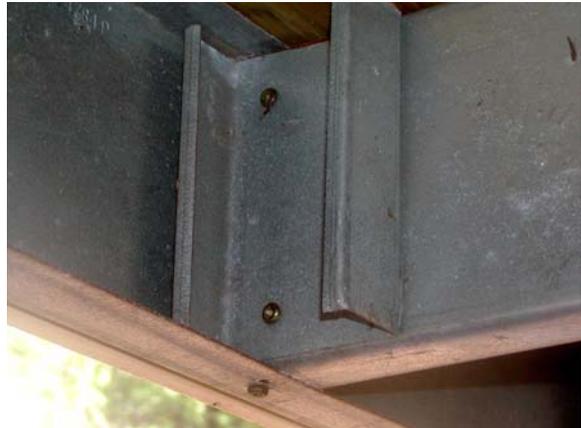
Figure C.20: Joist stiffener and fasteners

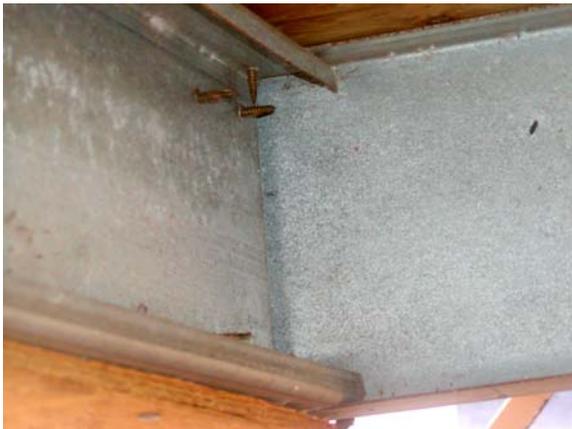
Figure C.21: Joist connection fasteners

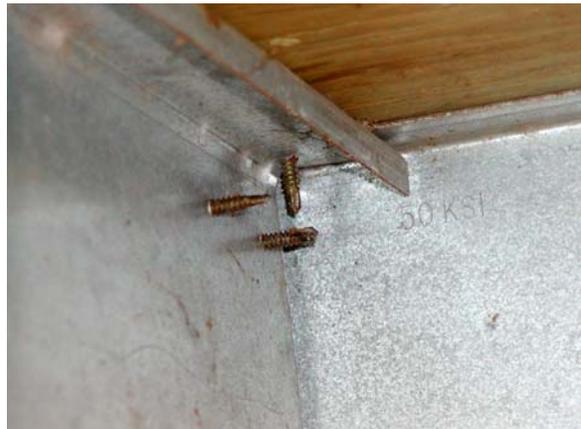
Figure C.22: Joist to track fasteners

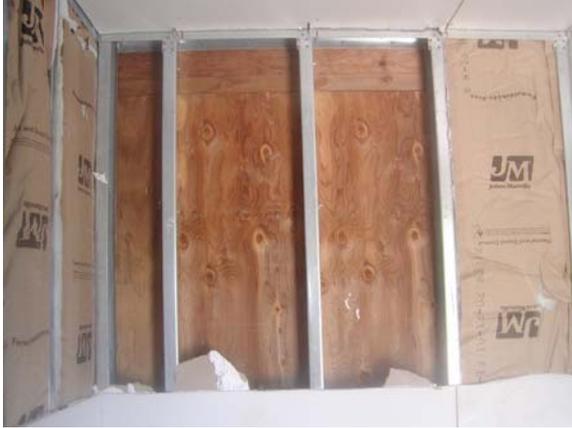
Figure C.23: East Wall – North End

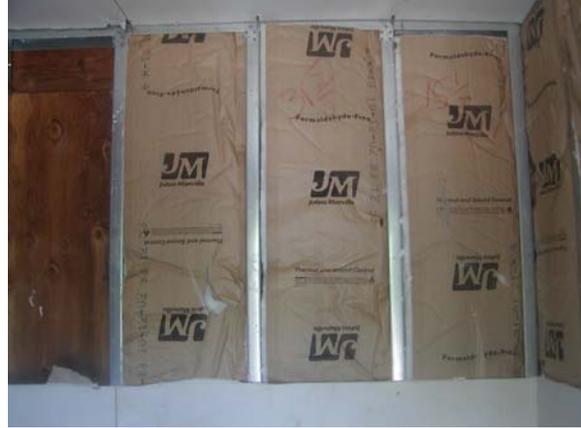
Figure C.24: East Wall – South End

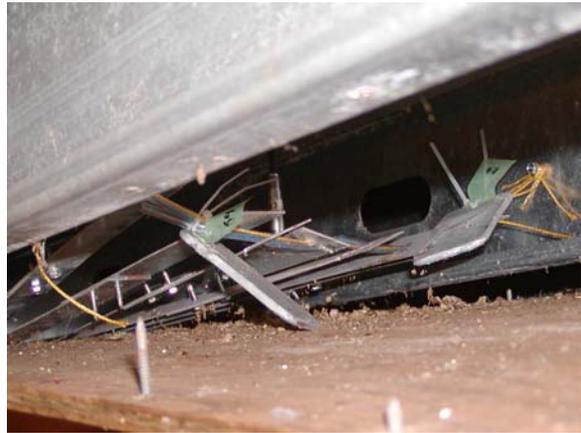
Figure C.65: Location 4 – Enclosed joists

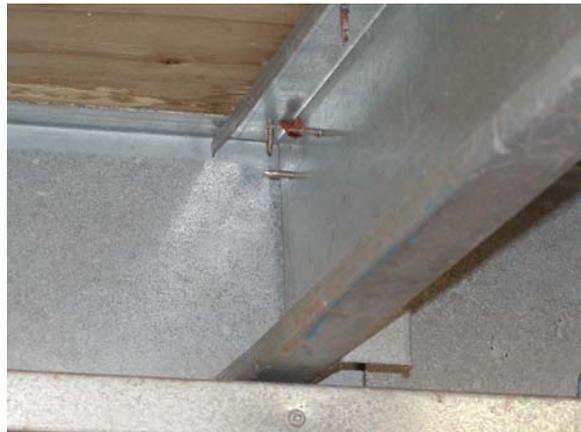
Figure C.67: Exposed joist connection

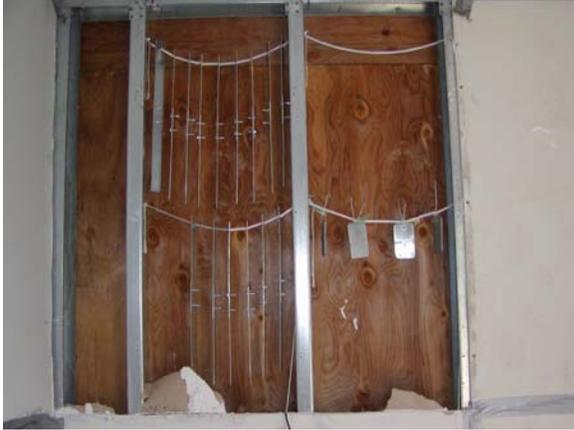
Figure C.68: Location 1 – Interior wall

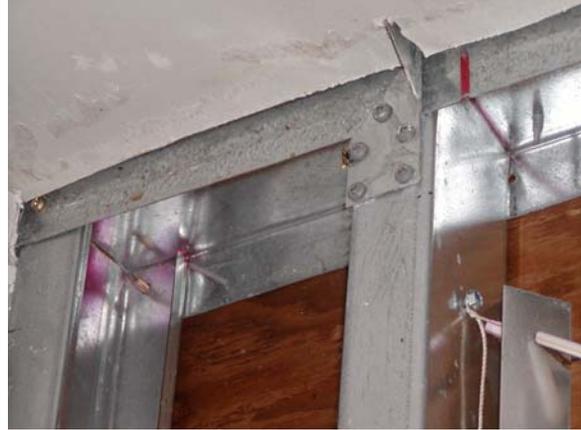
Figure C.69: Location 1 – Top track connections

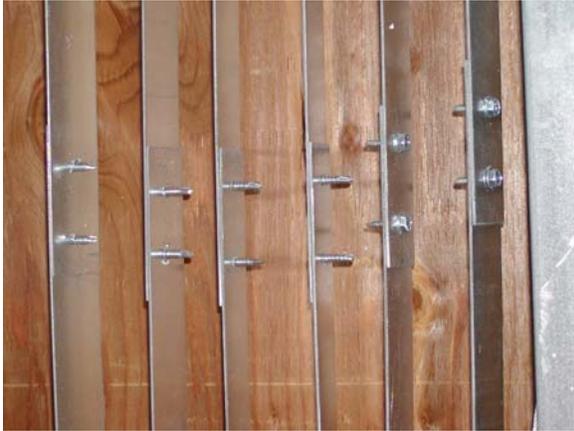
Figure C.70: Location 1 – connection fasteners

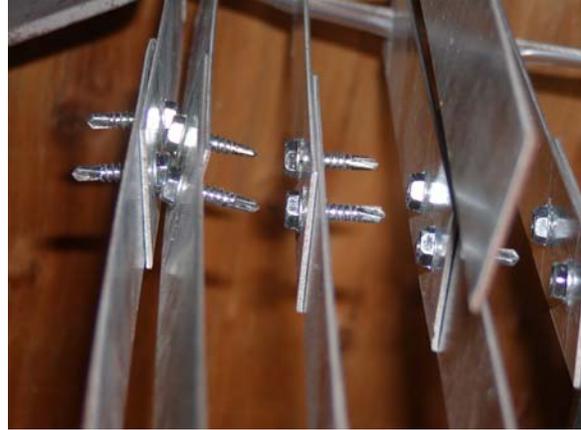
Figure C.73: Location 2 – test connections

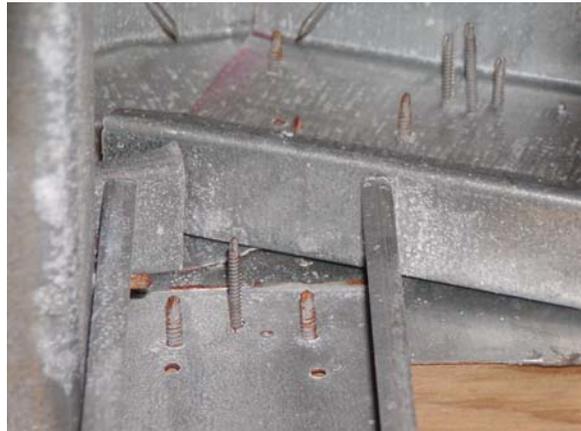
Figure C.75: Location 2 – Ridge truss connection

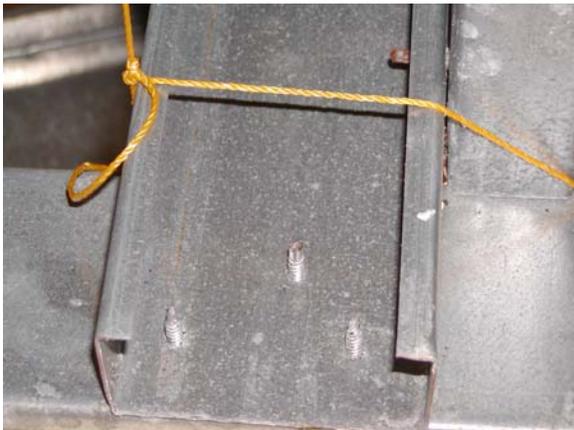
Figure C.76: Location 2 – Truss bottom connection

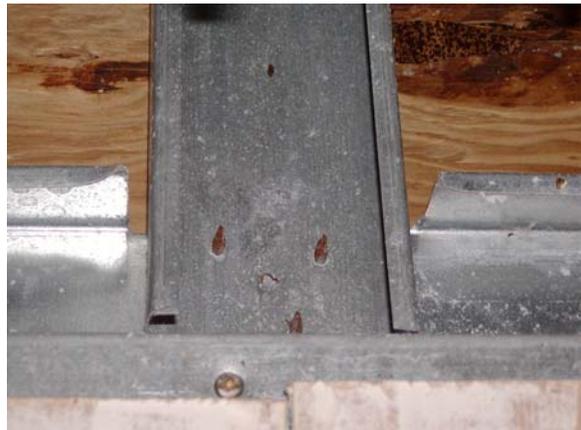
Figure C.77: Truss bottom connection

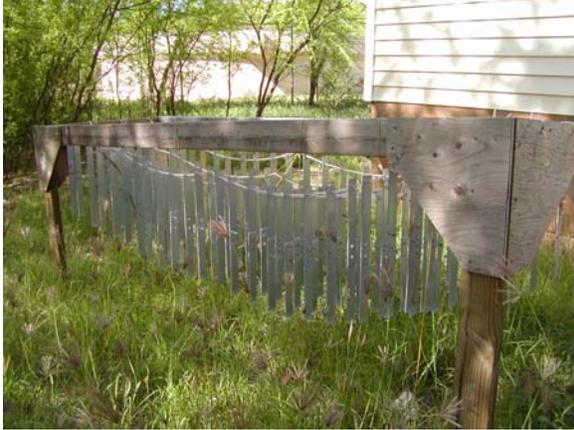
Figure C.78: Location 5 – Test connections

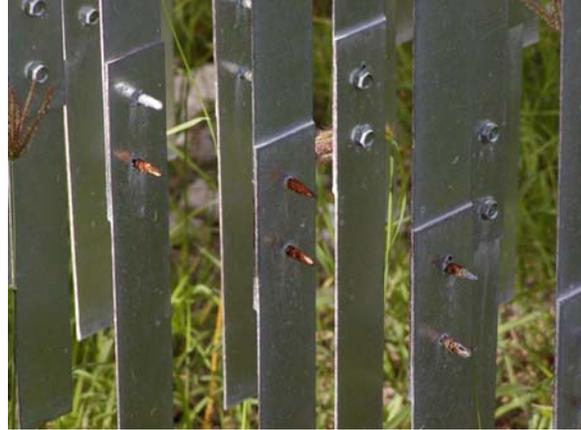
Figure C.79: Location 5 – connection fasteners

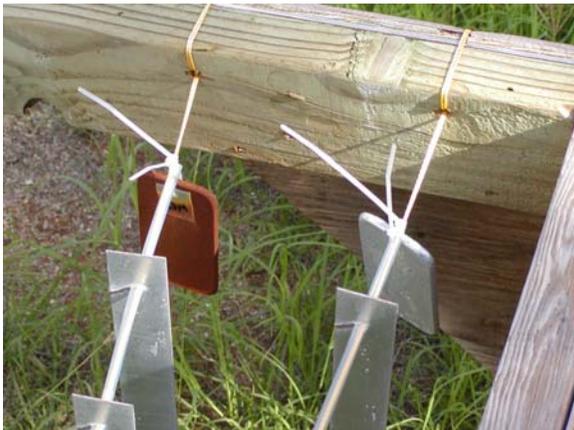
Figure C.82: Location 5 – Steel and zinc coupons

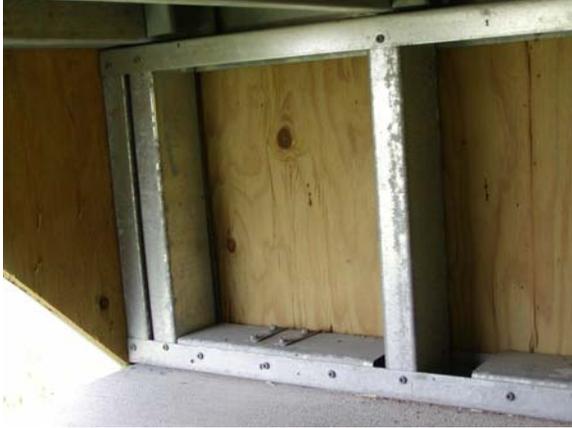
Figure D.13: SW end of cripple wall

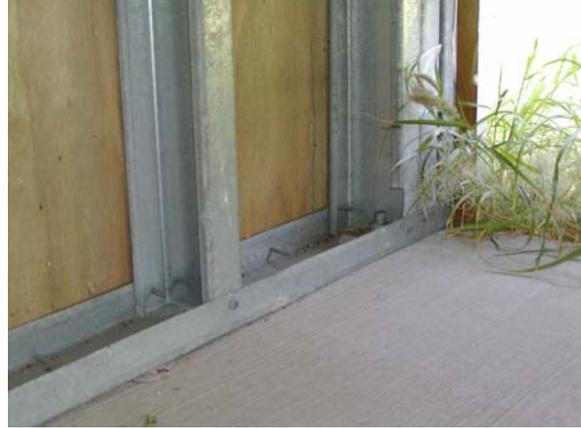
Figure D.14: NW end of cripple wall

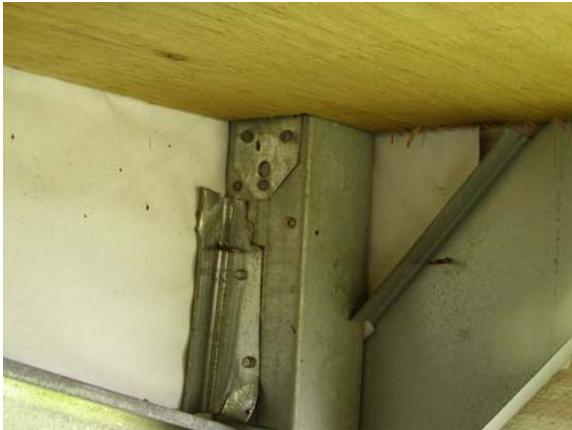
Figure D.15: NE post – top

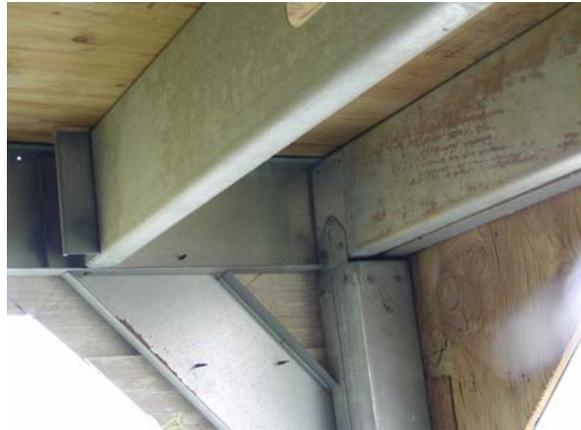
Figure D.16: SE post - top

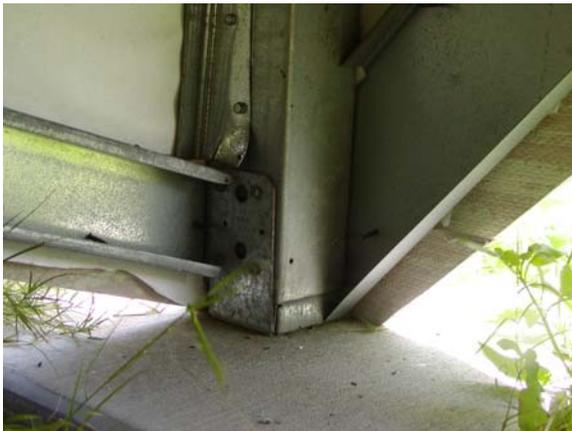
Figure D.17: NE post - base

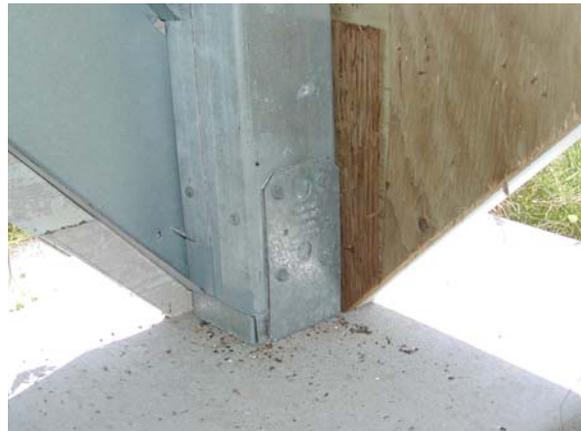
Figure D.18: SE post - base

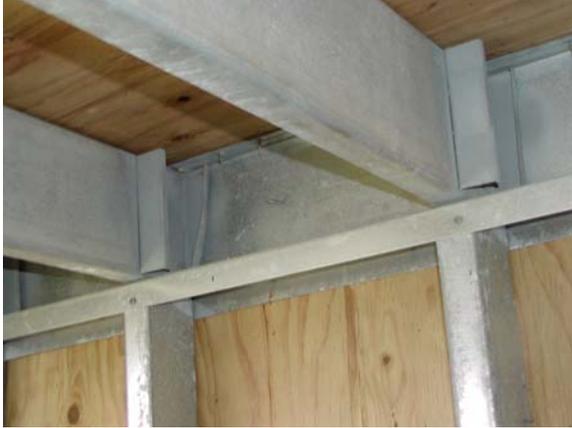
Figure D.19: Joist ends bearing on cripple wall

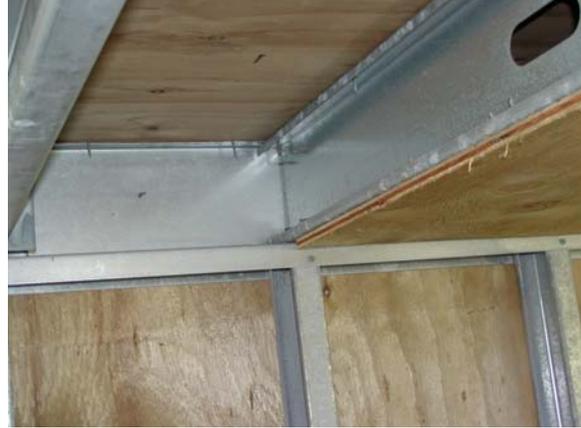
Figure D.20: Exposed and covered joist - West

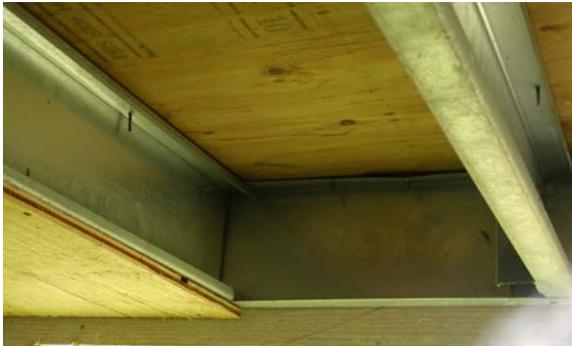
Figure D.21: Exposed and covered joists - East
