Wheeler Army Airfield - Field Enclosure Photographs

HUD CONTRACT No.:	H-21248CA
PROJECT TITLE:	“Corrosion of Galvanized Fasteners used in Cold-Formed Steel Framing”
CONTRACTOR:	North American Steel Framing Alliance 1726 M Street, NW, Suite 601 Washington, DC 20036
Principal Investigator:	Tim Waite
Co/Investigators:	Don Moody, Kevin Bielat
SUB-CONTRACTOR:	University of Hawaii Dept. of Civil Engineering 2540 Dole Street, Holmes Hall 383 Honolulu, HI 96822
Principal Investigator	Dr. Ian N. Robertson
PROJECT PERIOD:	From 9/26/2000 to 11/25/2003
LITERATURE REVIEW REPORT:	December 27, 2000

CORROSION OF GALVANIZED FASTENERS USED IN COLD-FORMED STEEL FRAMING

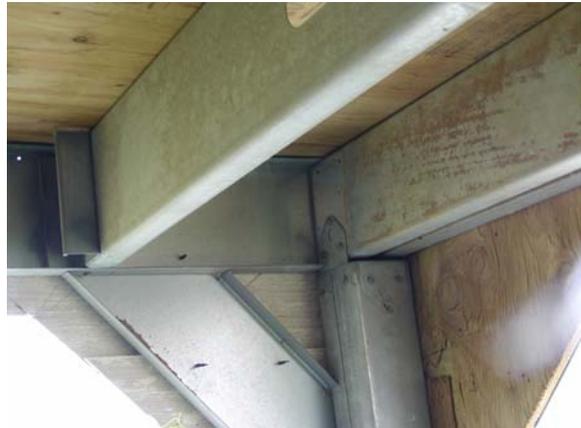
Figure D.22: Joist and double joist over post

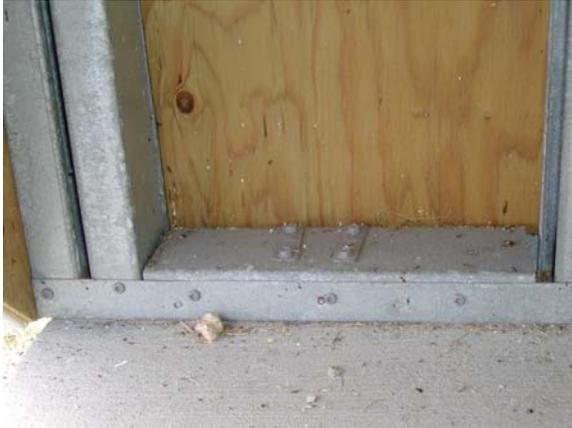
Figure D.23: SW corner cripple wall base

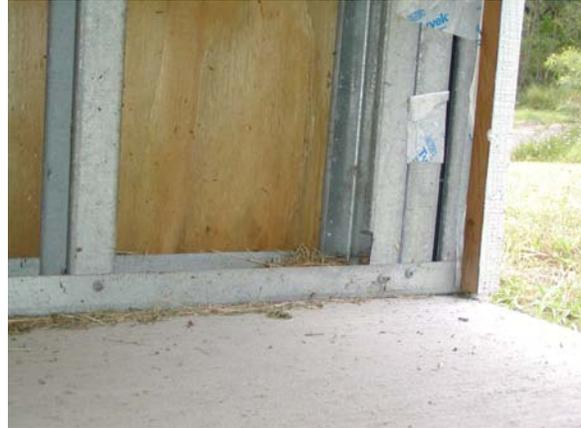
Figure D.24: NW corner cripple wall base

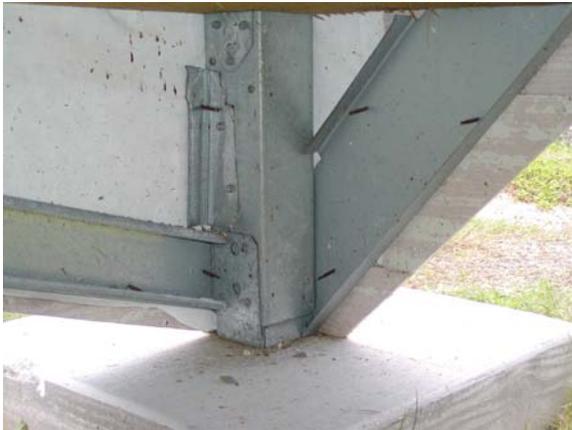
Figure D.25: NE corner post base

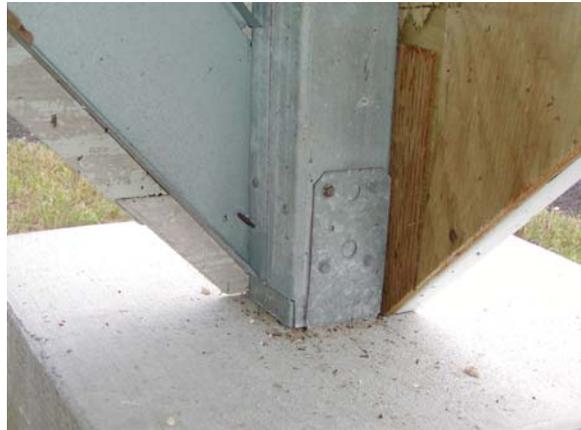
Figure D.26: SE corner post base

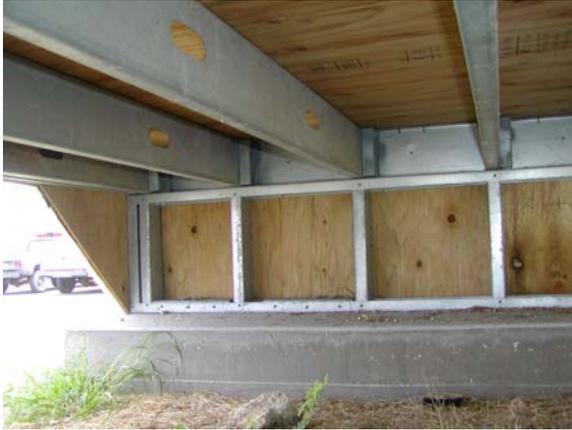
Figure D.27: SW corner exposed joists

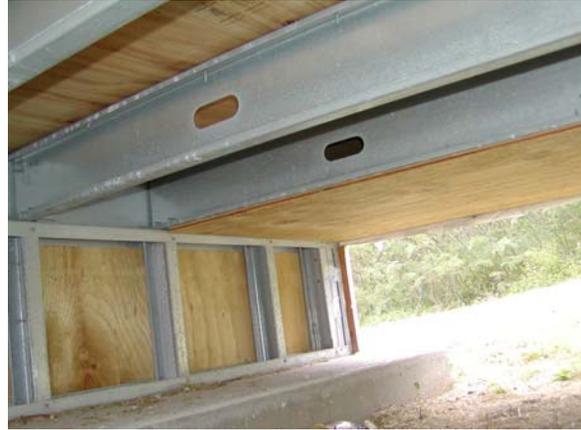
Figure D.28: NW exposed and covered joists

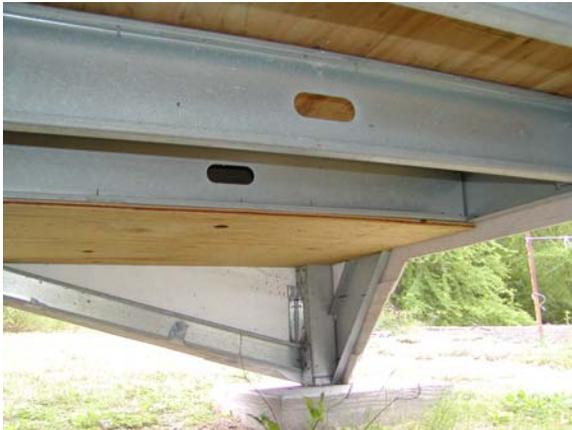
Figure D.29: NE exposed and covered joists

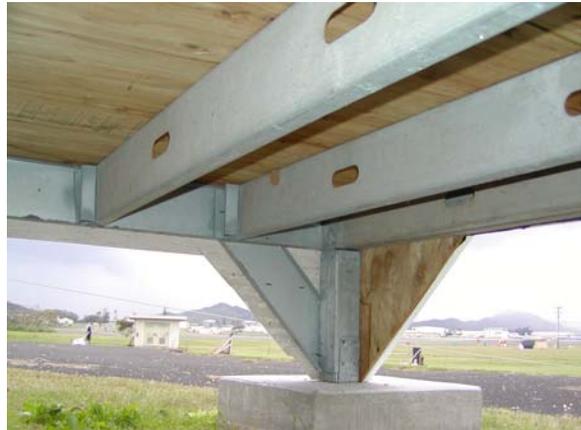
Figure D.30: SE exposed joists

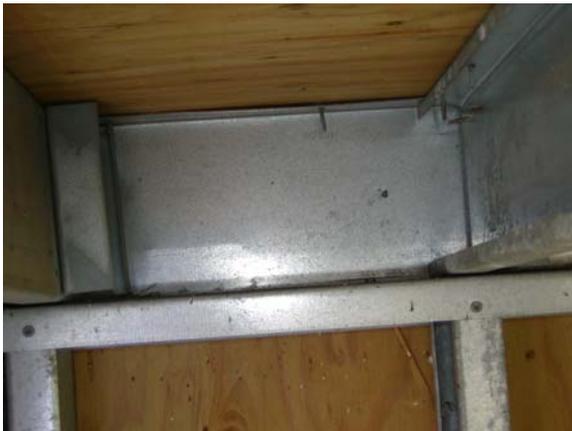
Figure D.31: Joist stiffener over cripple wall

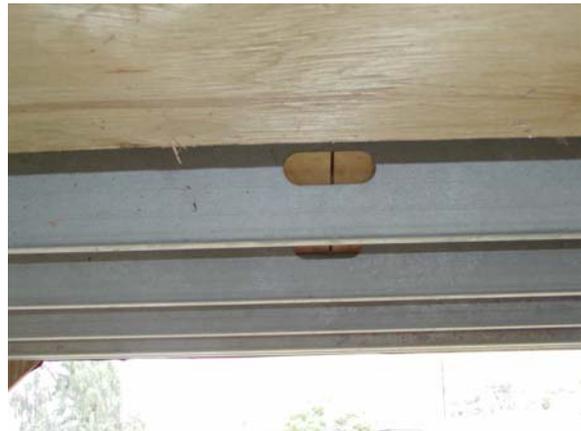
Figure D.32: Joist midspan

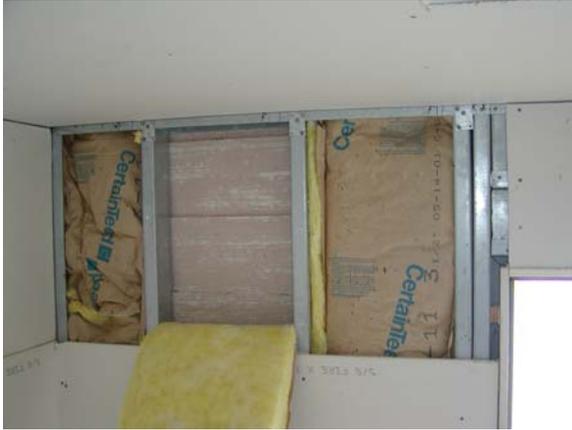
Figure D.33: E wall – Lap siding w/o vapor barrier

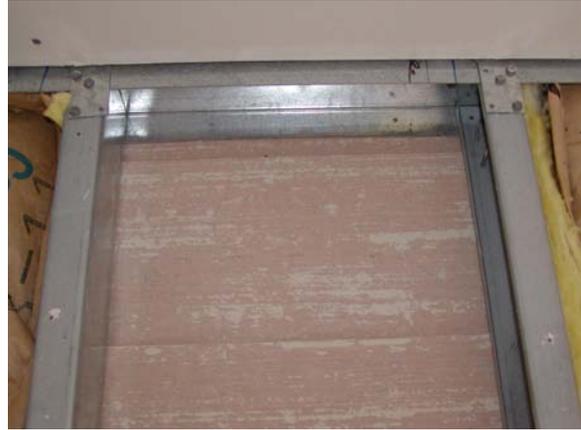
Figure D.34: E wall – Studs and top track

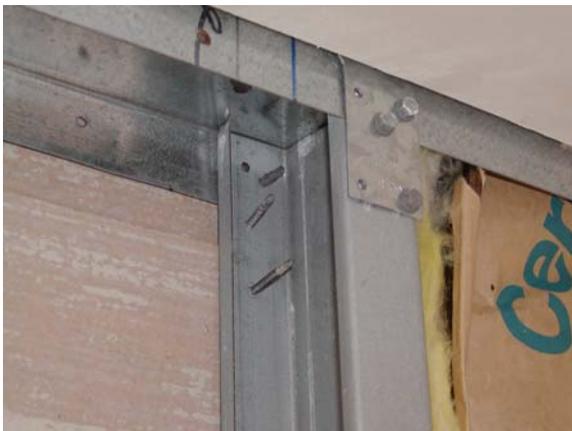
Figure D.35: E wall – Stud to top track connection

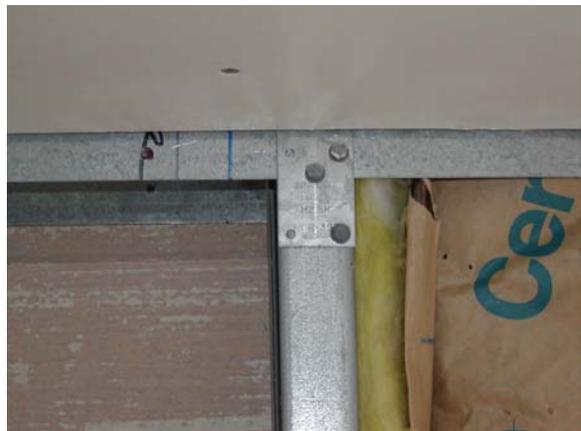
Figure D.36: E wall – Load path tie-down

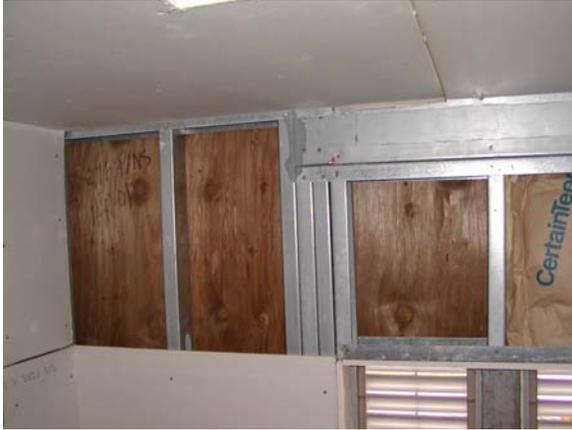
Figure D.37: S wall – plywood w/o vapor barrier

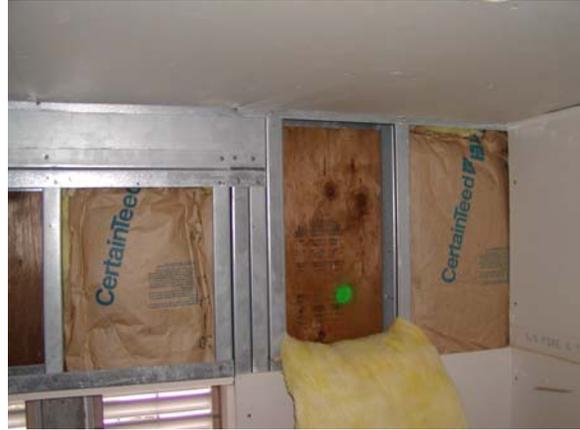
Figure D.38: S wall – plywood with insulation

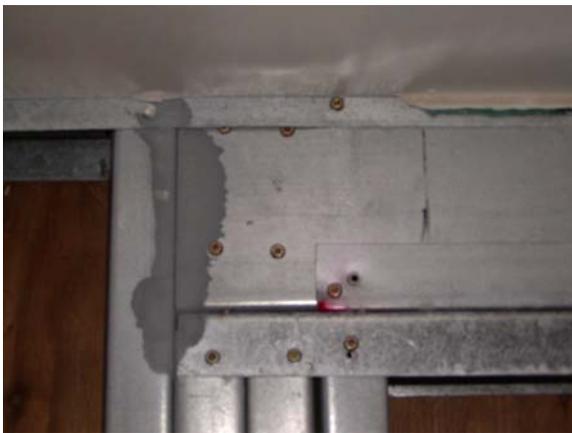
Figure D.39: S wall – East header connection

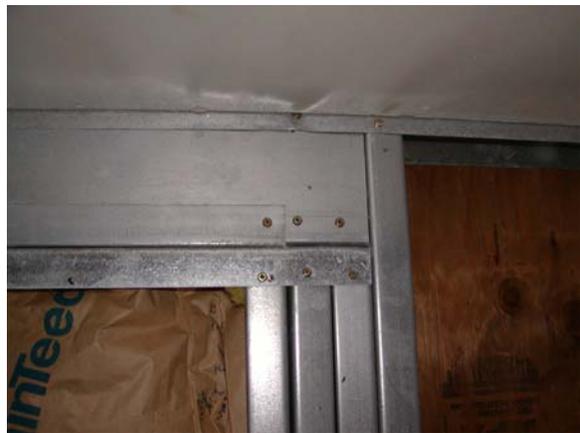
Figure D.40: S wall – West header connection

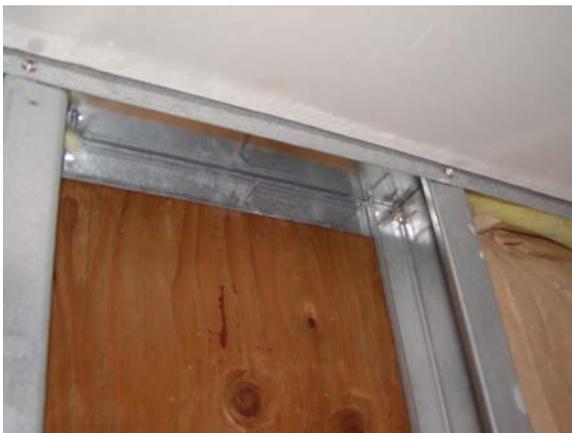
Figure D.41: S wall – Stud to top track connection

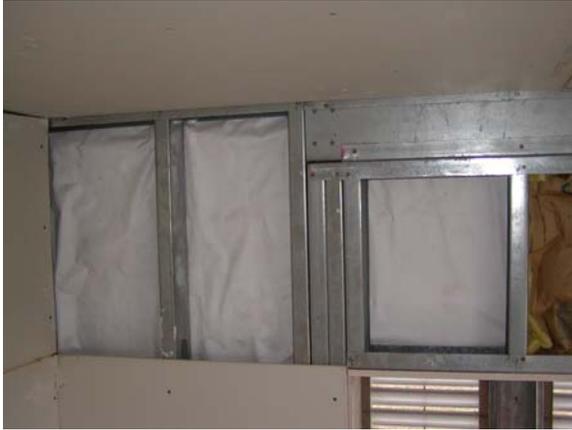
Figure D.42: N wall – Lap siding with vapor barrier

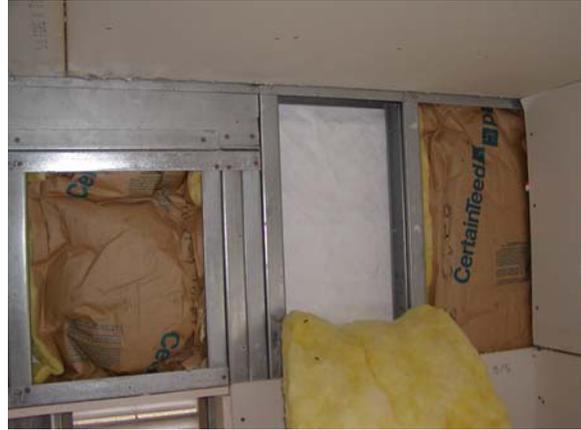
Figure D.43: N wall – Lap siding with insulation

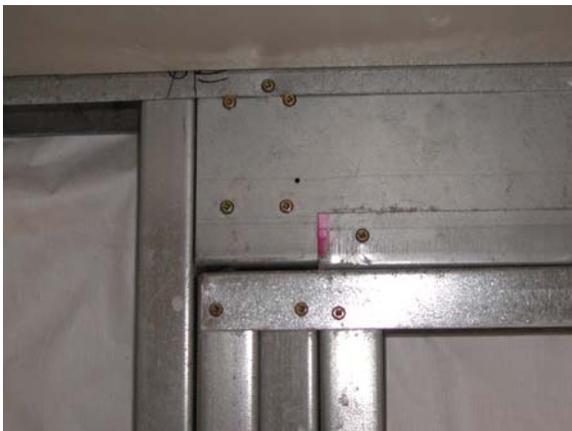
Figure D.44: N wall – Header connection

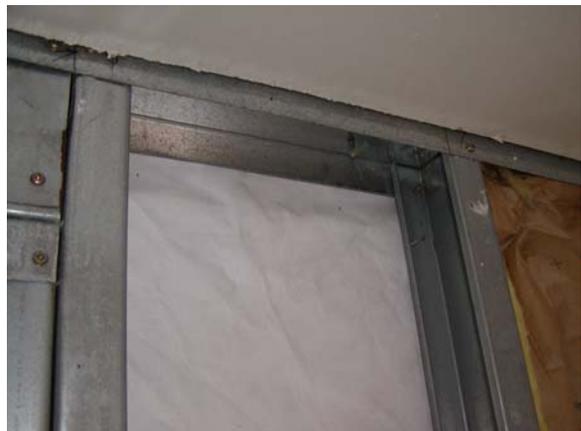
Figure D.45: N wall – Top track connections

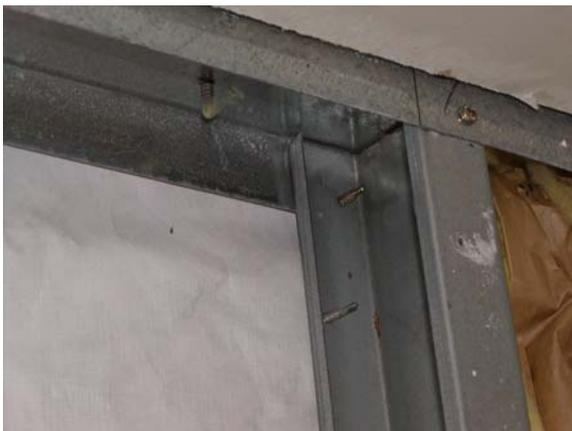
Figure D.46: N wall – Stud to top track connection

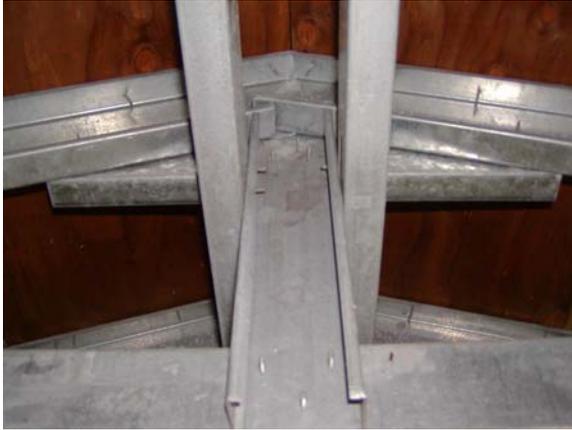
Figure D.47: Typical roof truss

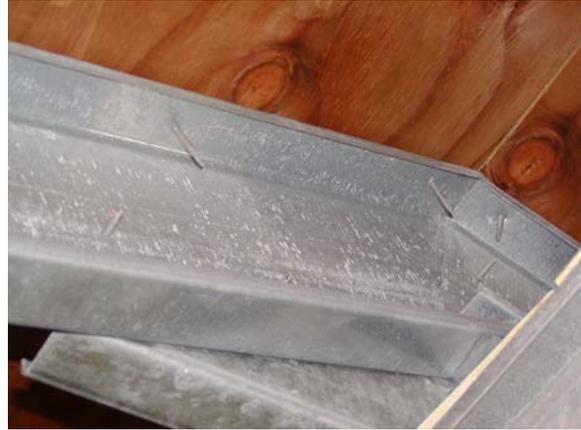
Figure D.48: Roof truss ridge connection

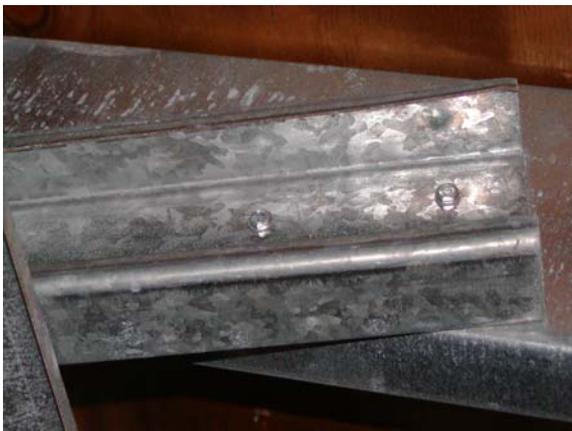
Figure D.49: Roof truss connection

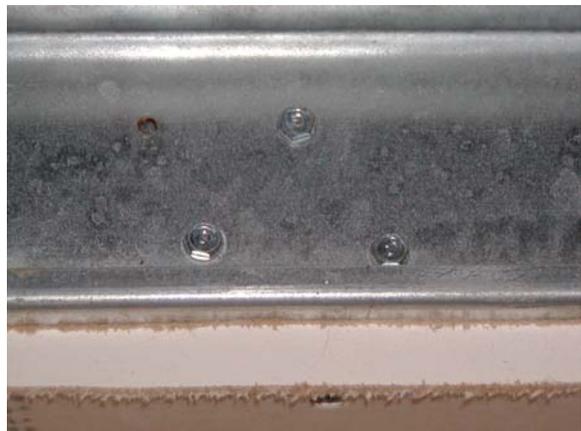
Figure D.50: Roof truss fasteners

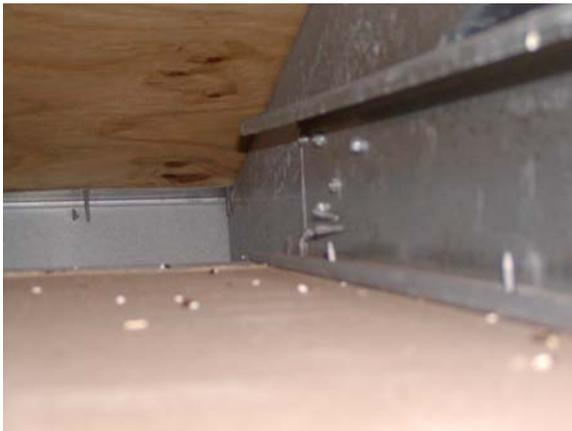
Figure D.51: Roof truss eave connection

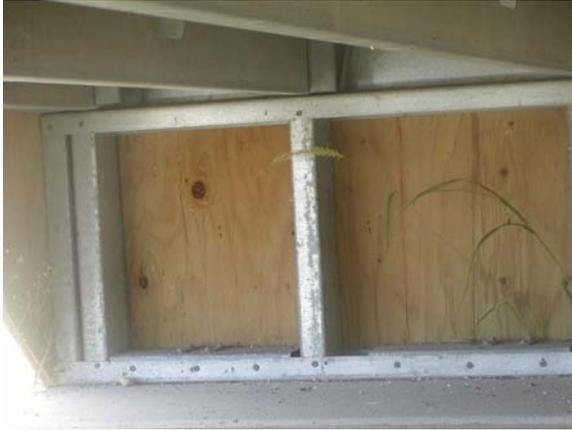
Figure D.52: SW corner cripple wall

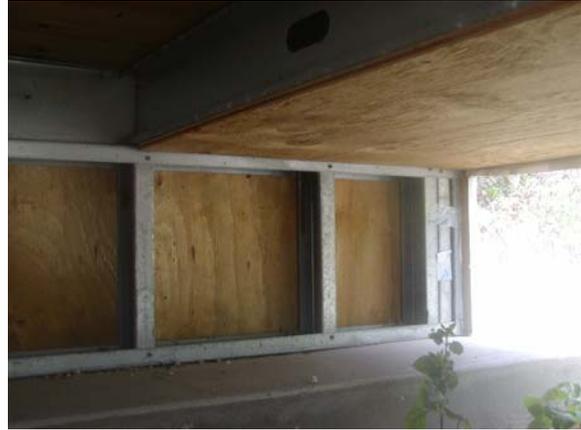
Figure D.53: NW corner cripple wall

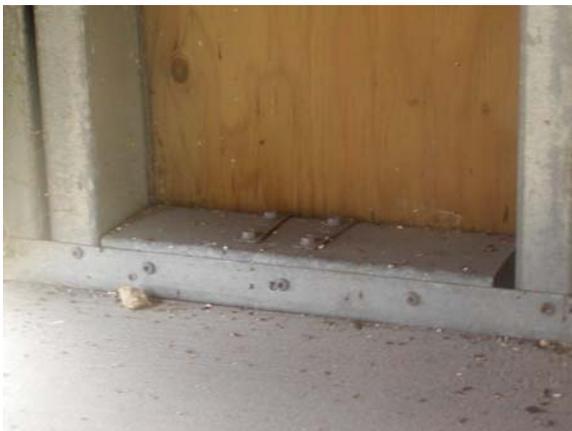
Figure D.54: SW Cripple Wall base connection

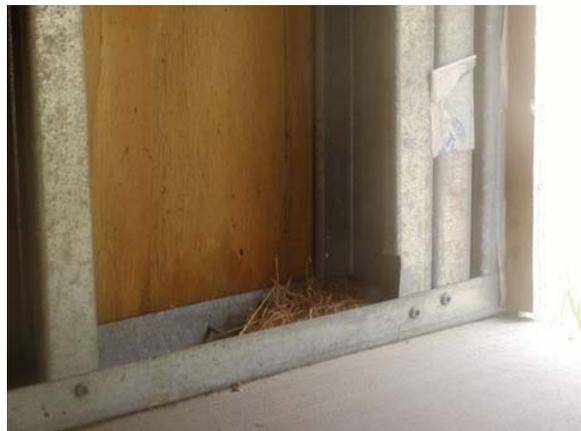
Figure D.55: NW Cripple Wall base connection

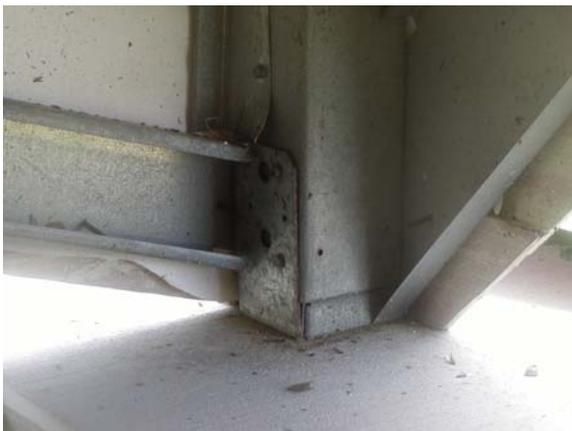
Figure D.56: NE Post base

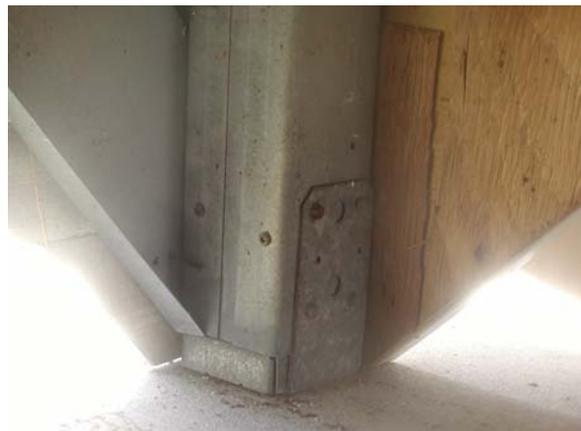
Figure D.57: SE Post base

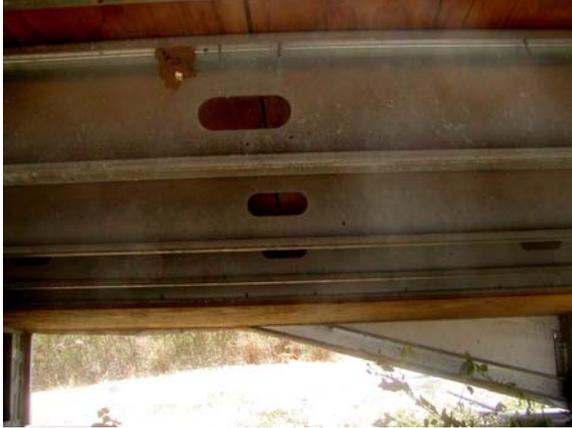
Figure D.58: Exposed floor joists

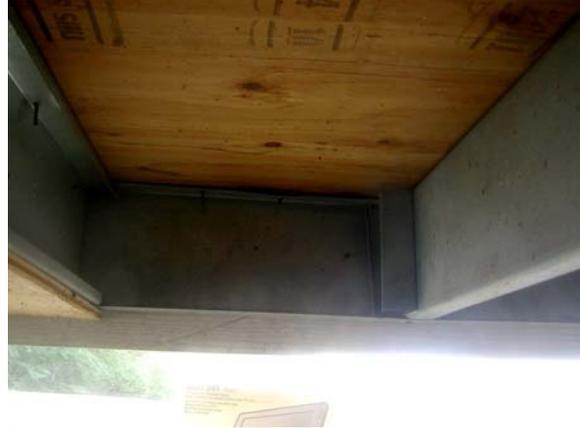
Figure D.59: Floor joist end connections

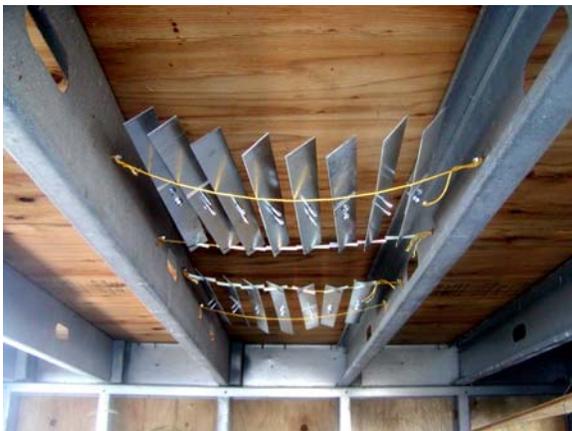
Figure D.60: Test coupons in location 6 - exposed

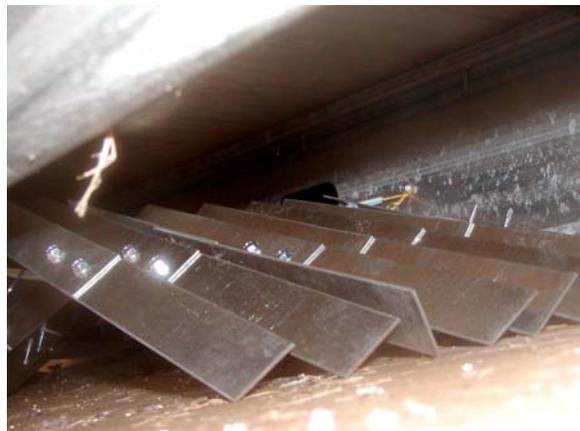
Figure D.61: Test coupons in location 7 - enclosed

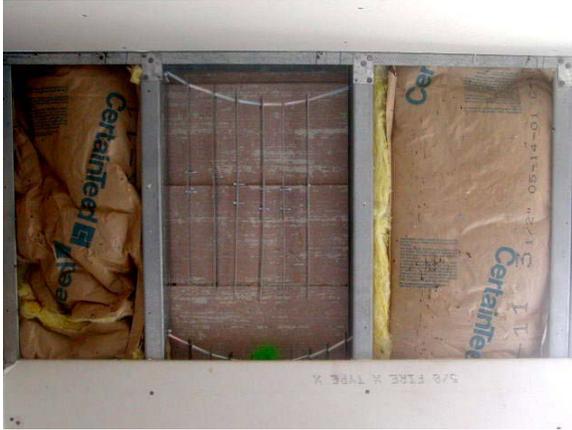
Figure D.62: Loc. 2 – lap siding w/o vapor barrier

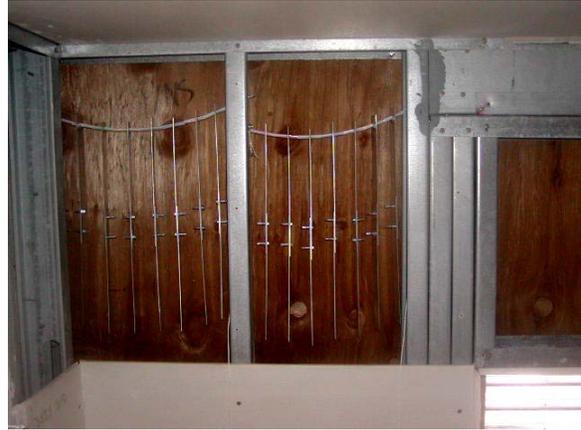
Figure D.63: Loc. 1 – plywood w/o vapor barrier

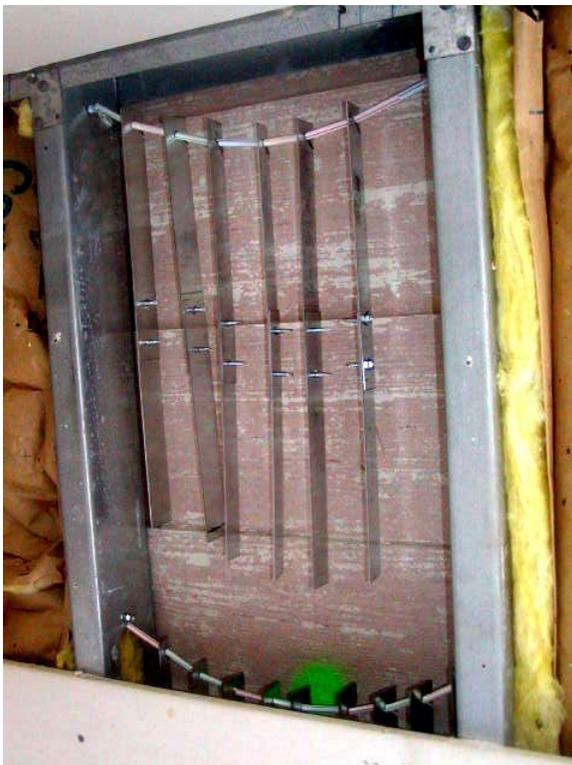
Figure D.64: Location 2 test connections

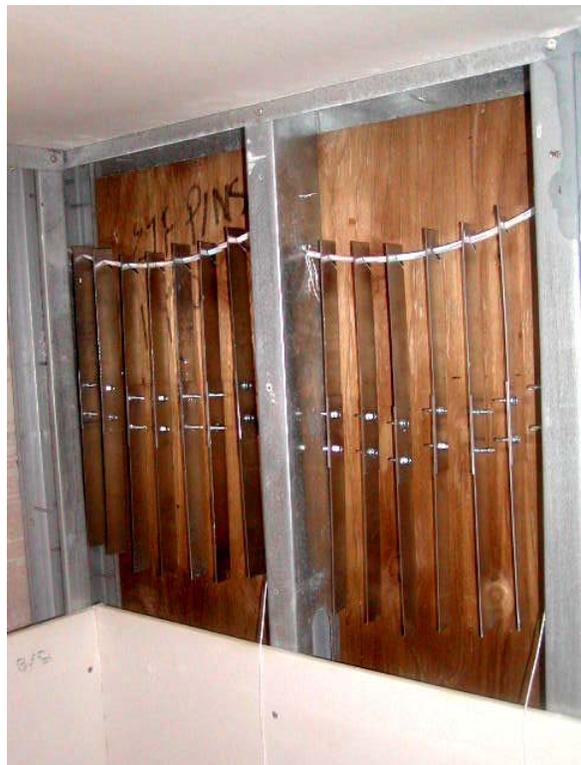
Figure D.65: Location 1 test connections

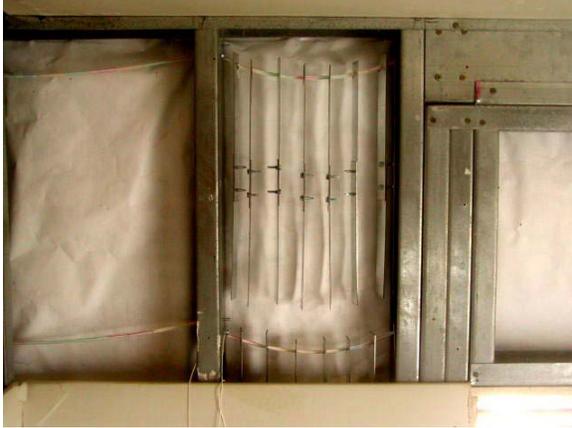
Figure D.66: Location 3 – wall with vapor barrier

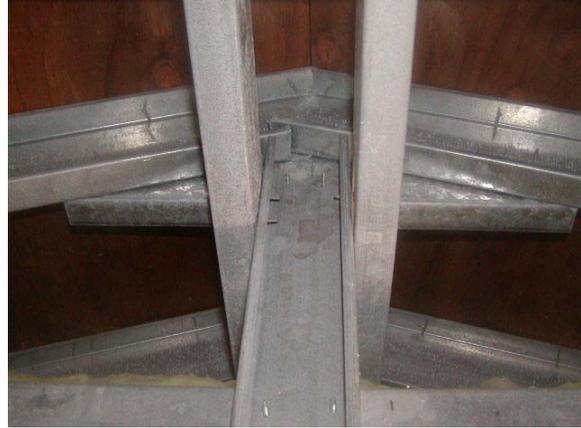
Figure D.67: Location 4 – roof framing

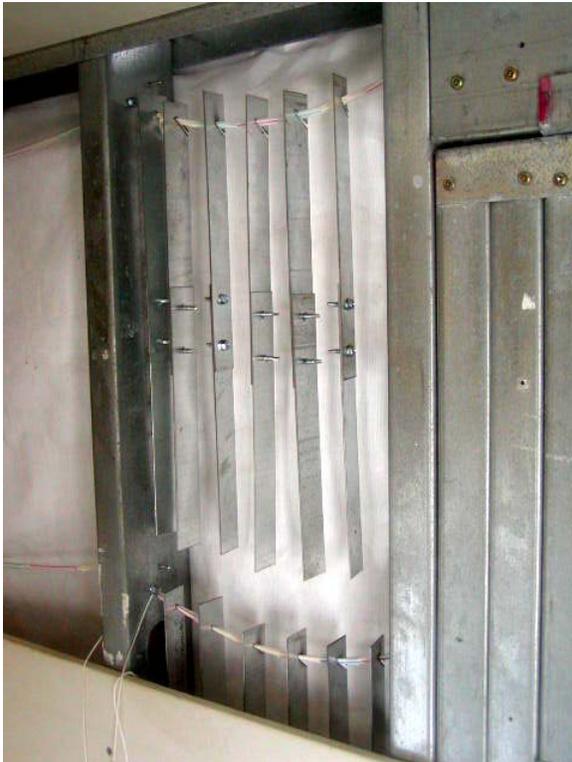
Figure D.68: Location 3 – test connections

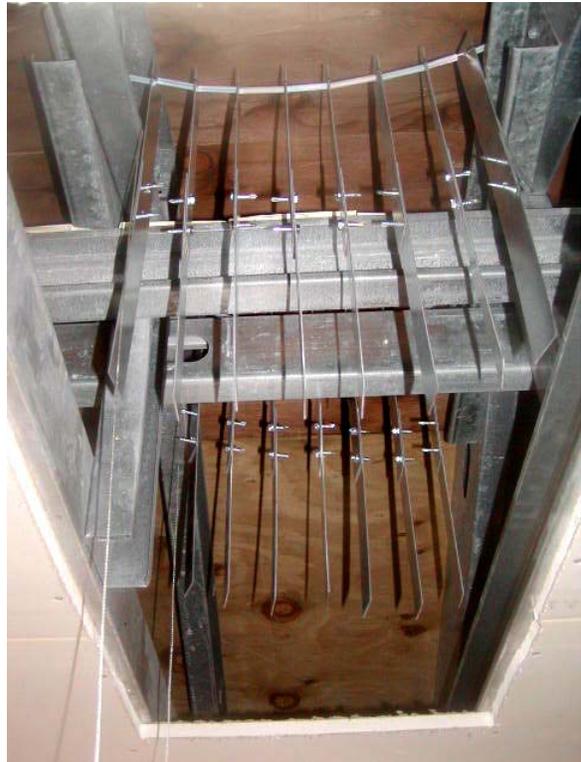
Figure D.69: Location 4 – test connections

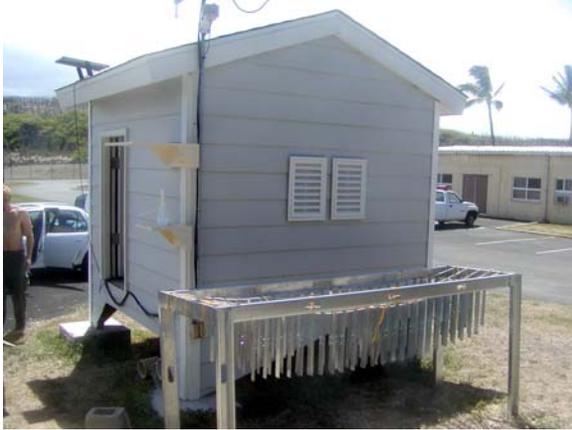
Figure D.70: Location 7 – exterior test connections

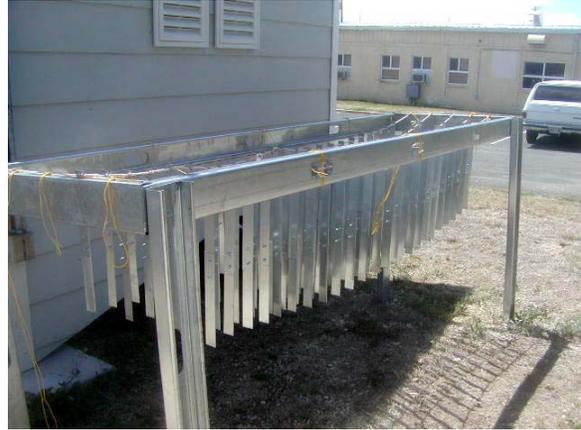
Figure D.71: Location 7 – exterior test connections

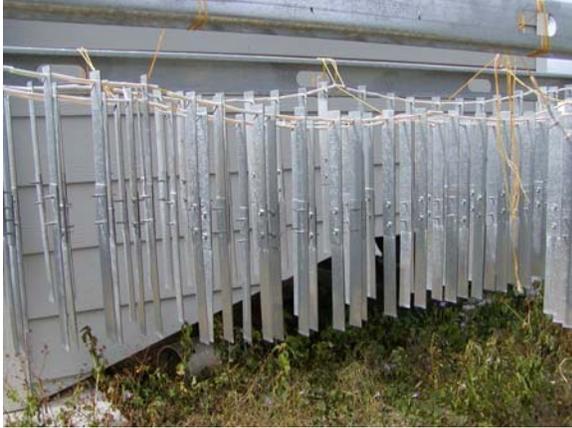
Figure D.74: Location 7 – 3 Month Exposure

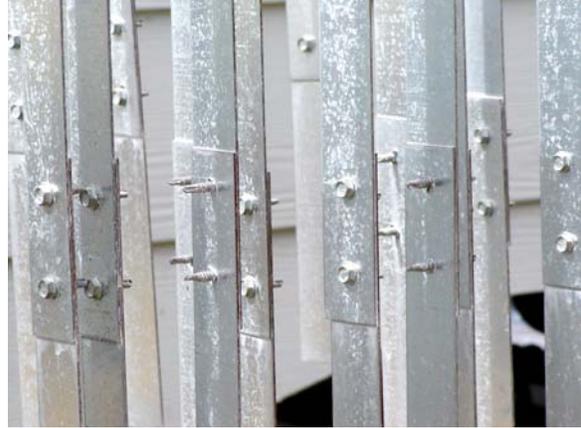
Figure D.75: Location 7 – 3 Month exp fasteners

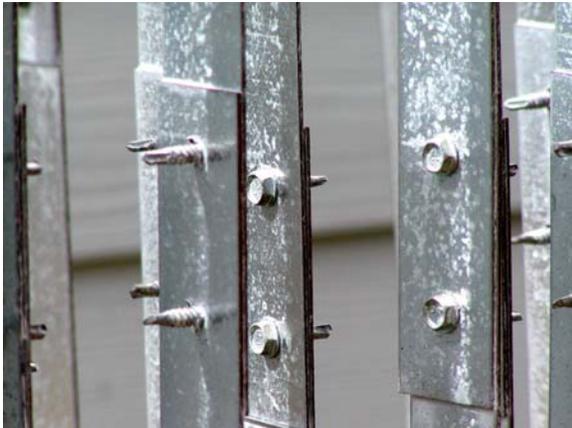
Figure D.76: Close-up of 3 Month exposure

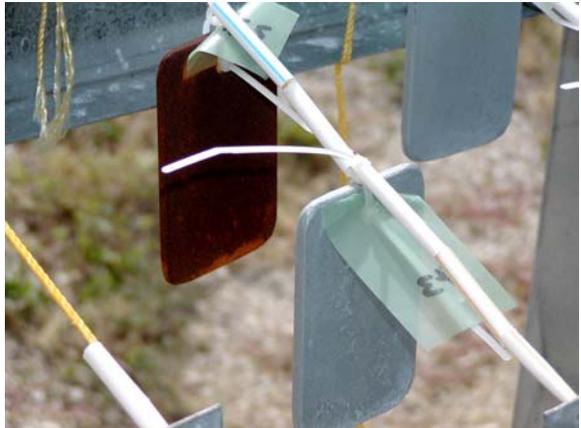
Figure D.77: Steel and zinc coupons – 3 Months

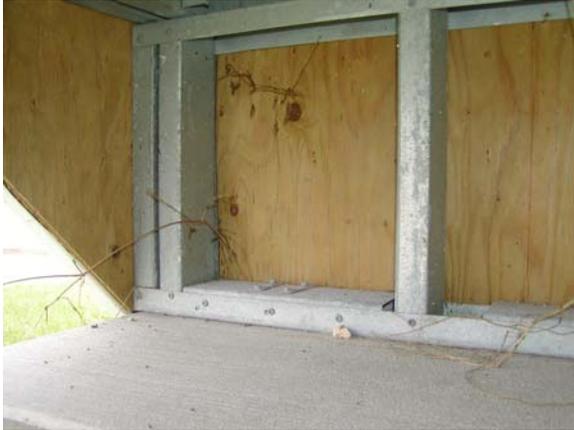
Figure D.78: Cripple Wall – SW corner

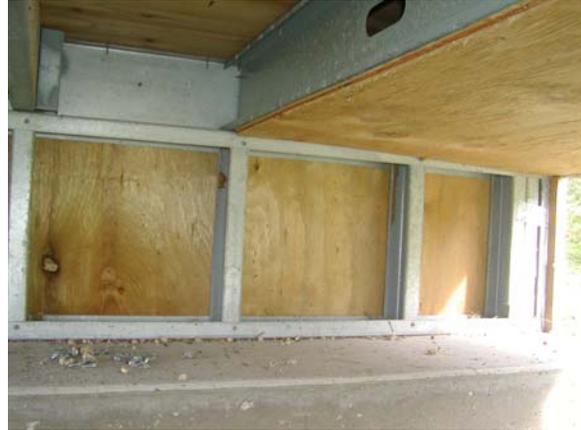
Figure D.79: Cripple Wall – NW corner

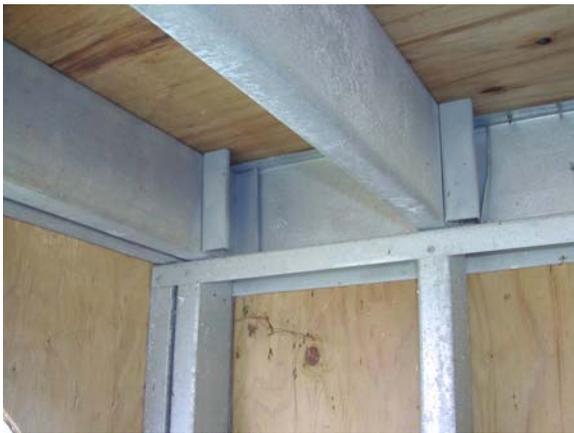
Figure D.80: Cripple Wall Top – SW corner

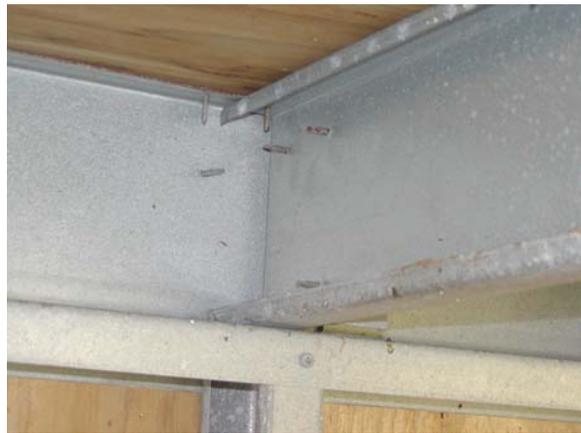
Figure D.81: Cripple Wall Top – Joist connection

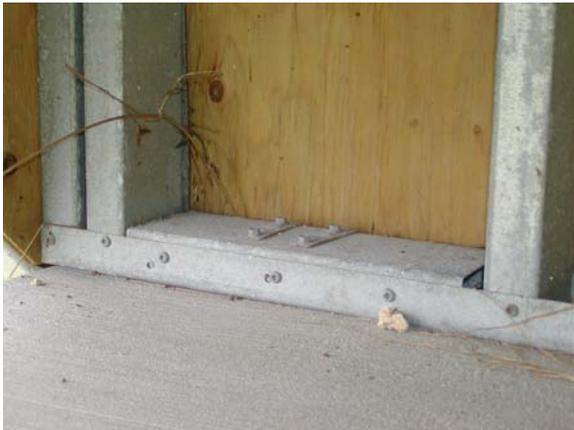
Figure D.82: Cripple Wall Base – SW corner

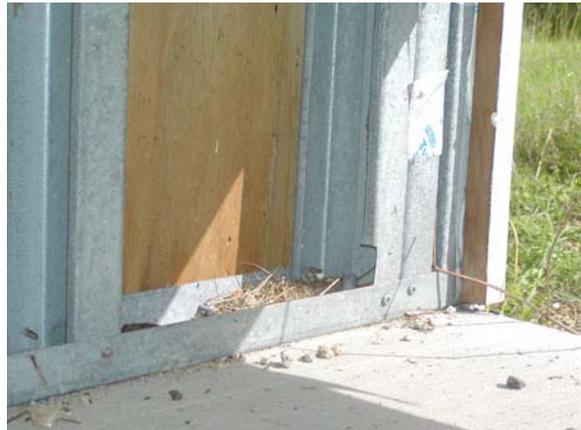
Figure D.83: Cripple Wall Base – NW corner

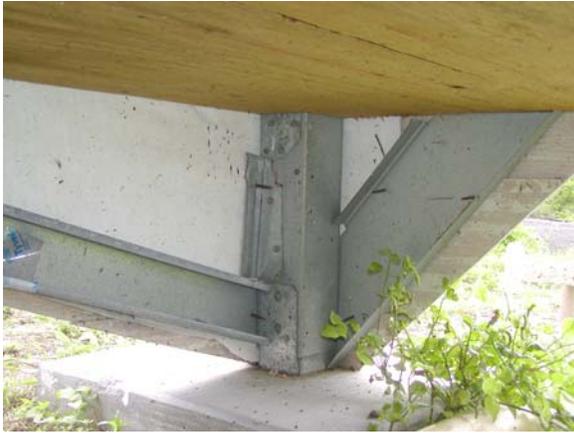
Figure D.84: Post – NE corner

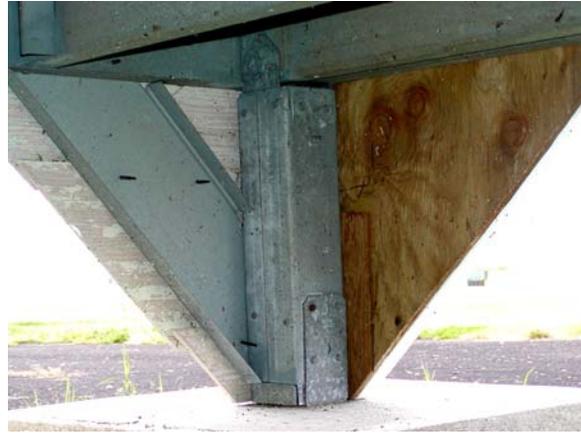
Figure D.85: Post – SE corner

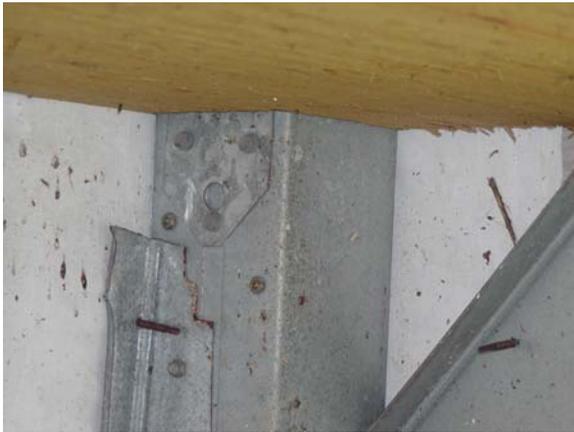
Figure D.86: Post Top – NE corner

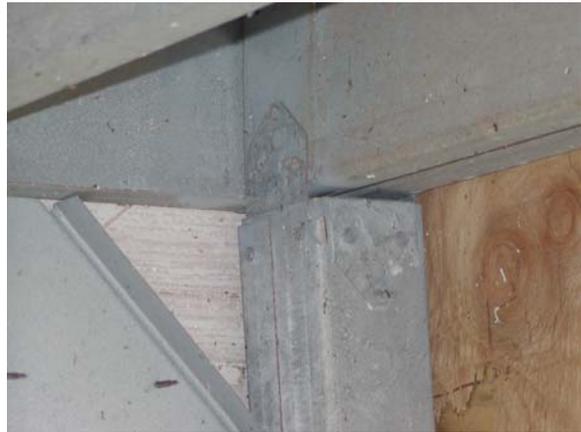
Figure D.87: Post Top – SE corner

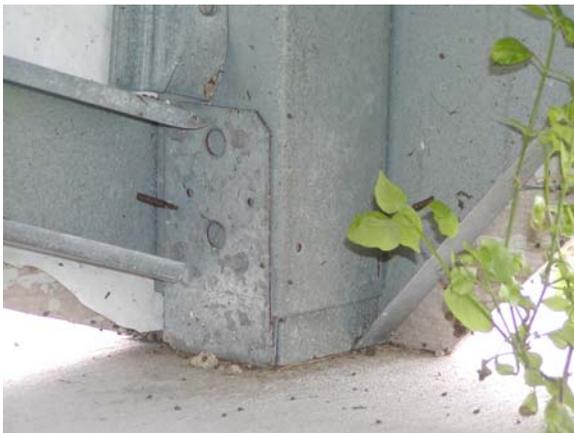
Figure D.88: Post Base – NE corner

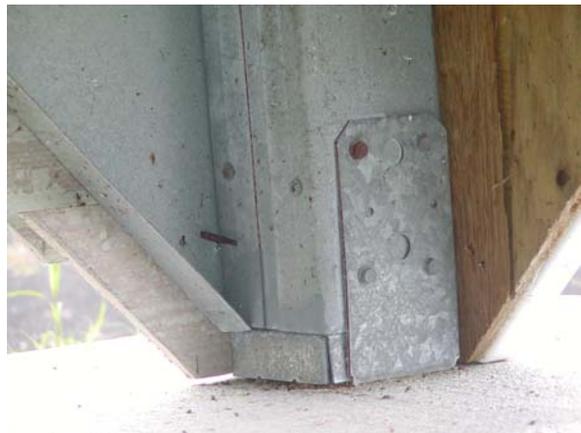
Figure D.89: Post Base – SE corner

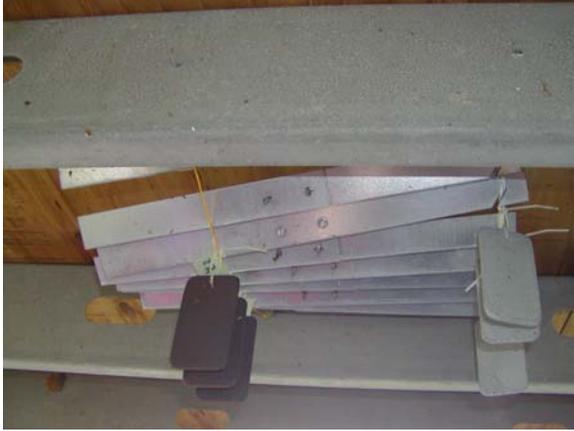
Figure D.90: Location 5 specimens - open crawl

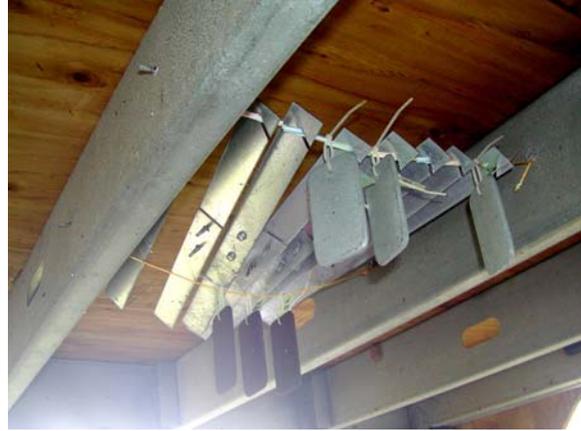
Figure D.91: Joists and specimens – open crawl

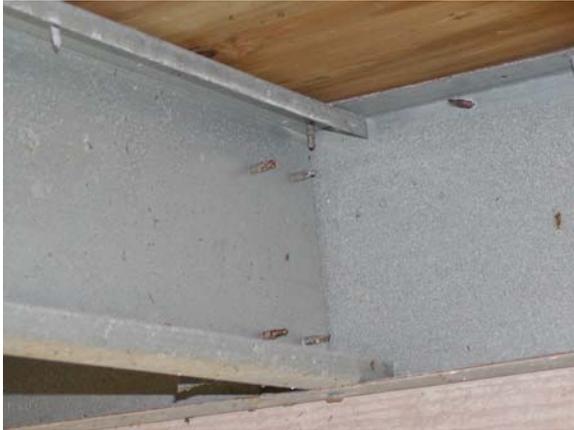
Figure D.92: Joist end connection – open crawl

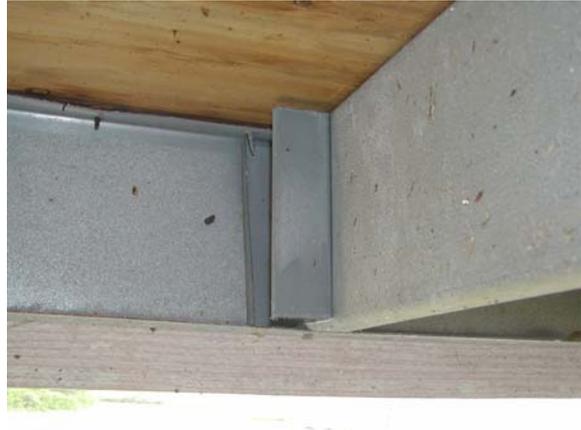
Figure D.93: Joist end stiffener- open crawl

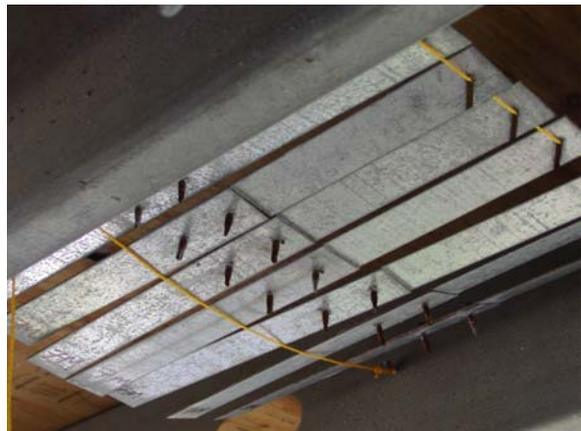
Figure D.95: 7 Month exterior exposure specimens

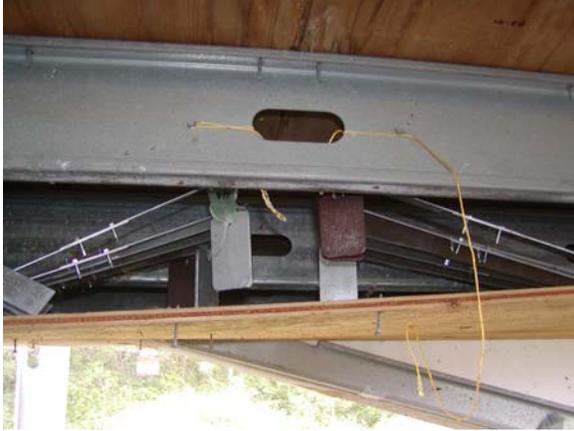
Figure D.96: Joists and specimens – covered crawl

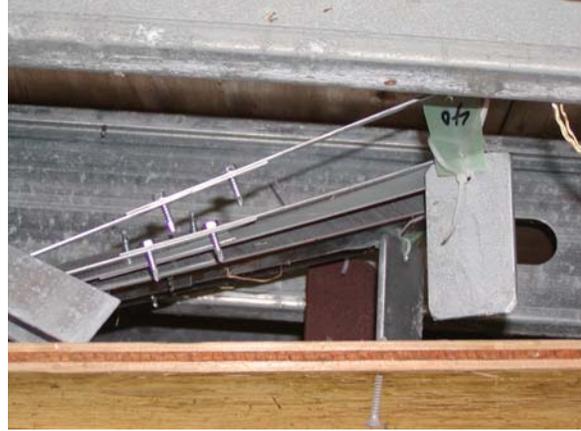
Figure D.97: Joists and specimens – covered crawl

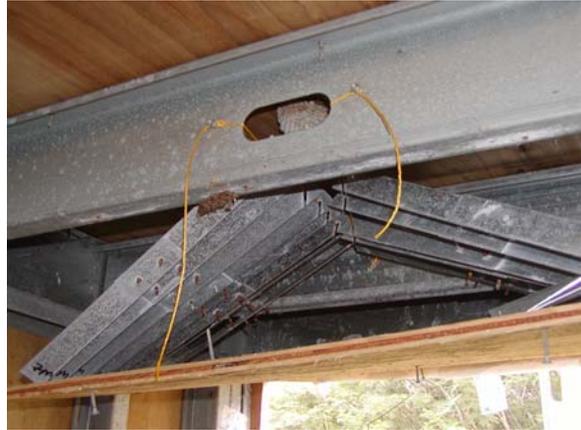
Figure D.99: 7 Month exterior specimens added

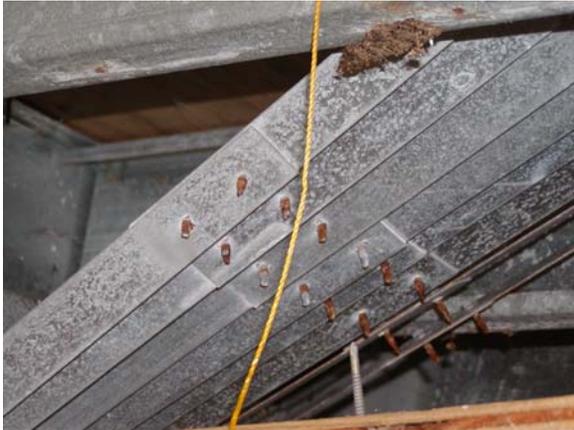
Figure D.100: 7 Month exterior exposure specimens

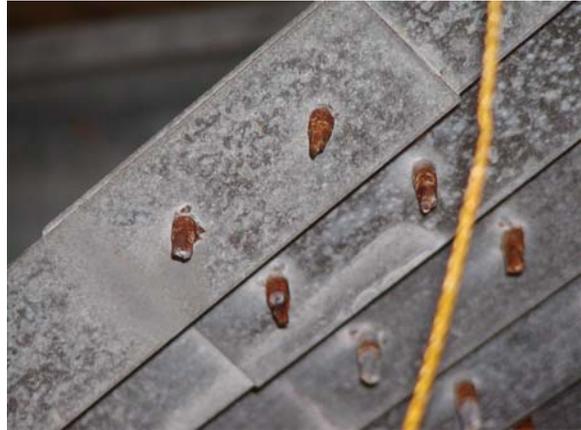
Figure D.101: 7 Month exterior fasteners

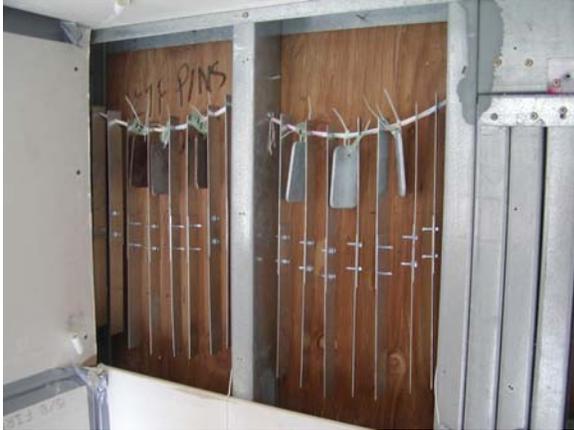
Figure D.102: Location 1 - S wall - plywood

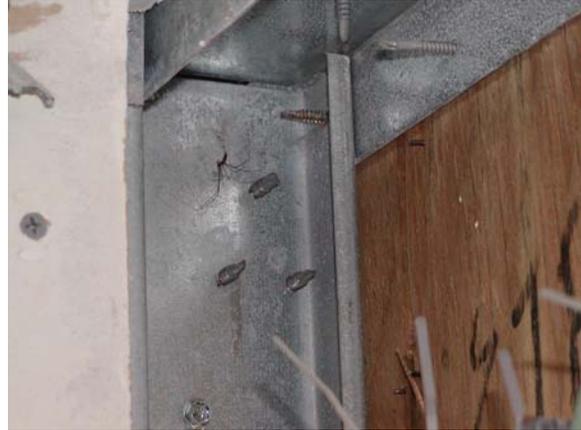
Figure D.103: Location 1 – corner connection

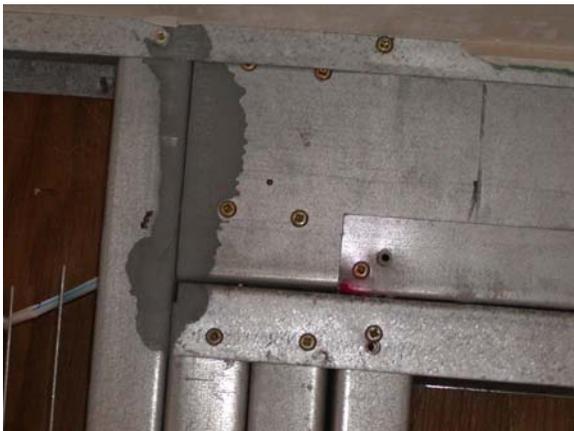
Figure D.104: Location 1 header connection

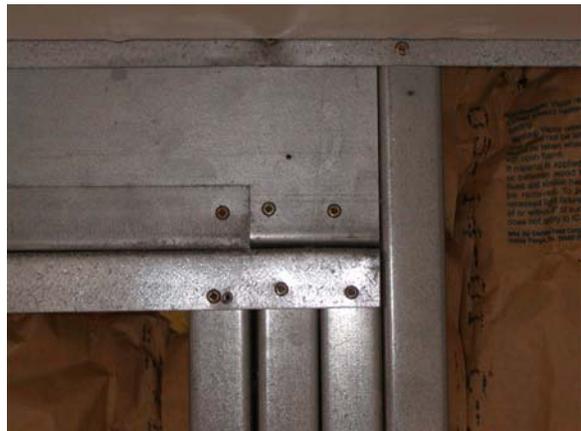
Figure D.105: Location 1 header connection

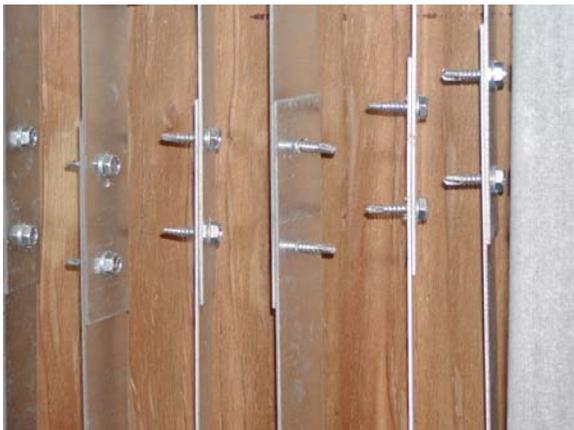
Figure D.106: Location 1 – test connections

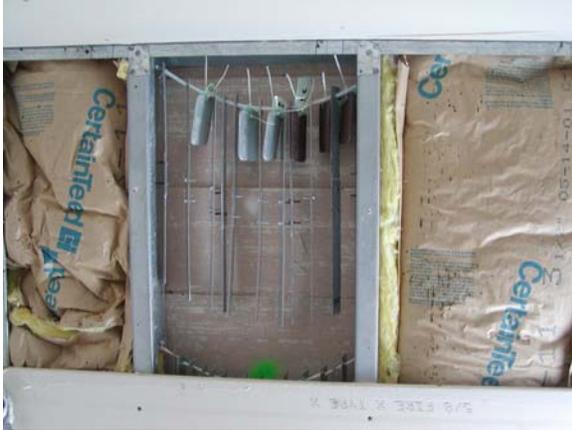
Figure D.108: Location 2 - E wall – Lap siding

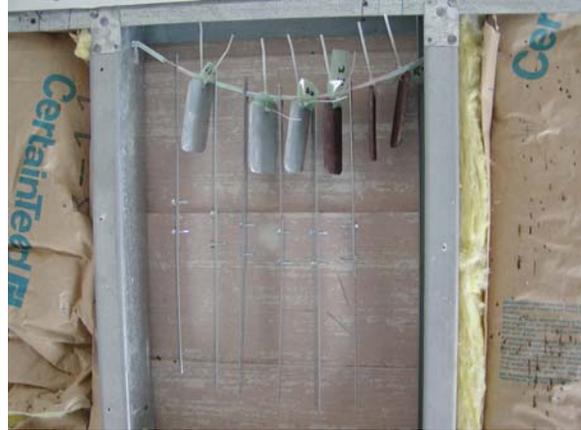
Figure D.109: Location 2 – test specimens

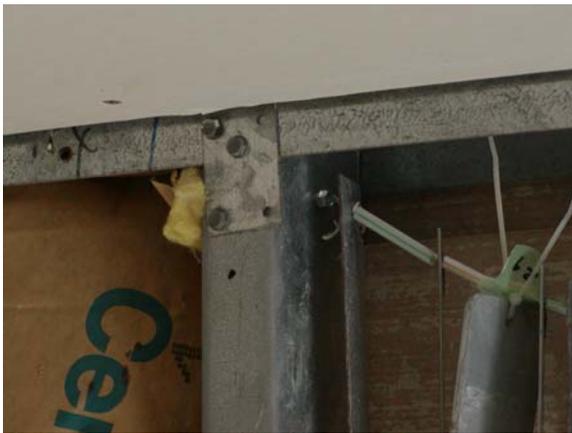
Figure D.110: Location 2 – top plate connection

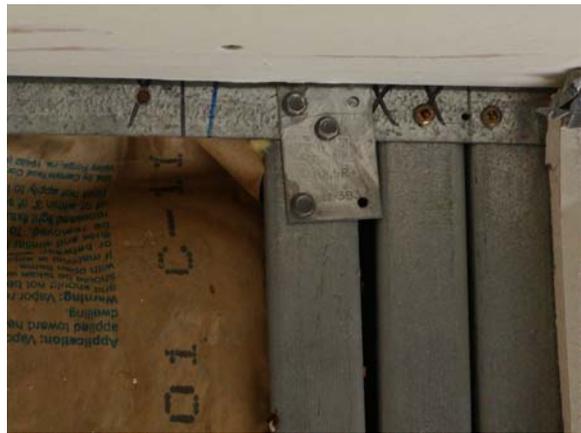
Figure D.111: Location 2 – top plate connection

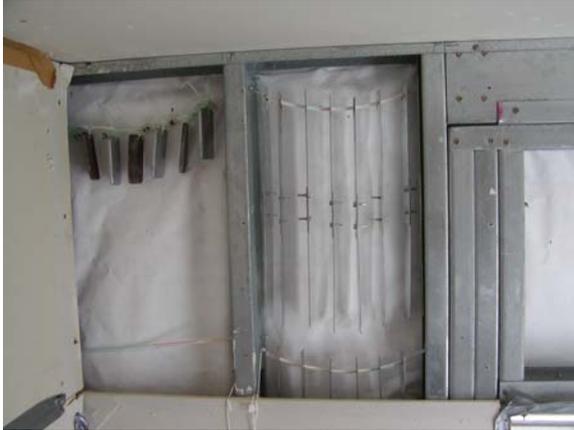
Figure D.114: Location 3 - N wall – vapor barrier
