Wheeler Army Airfield - Field Enclosure Photographs

HUD CONTRACT No.:	H-21248CA
PROJECT TITLE:	“Corrosion of Galvanized Fasteners used in Cold-Formed Steel Framing”
CONTRACTOR:	North American Steel Framing Alliance 1726 M Street, NW, Suite 601 Washington, DC 20036
Principal Investigator:	Tim Waite
Co/Investigators:	Don Moody, Kevin Bielat
SUB-CONTRACTOR:	University of Hawaii Dept. of Civil Engineering 2540 Dole Street, Holmes Hall 383 Honolulu, HI 96822
Principal Investigator	Dr. Ian N. Robertson
PROJECT PERIOD:	From 9/26/2000 to 11/25/2003
LITERATURE REVIEW REPORT:	December 27, 2000

CORROSION OF GALVANIZED FASTENERS USED IN COLD-FORMED STEEL FRAMING

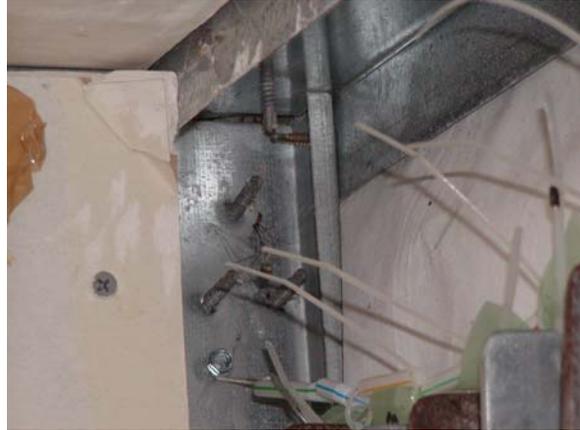
Figure D.115: Location 3 – corner connection

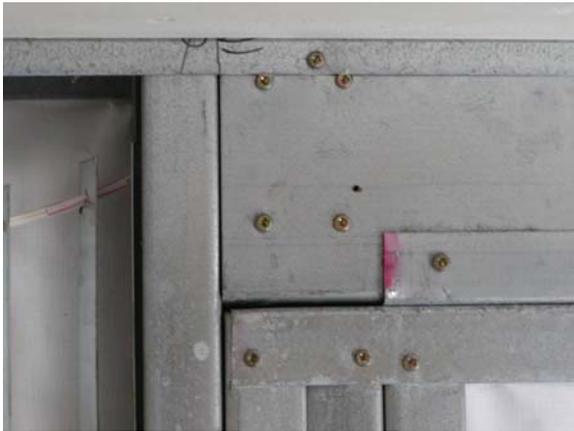
Figure D.116: Location 3 – Header connection

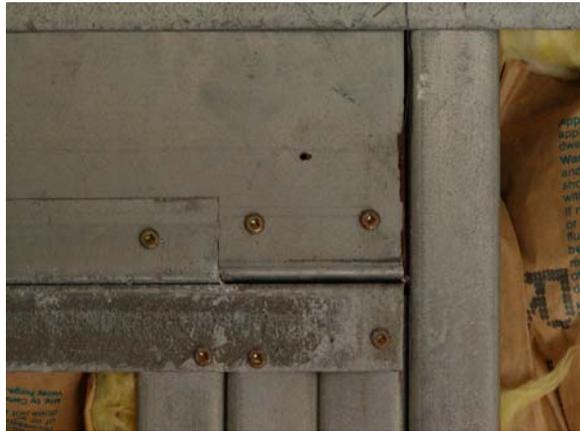
Figure D.117: Location 3 – Header connection

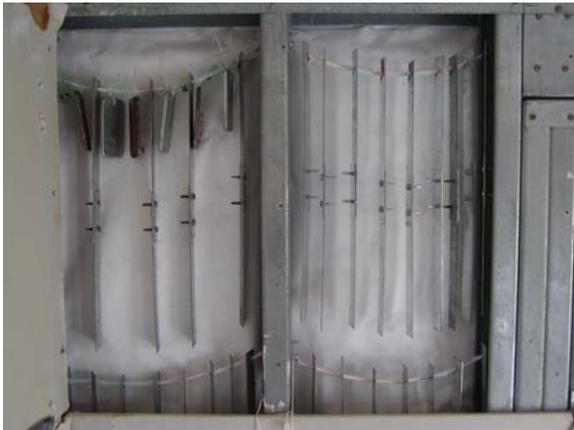
Figure D.118: Location 3 – ext connections added

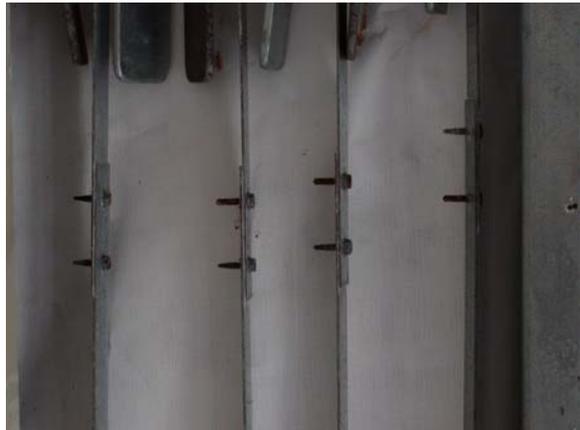
Figure D.119: 7 Month exterior connections added

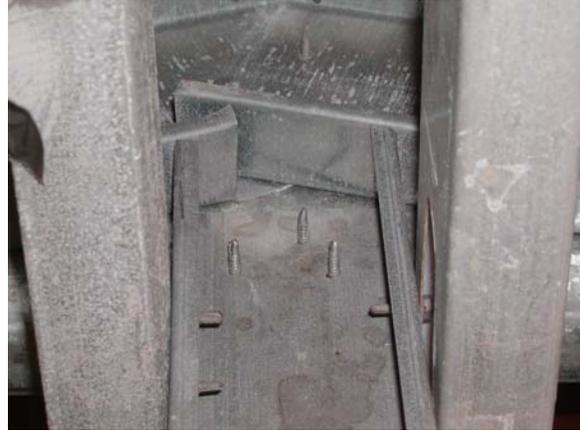
Figure D.121: Location 4 – top truss connection

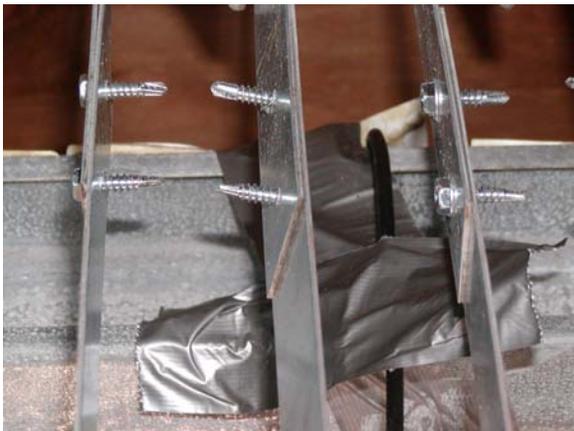
Figure D.122: Location 4 – connection fasteners

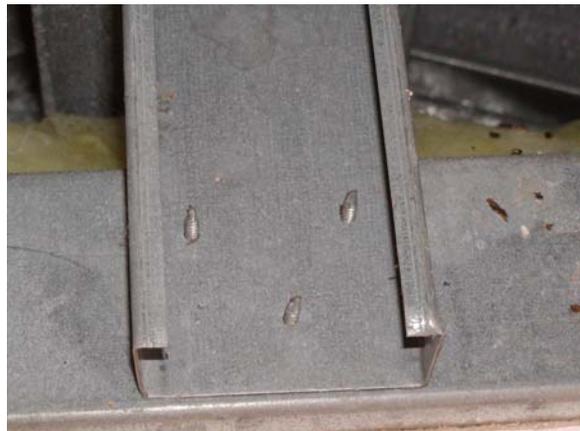
Figure D.123: Location 4 – bottom truss connection

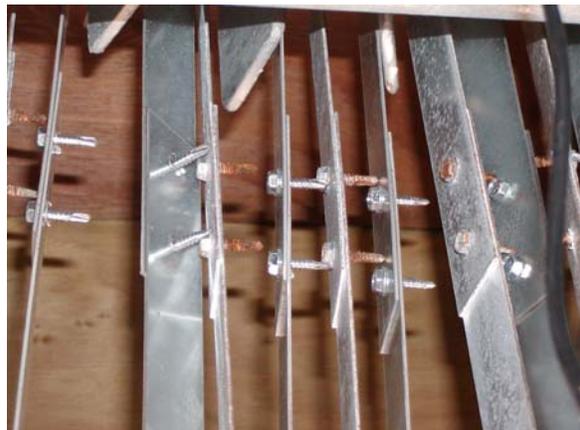
Figure D.125: 7 Month exterior connections added

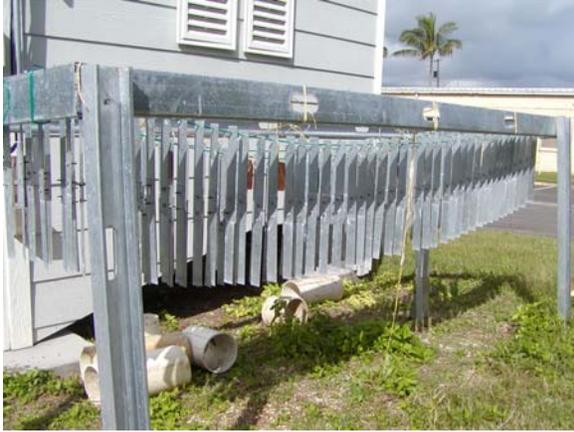
Figure D.126: Location 7 – test connections

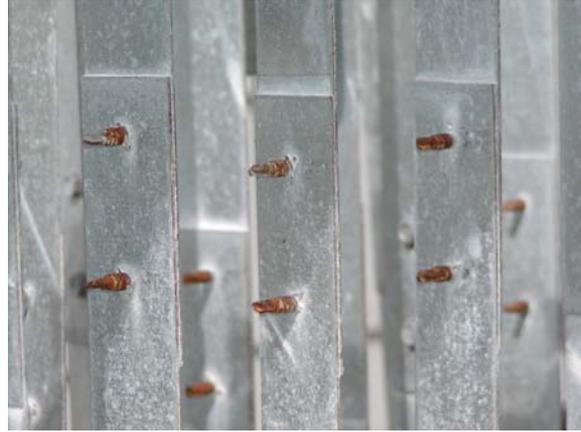
Figure D.127: Location 7 – fasteners threads

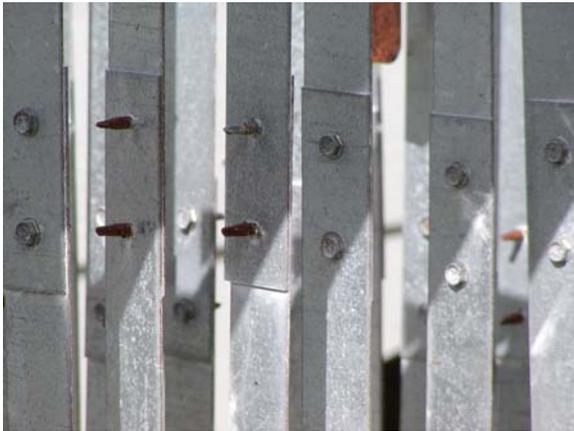
Figure D.128: Location 7 – fasteners heads

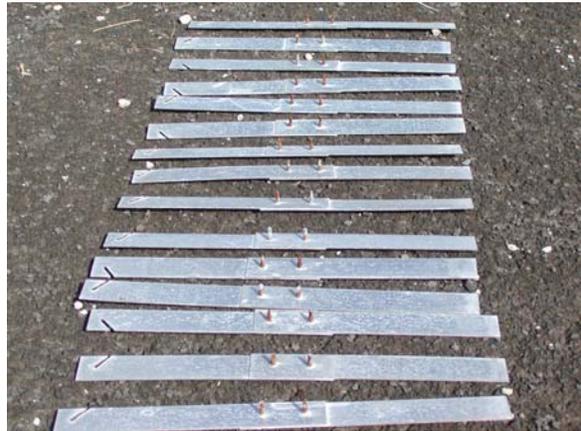
Figure D.129: Location 7 – test connection set

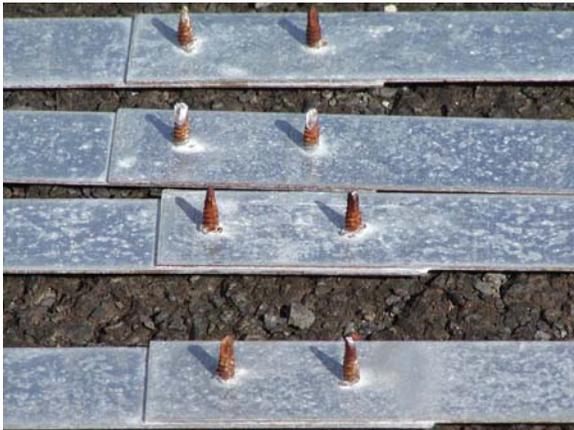
Figure D.130: Location 7 – test set fasteners

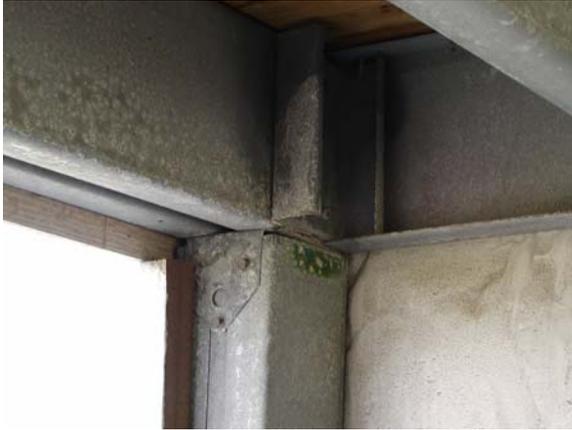
Figure E.7: Top of NW post

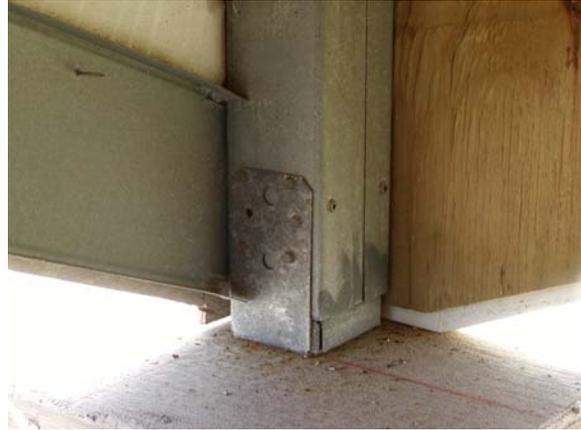
Figure E.8: Bottom of NE post

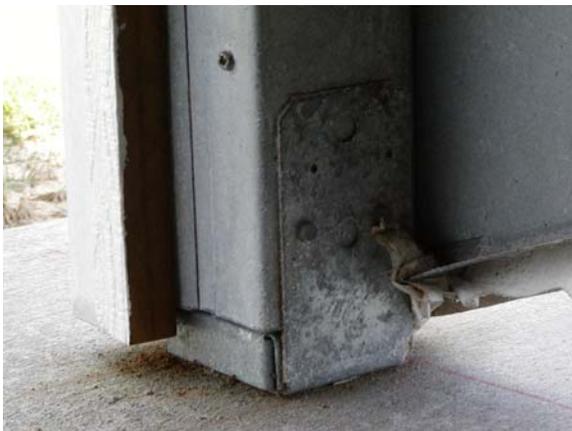
Figure E.9: Bottom of NW post

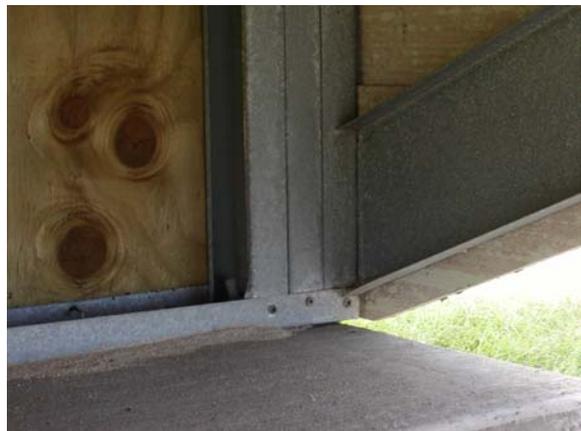
Figure E.10: Bottom of Cripple Wall - SW

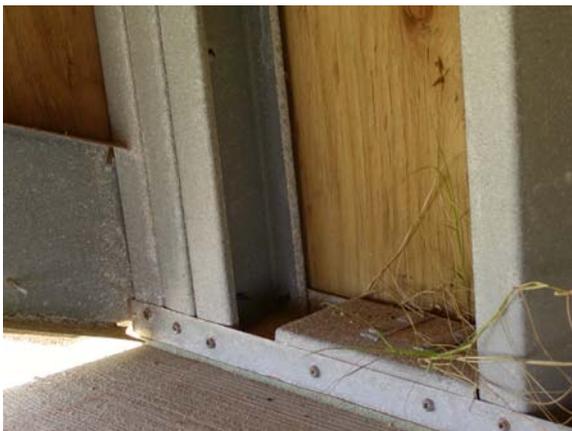
Figure E.11: Bottom of Cripple Wall - SE

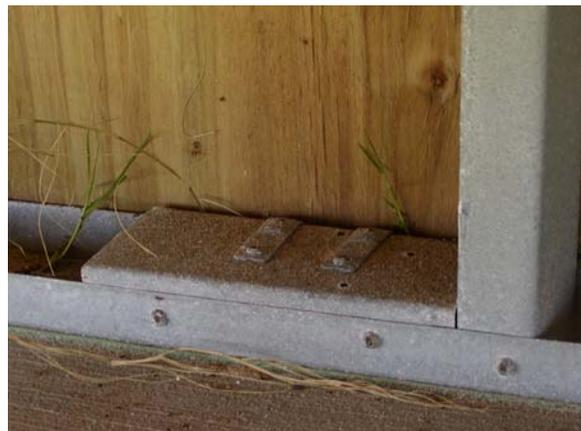
Figure E.12: Cripple Wall Tiedown

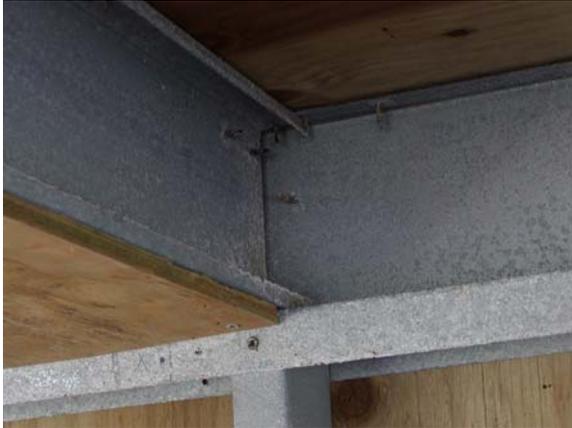
Figure E.13: Exposed Floor Joist – S Wall

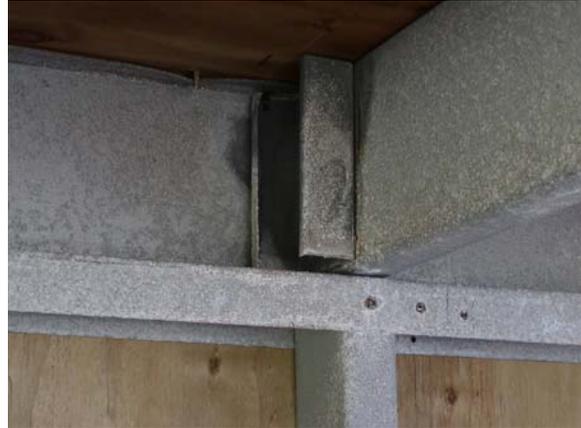
Figure E.14: Exposed Floor Joist Stiffener

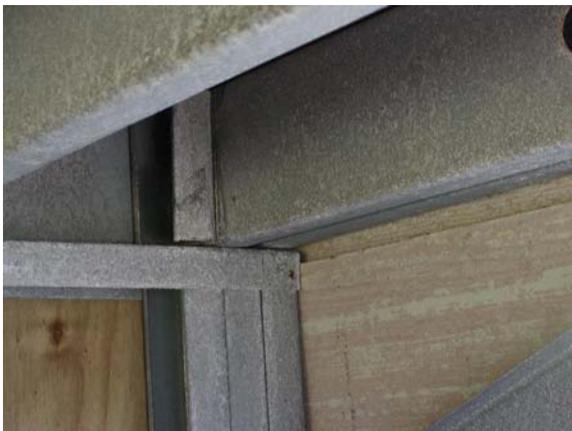
Figure E.15: Double Joist at SW corner

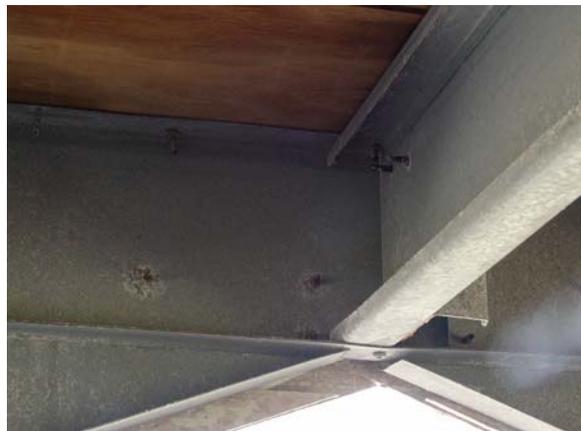
Figure E.16: Exposed Joist – N end - Center

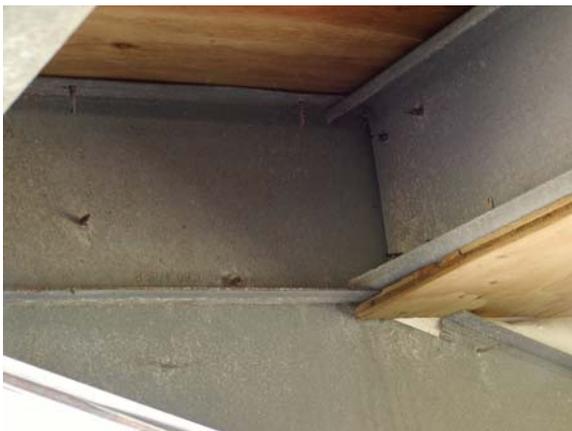
Figure E.17: Exposed Joist – N end - E of center

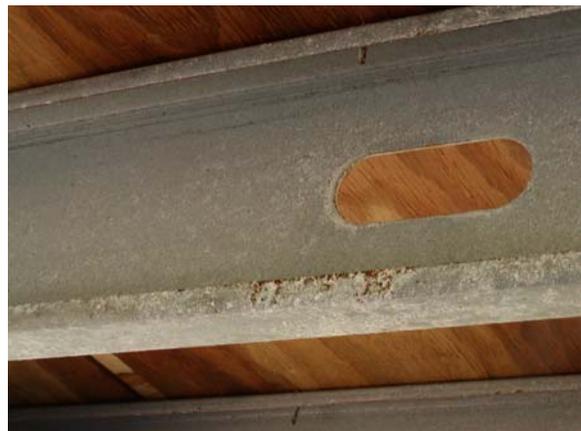
Figure E.18: Exposed Joist - Midspan

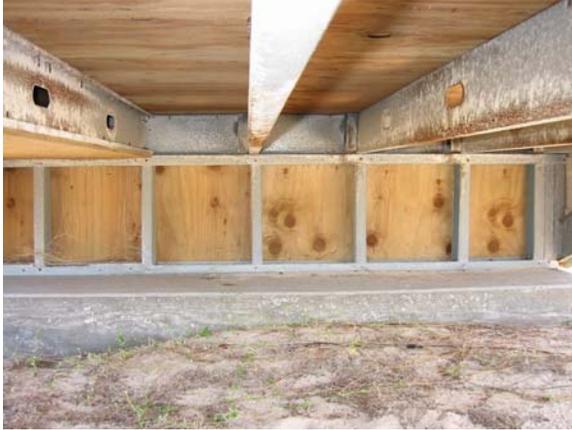
Figure E.19: Exposed Joists and Cripple Wall

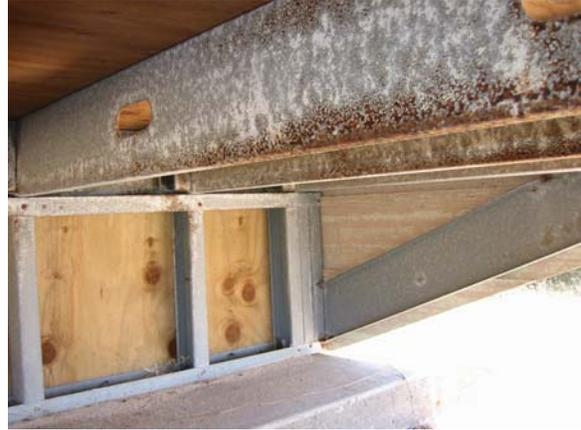
Figure E.20: Exposed Joists and Wall - SW

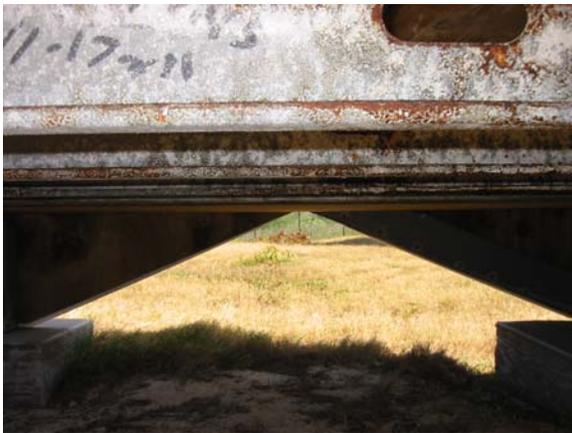
Figure E.21: Exposed Joists Midspan – West

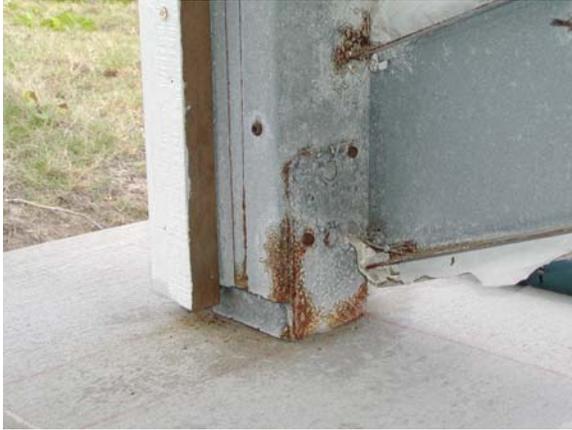
Figure E.22: Post Base – NW corner

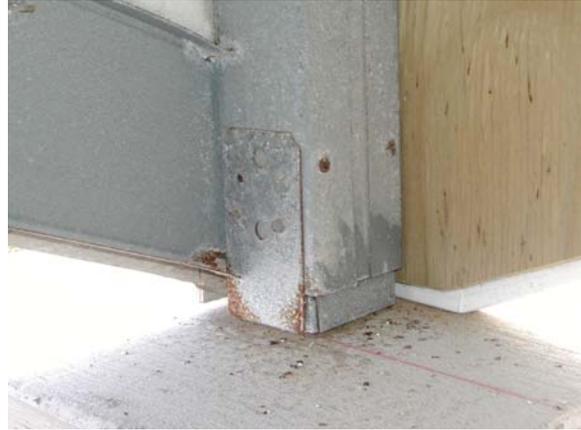
Figure E.23: Post Base – NE corner

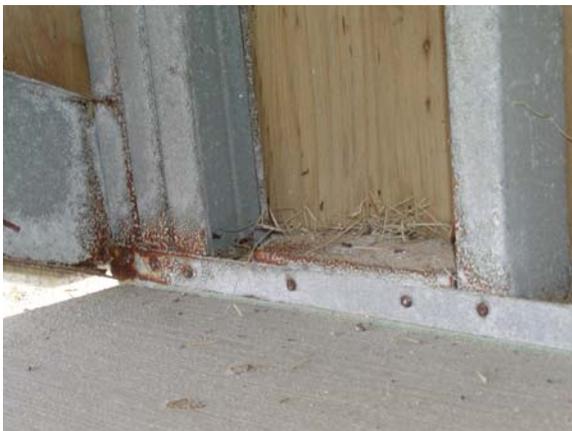
Figure E.24: Cripple Wall Base – SE corner

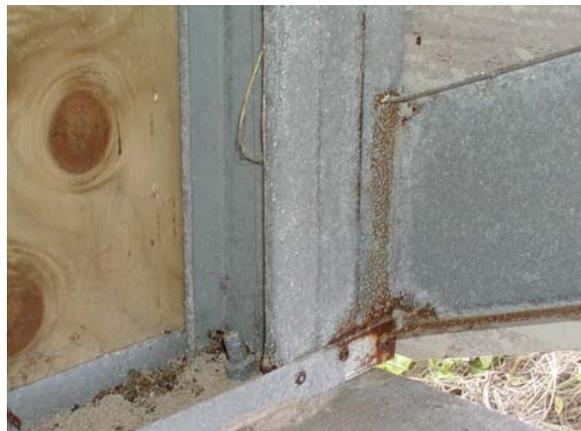
Figure E.25: Cripple Wall Base – SW corner

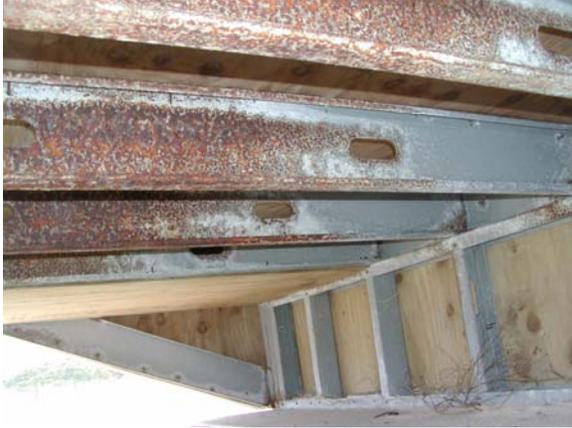
Figure E.26: Exposed Floor Joists - SE

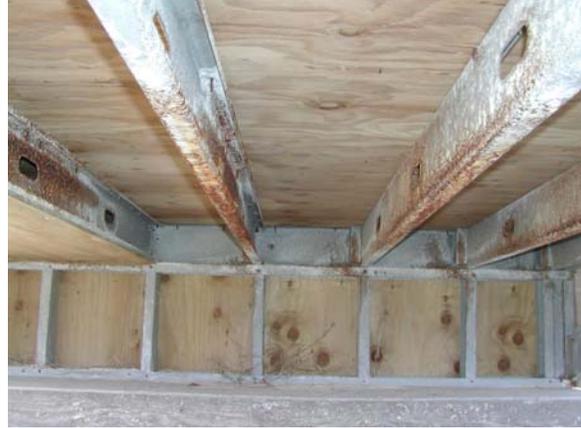
Figure E.27: Exposed Floor Joists - South

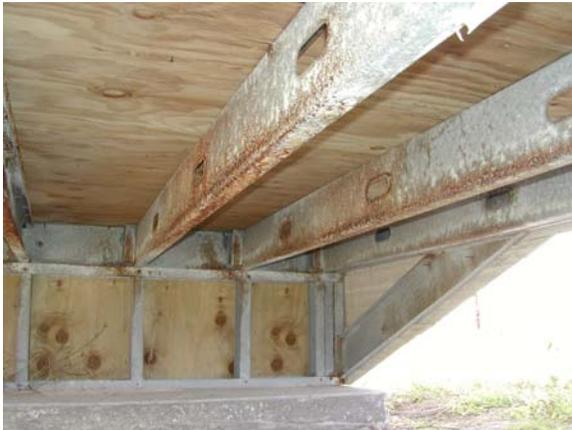
Figure E.28: Exposed Floor Joists - SW

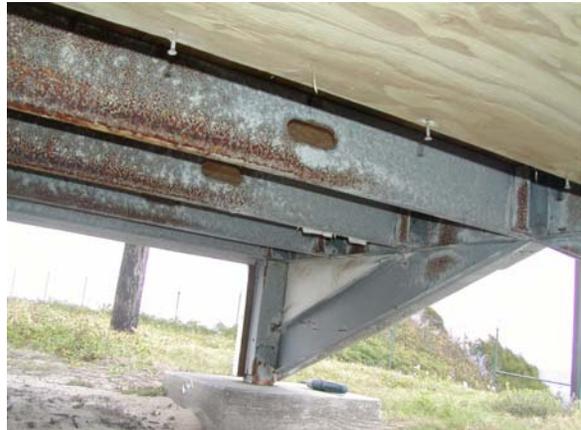
Figure E.29: Exposed Floor Joists - NW

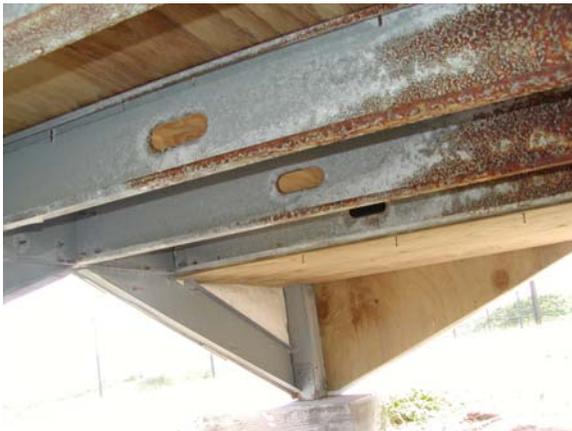
Figure E.30: Exposed Floor Joists - NE

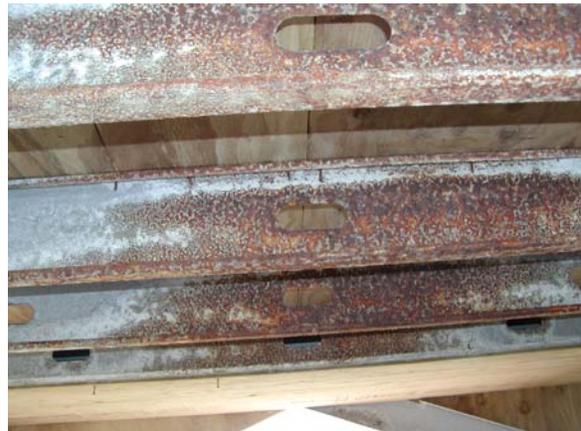
Figure E.31: Exposed Floor Joists – Midspan - E

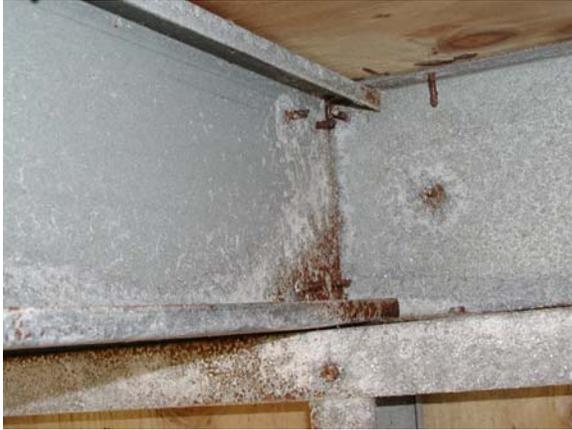
Figure E.32: Joist connection at cripple wall

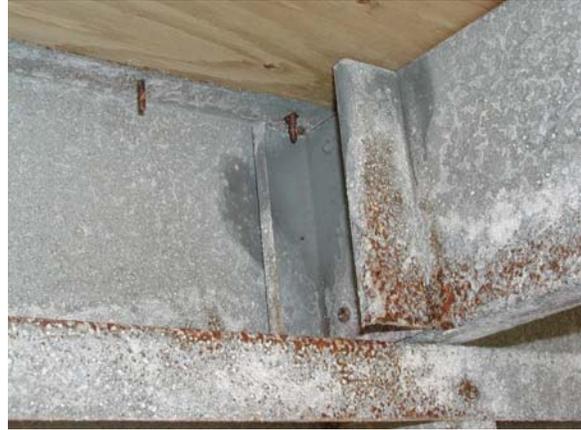
Figure E.33: Joist stiffener at cripple wall

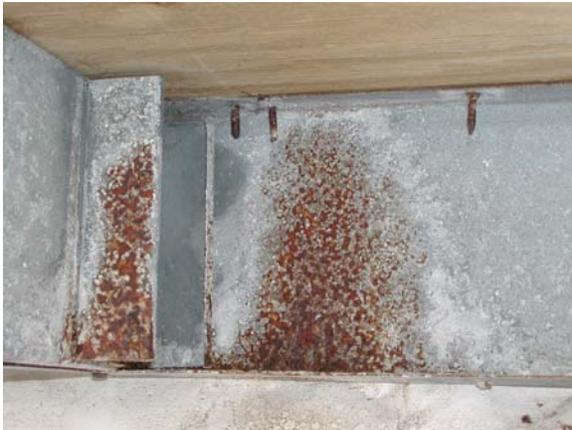
Figure E.34: Joist stiffener at South end

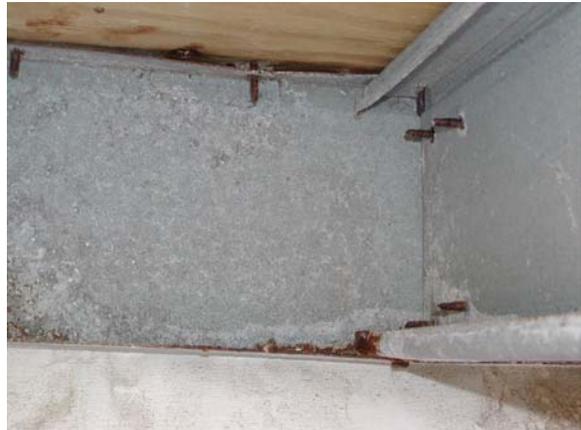
Figure E.35: Joist connection at South end

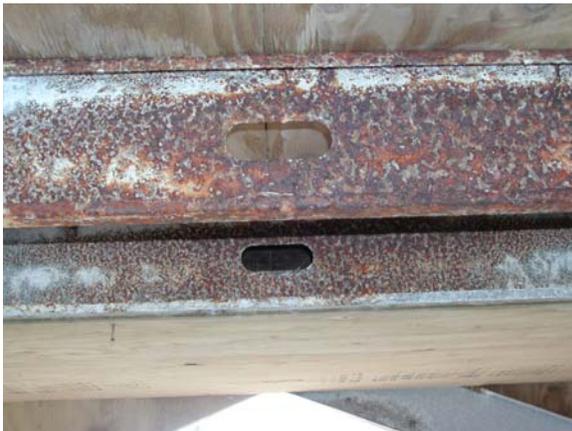
Figure E.36: Exposed joist detail at midspan

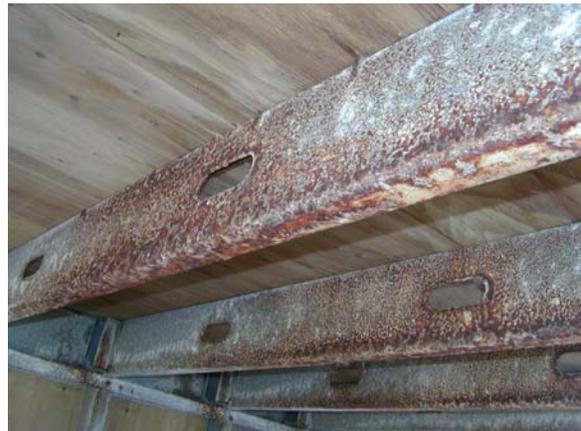
Figure E.37: Exposed joist soffit at midspan

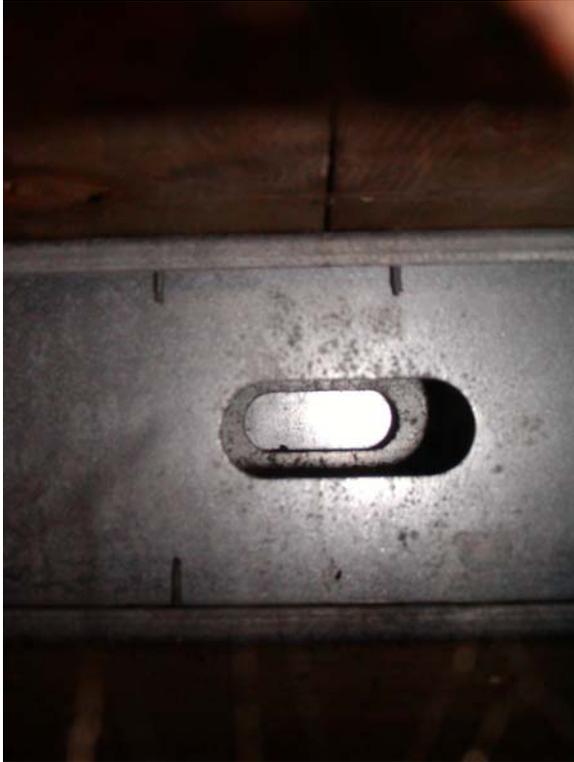
Figure E.38: Enclosed floor joist punch-out

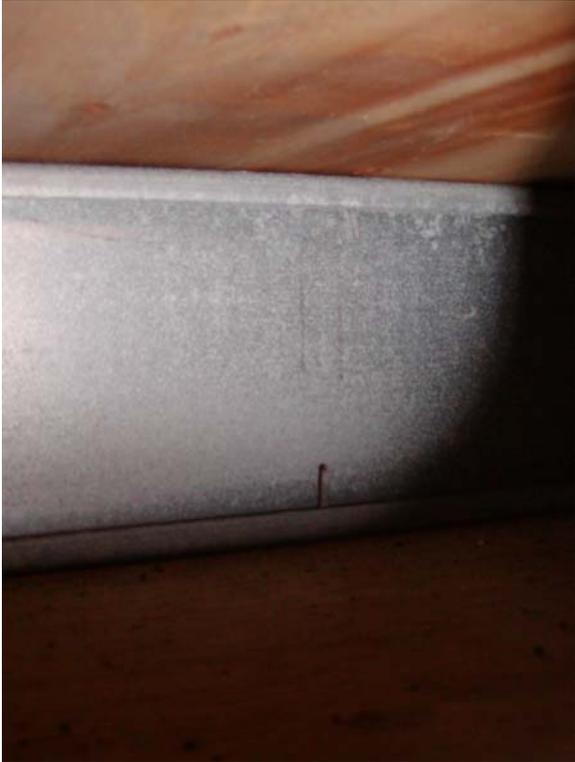
Figure E.39: Enclosed floor joist detail

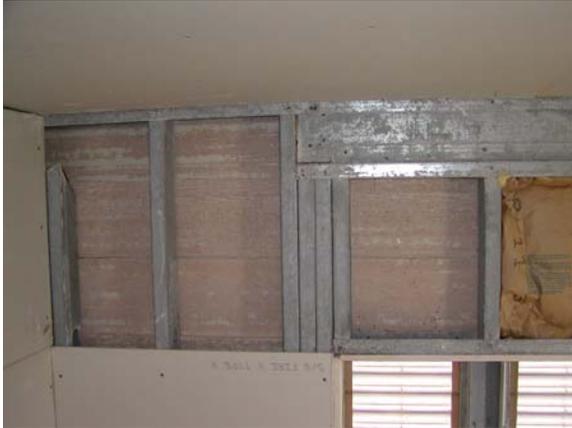
Figure E.40: W wall – Lap siding w/o vapor barrier

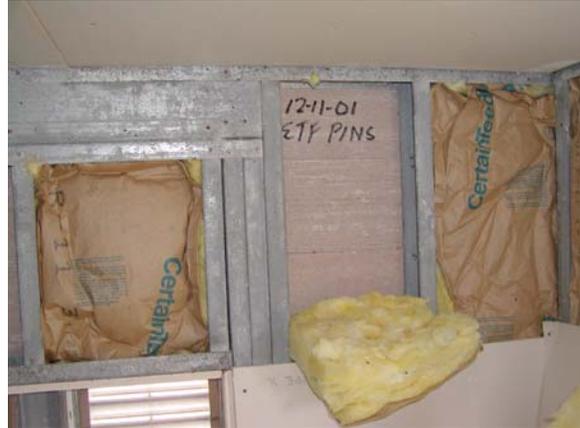
Figure E.41: W wall – Lap siding with insulation

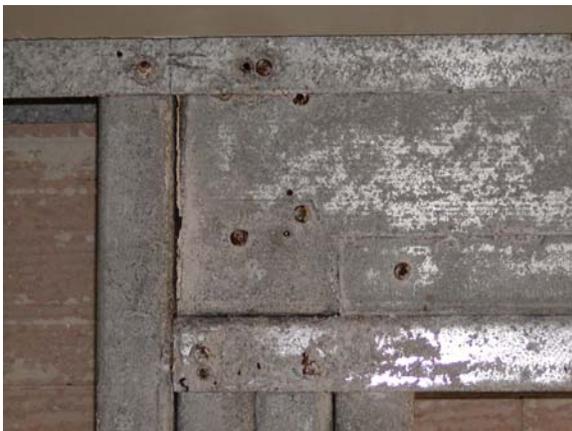
Figure E.42: W wall header connection

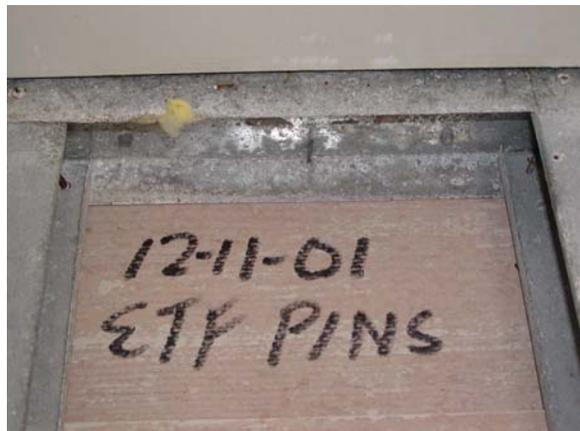
Figure E.43: W wall top track

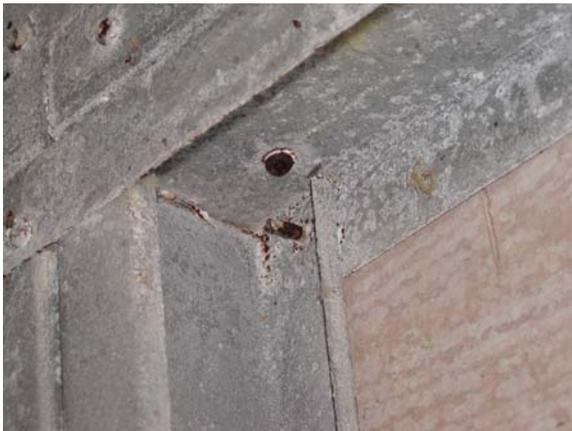
Figure E.44: W Wall top track connection

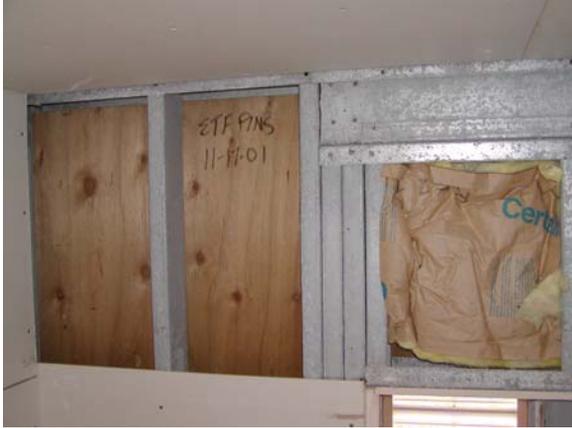
Figure E.46: E wall – Plywood w/o vapor barrier

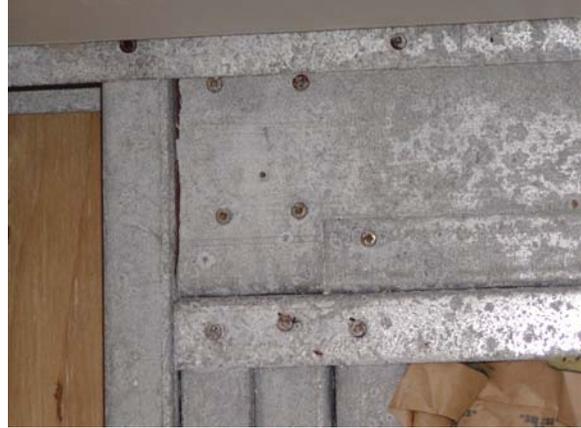
Figure E.47: E wall – Header connection

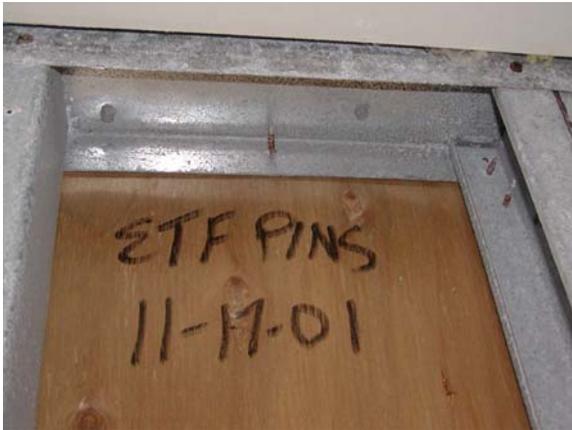
Figure E.48: E wall – Top track

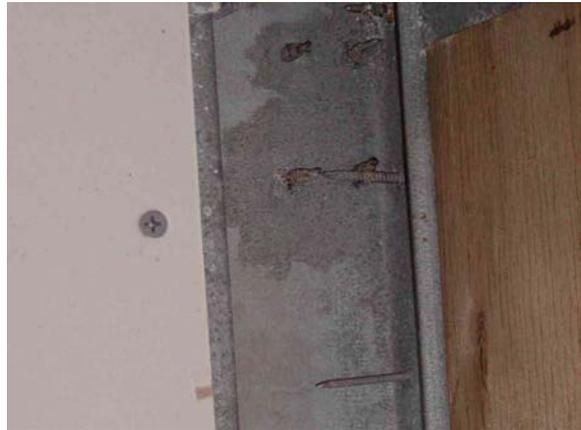
Figure E.49: E wall – Sheathing & stud fasteners

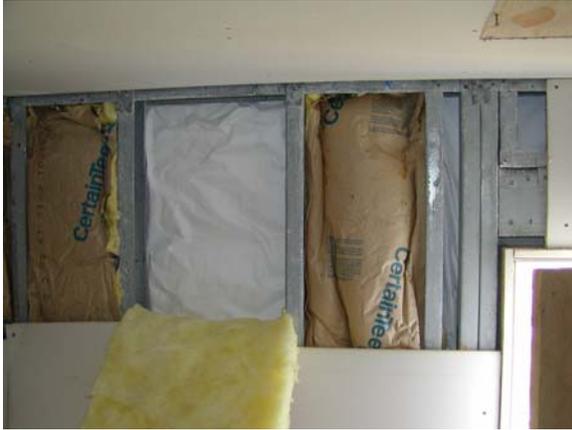
Figure E.50: N wall – vapor barrier & insulation

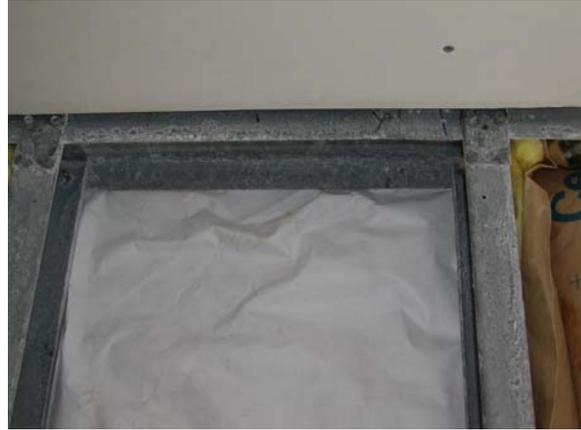
Figure E.51: N wall – top track

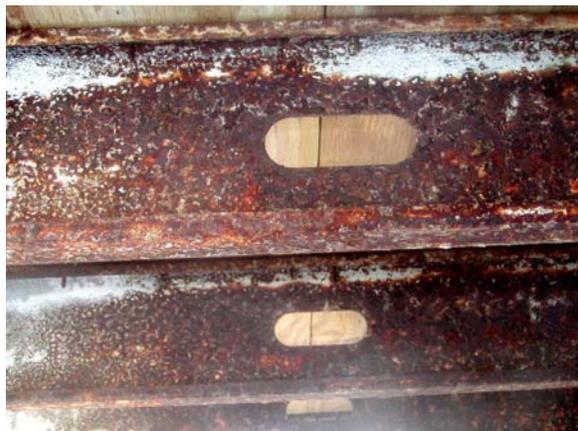
Figure E.71: Exposed Joists – Midspan corrosion

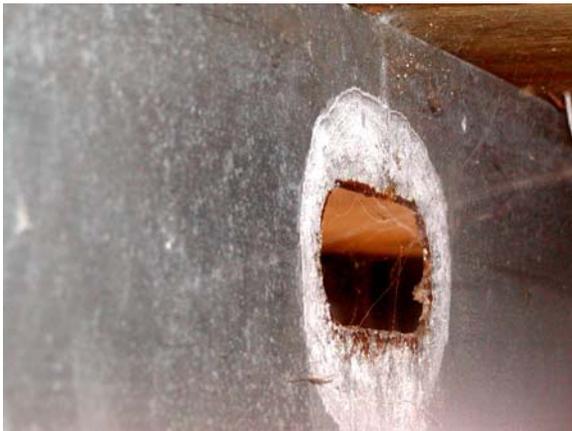
Figure E.82: Corrosion around opening in joist

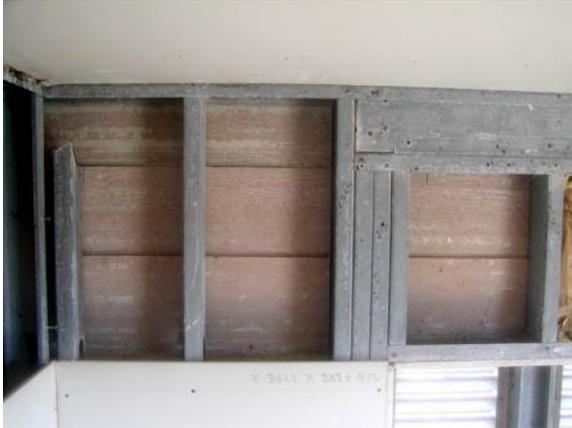
Figure E.84: W wall – Lap siding w/o vapor barrier

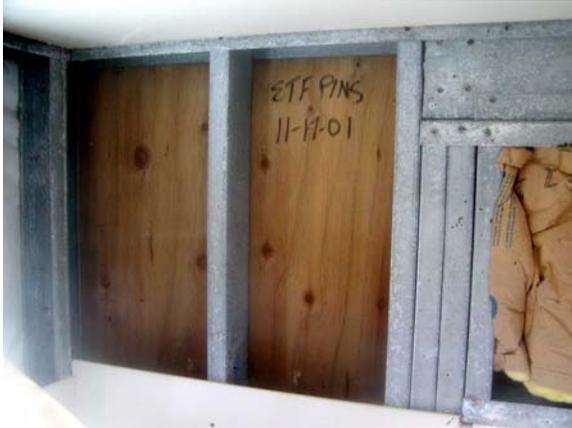
Figure E.90: E wall – Plywood w/o vapor barrier
